**OHAKPU COMMUNITY
PRIMARY SCHOOL,
ORU WEST,
IMO STATE, NIGERIA.**

CHARIS LEARNING FOUNDATION

SITE ANALYSIS

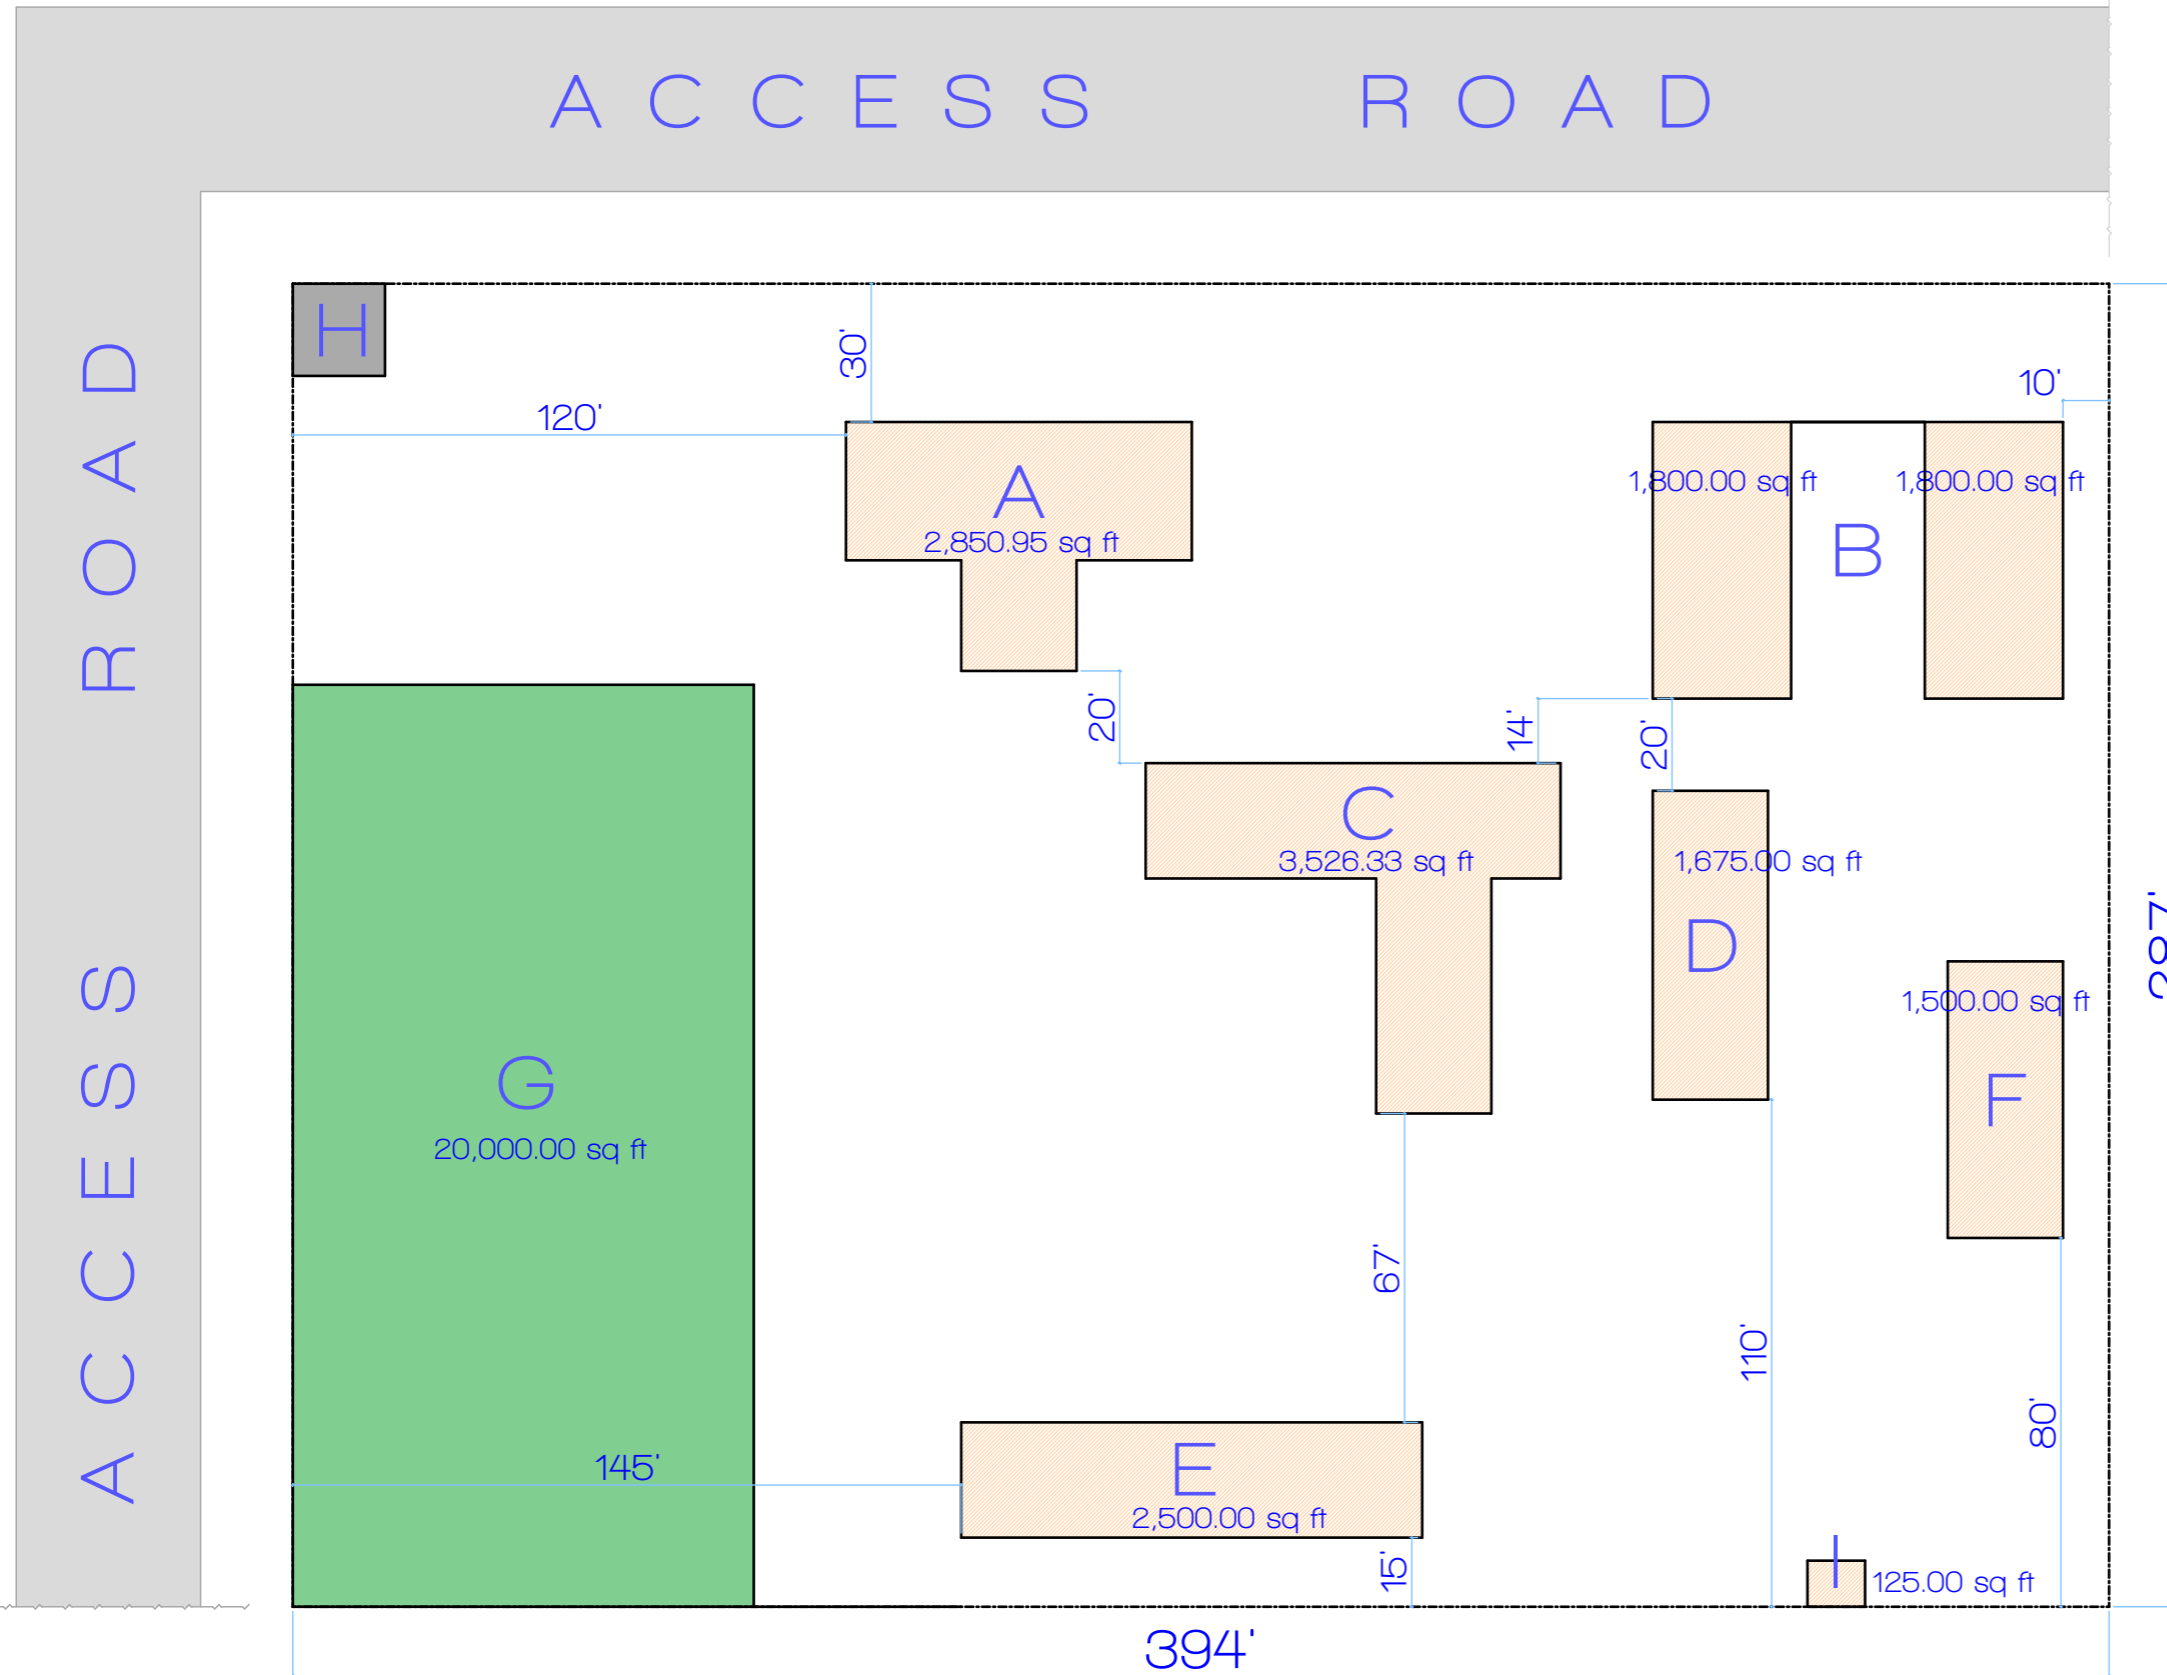
- Premises is unkempt; overgrown with bushes.
- Playground not properly maintained.
- No covered connecting walkways amongst buildings.
- No security. No perimeter fences. Site is porous on all its perimeters and thus susceptible to predators.
- Dilapidated Structures on site.
- No proper Landscape design
- No proper water system within the premises
- No clinic, sick bay, or first aid facility for the school

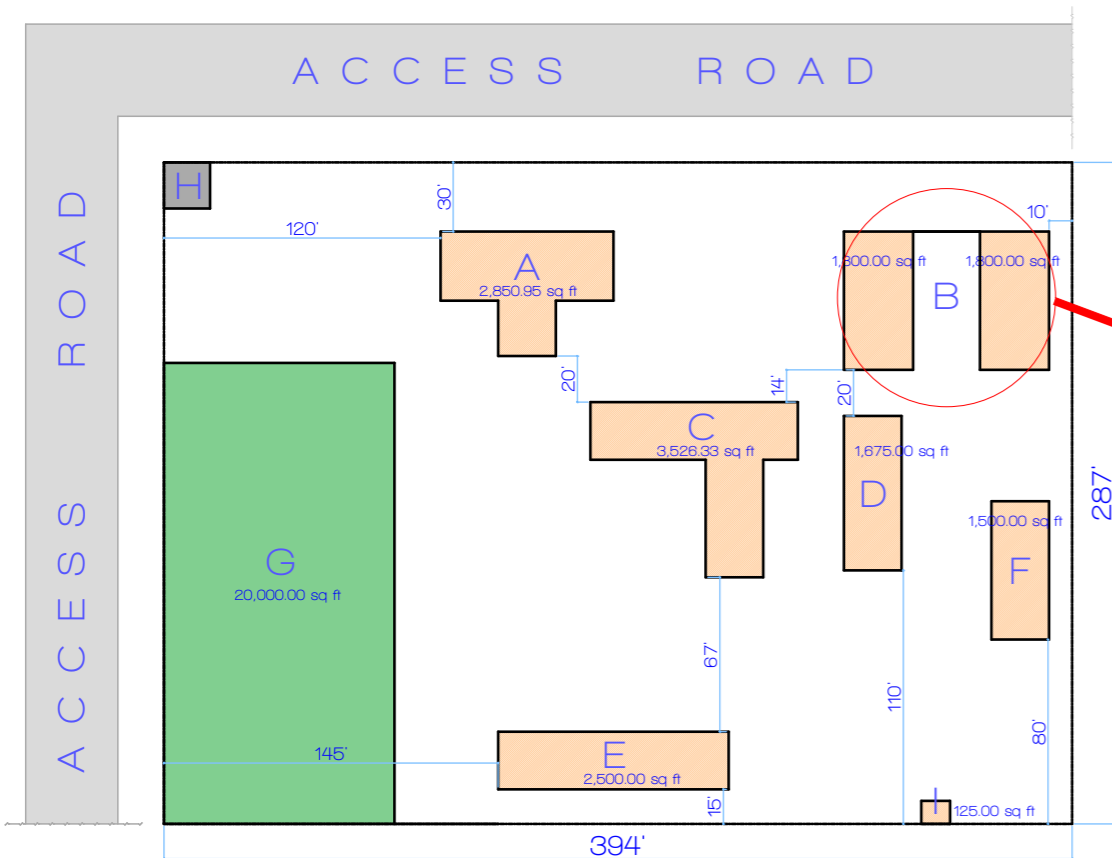
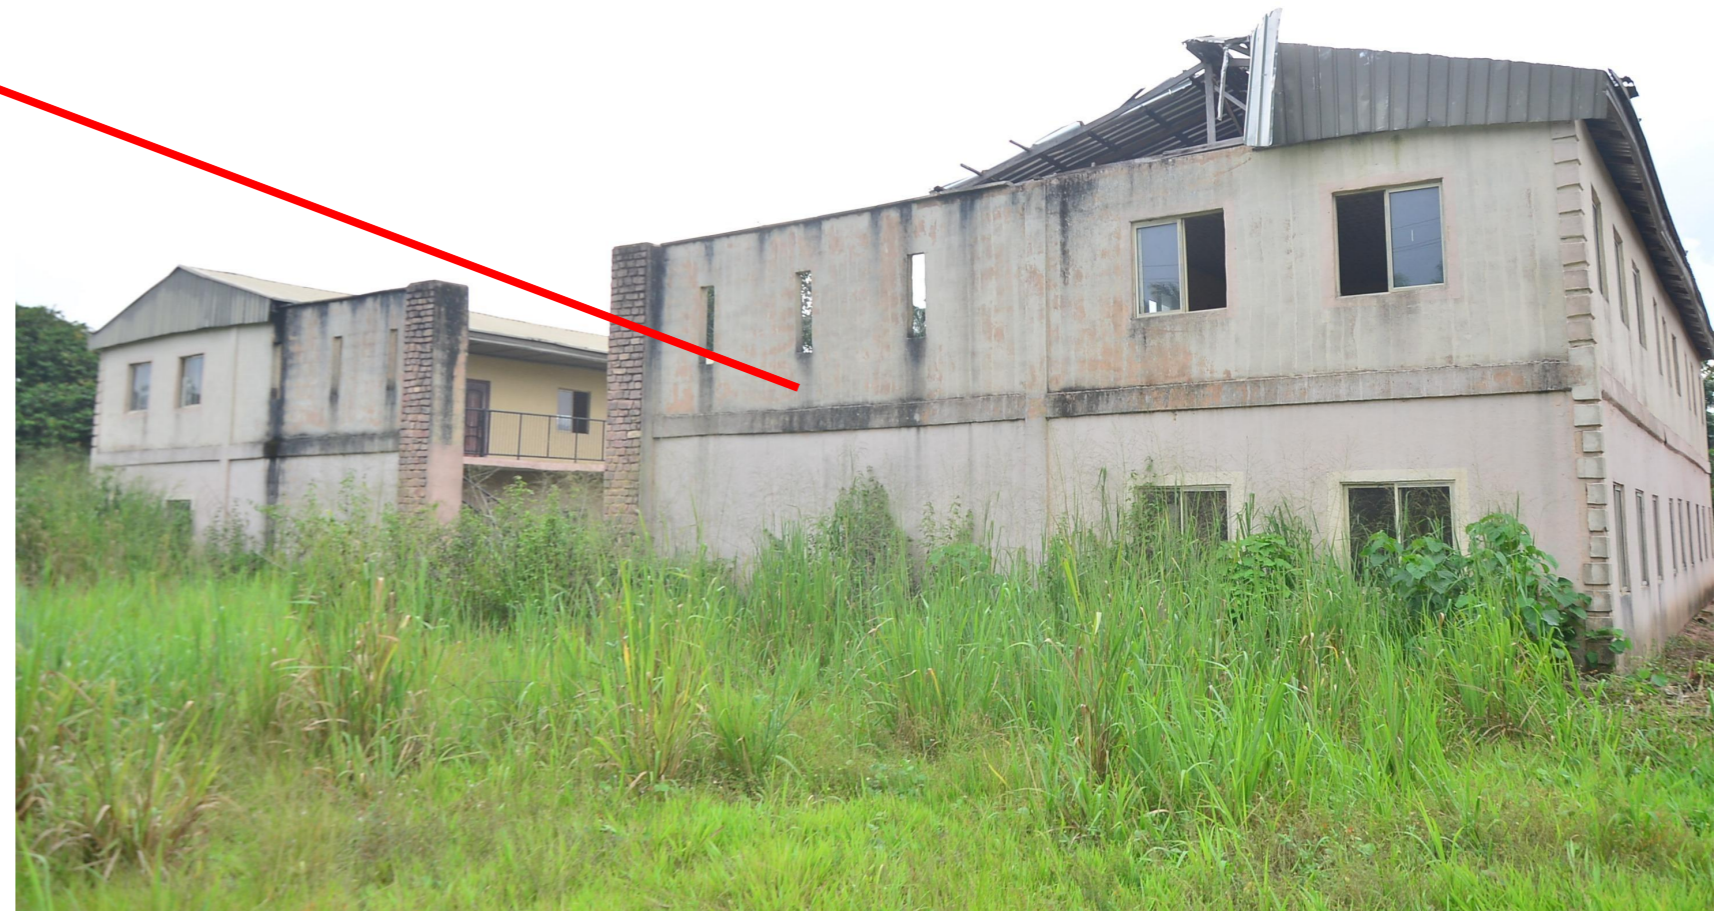
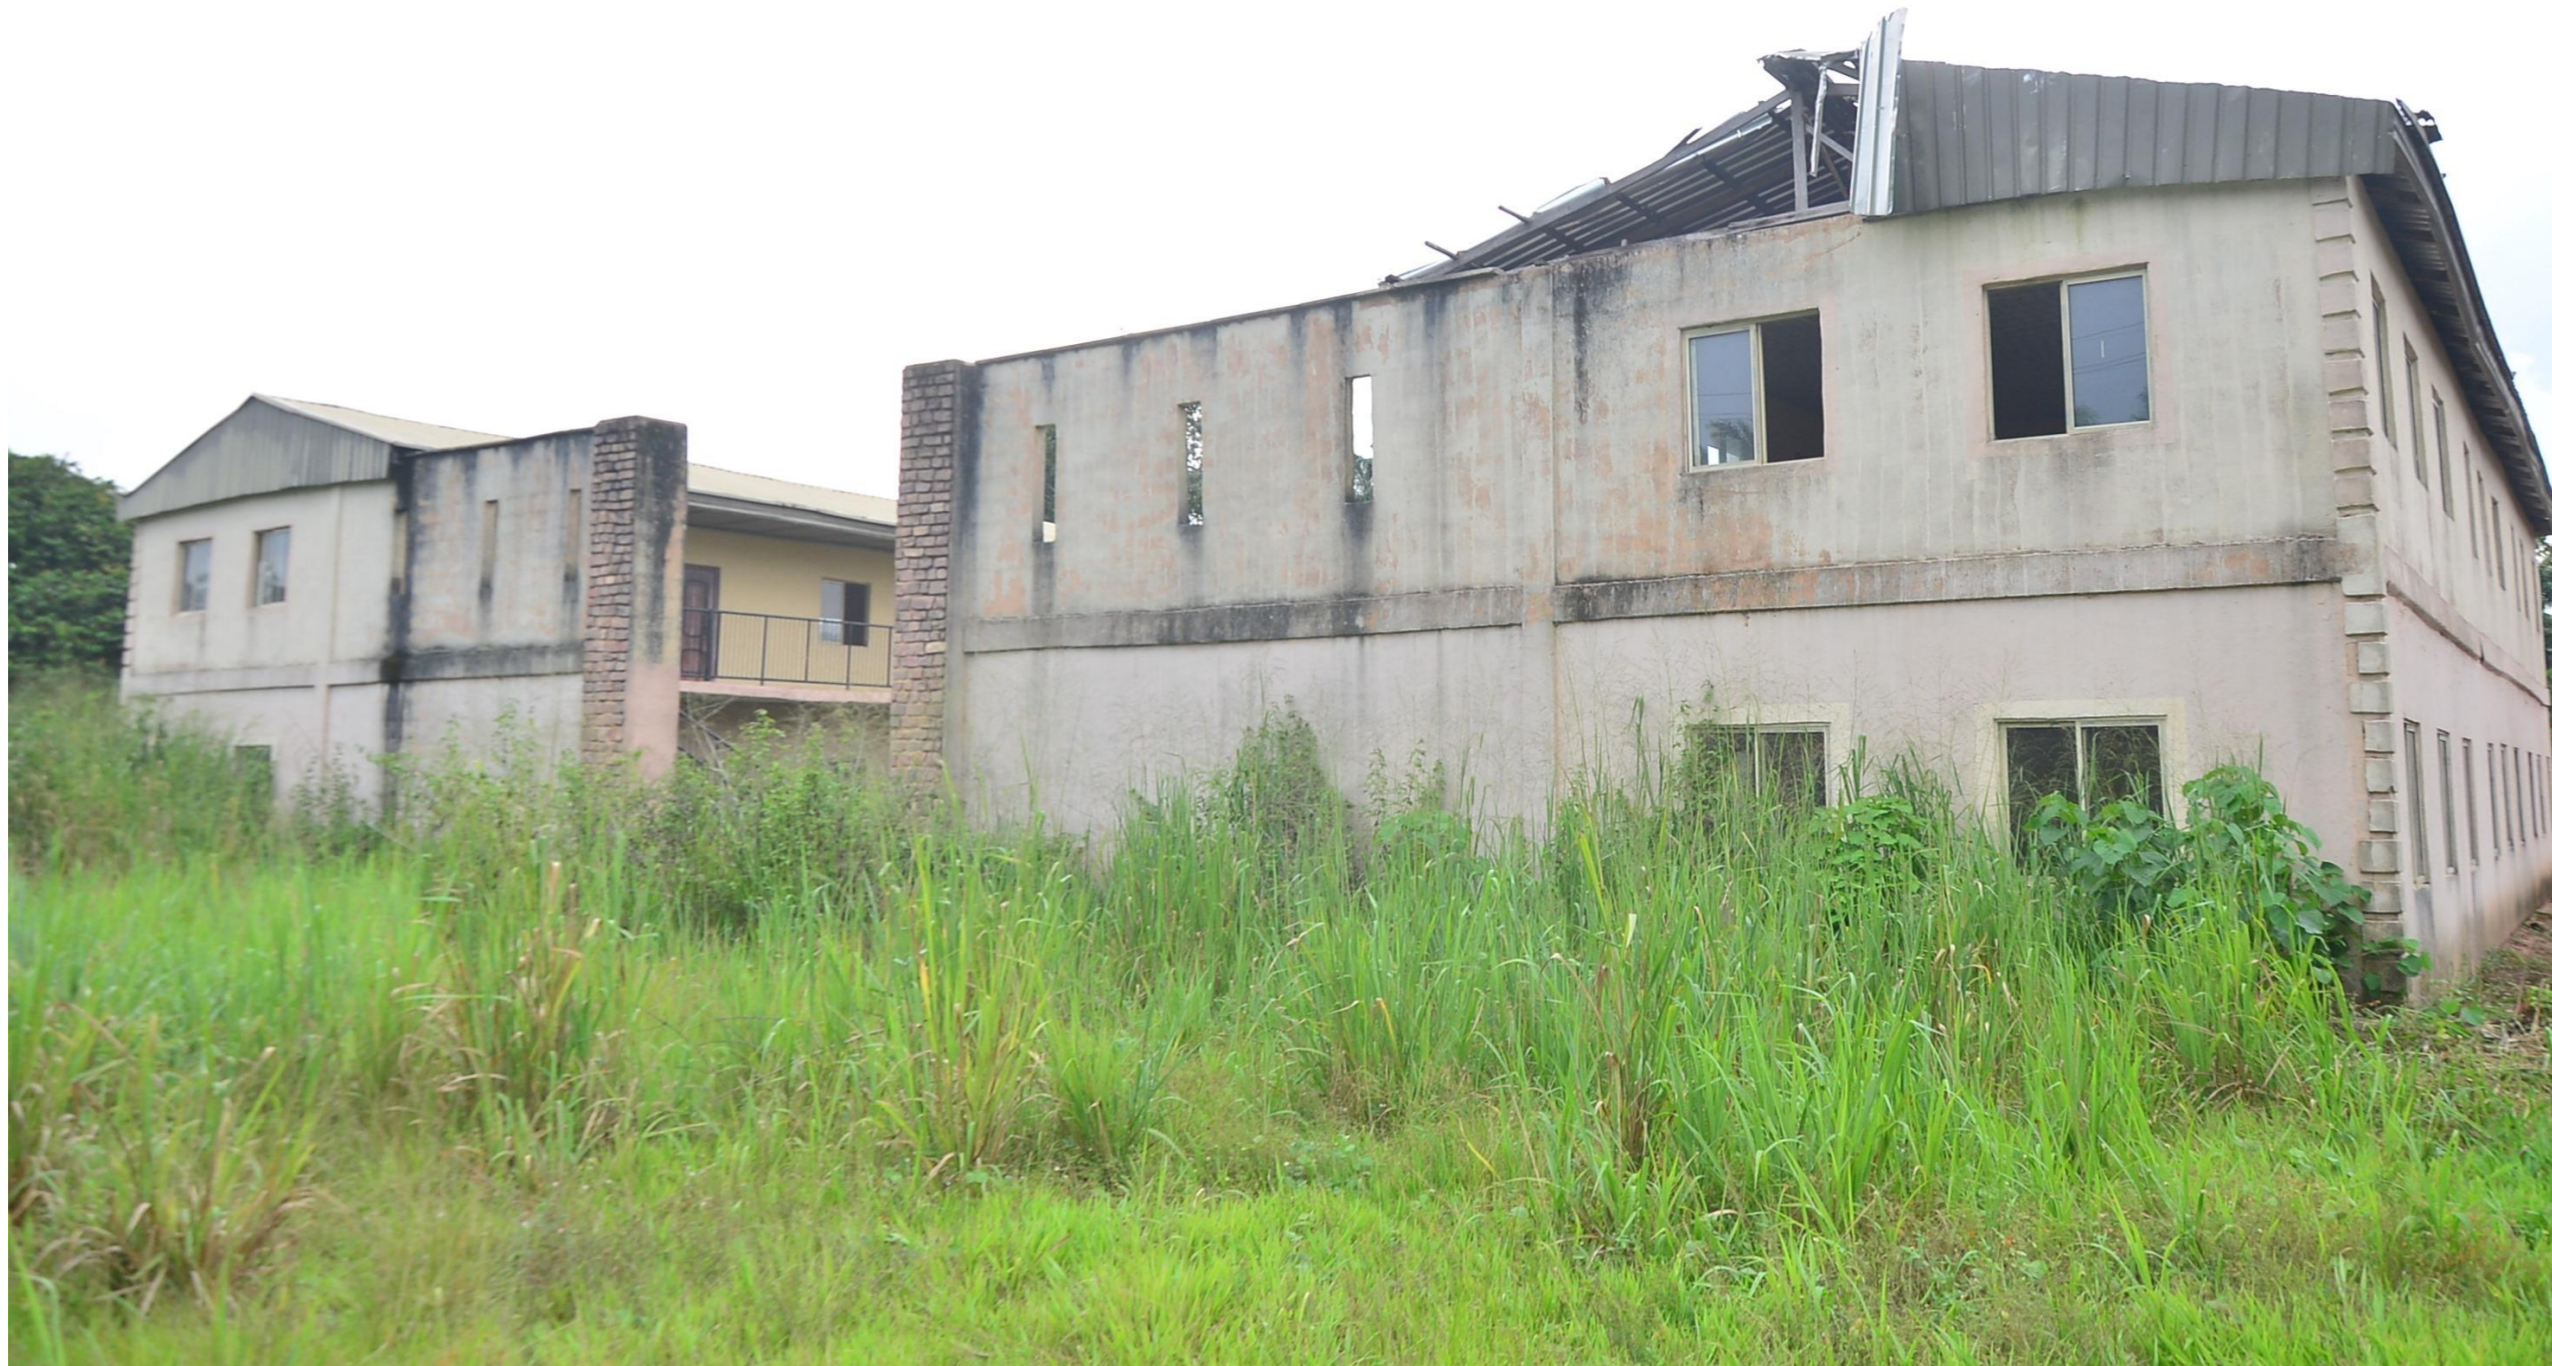
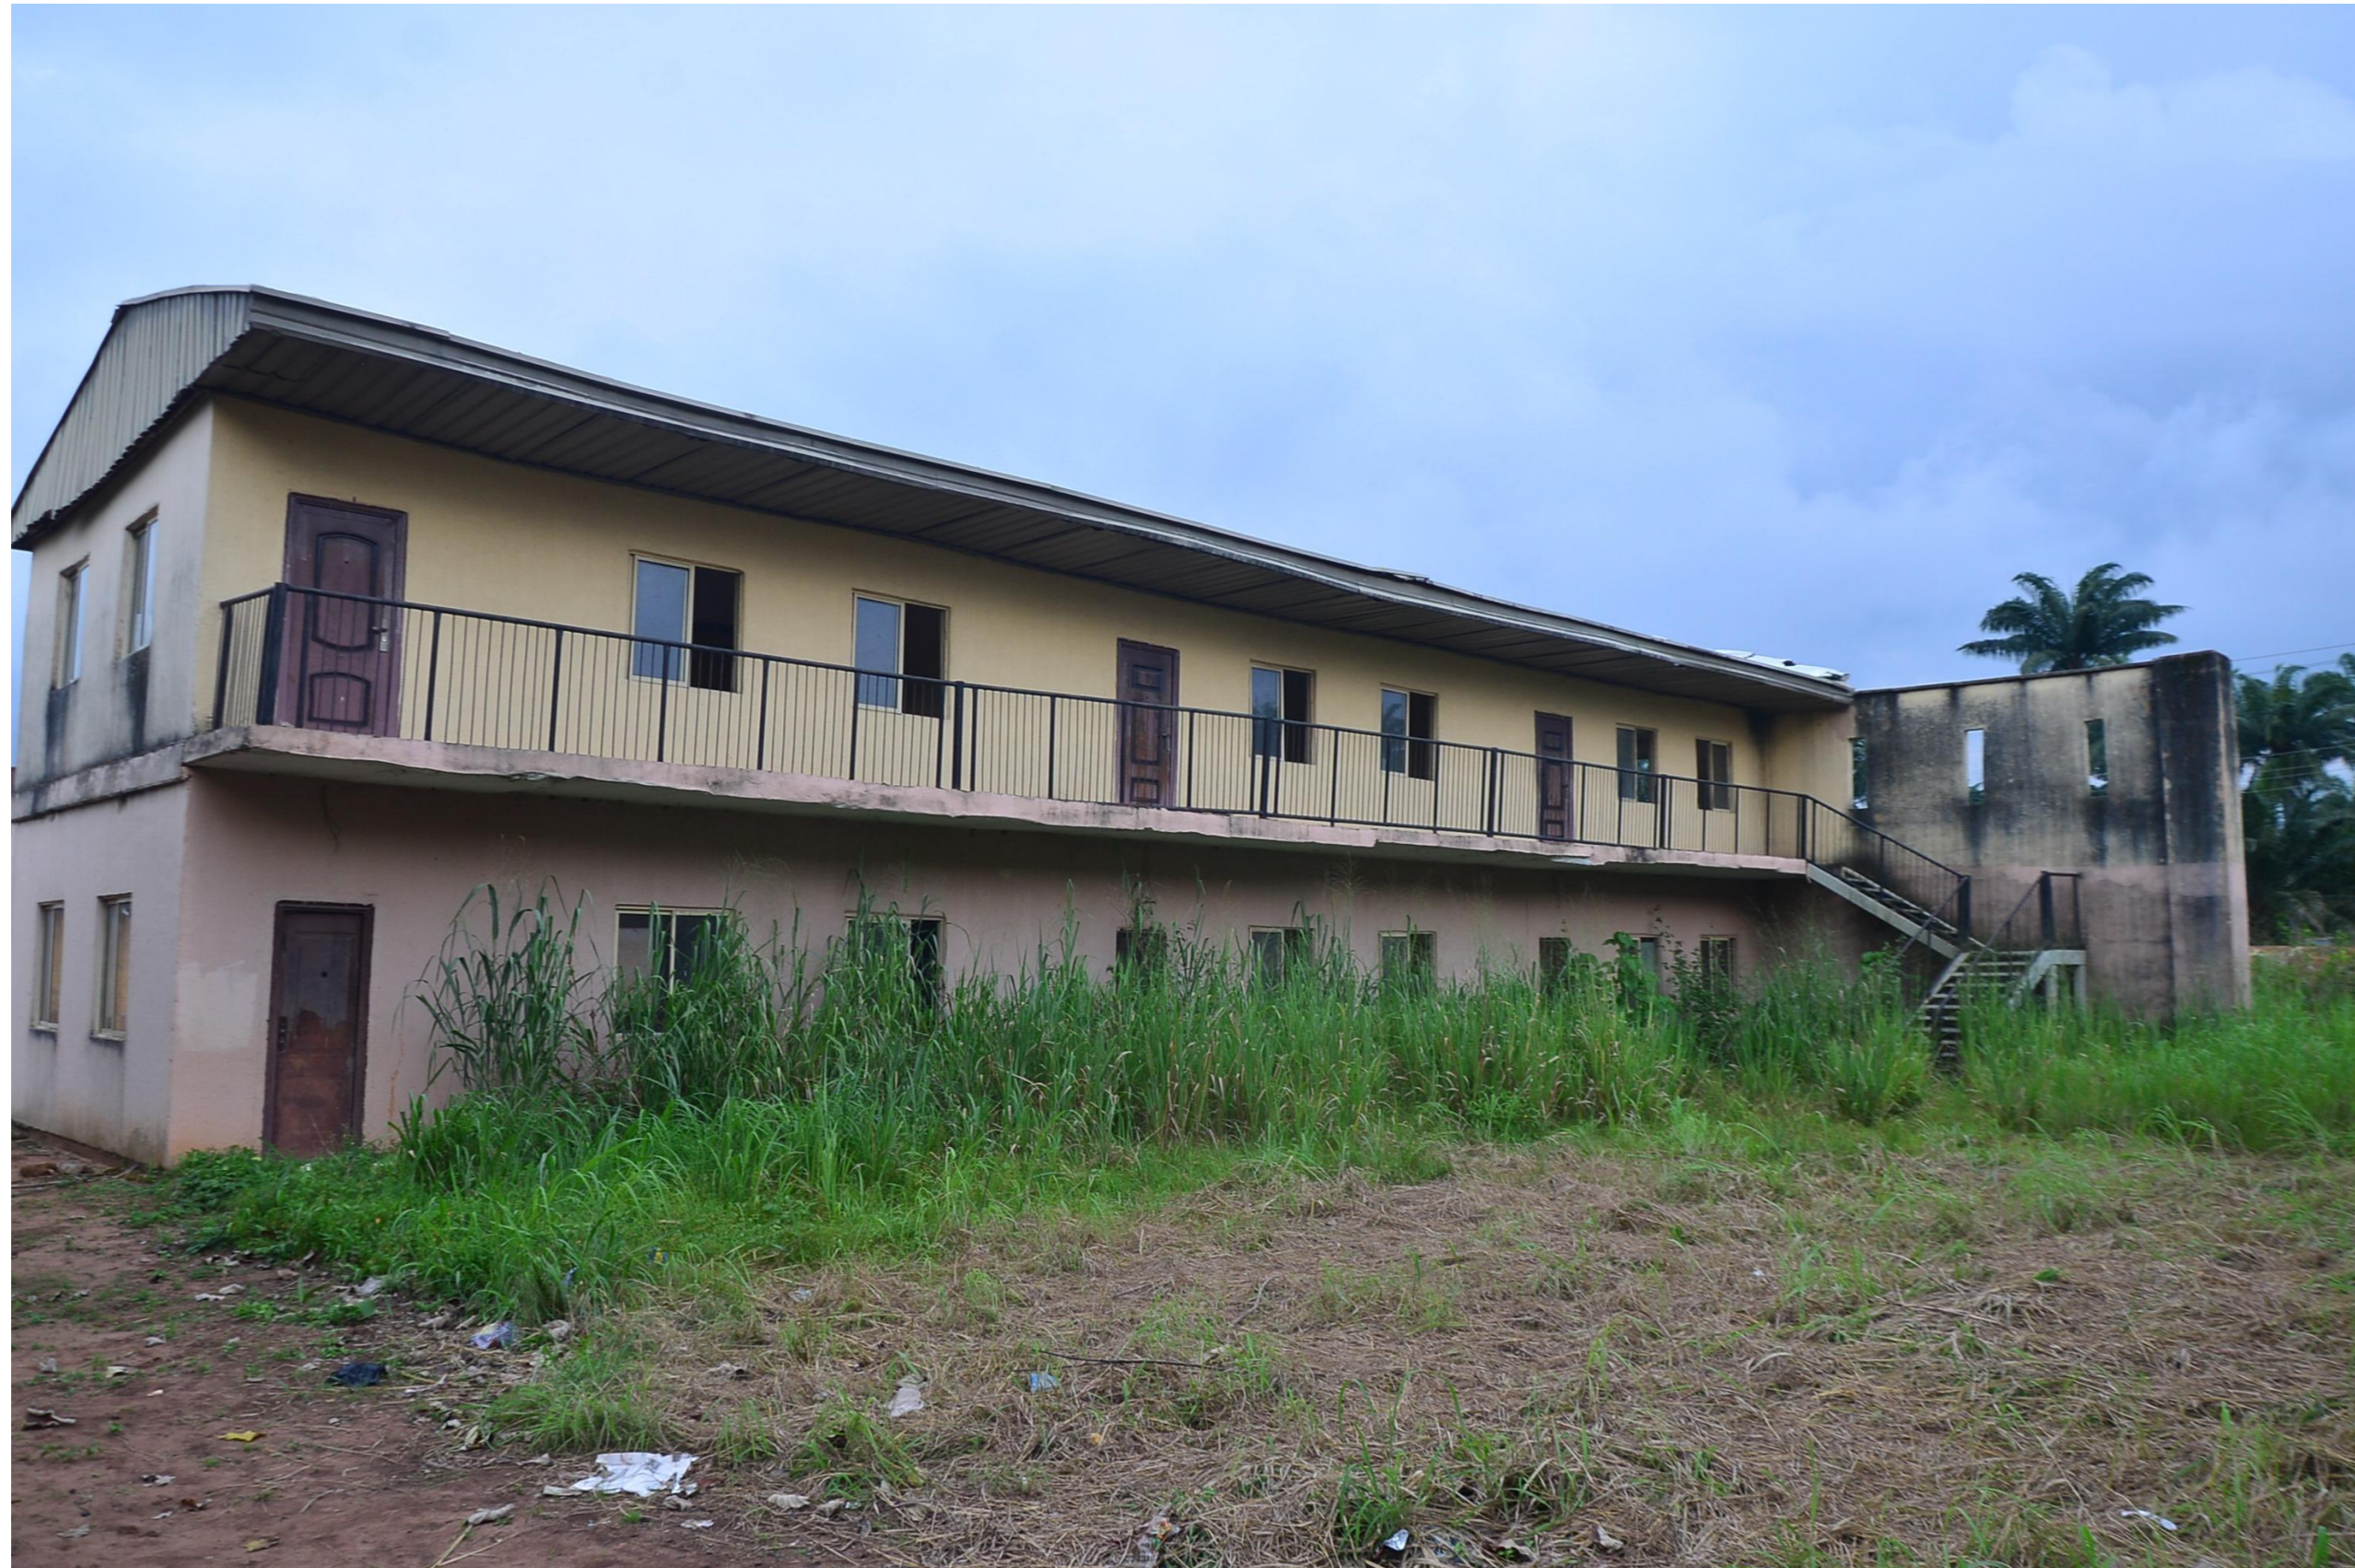
BLOCK B: ROCHAS' ADMINISTRATION'S

ENVIRONMENTAL ASSESSMENT	<ul style="list-style-type: none"> - Surrounding premises, very unkempt, with overgrown bushes. - Surrounding Premises, susceptible to flood.
STRUCTURAL ASSESSMENT	<ul style="list-style-type: none"> - Dilapidating. Roofing sheets and trusses torn out. - Guard Rails structural integrity are suspect. - The structure, a pre-fabricated structure do not appear and feel properly fabricated and fixed, going by the presence of wall cracks and quivering nature of the structure.

FACILITIES ASSESSMENT	<ul style="list-style-type: none"> - Facility not safe for use.
SAFETY ASSESSMENT	<ul style="list-style-type: none"> - Block not adequately burglary-proof - Block not adequately protected from unfavourable weather conditions - Block not structurally sound for use.
