**OHAKPU COMMUNITY
PRIMARY SCHOOL,
ORU WEST,
IMO STATE, NIGERIA.**

CHARIS LEARNING FOUNDATION

SITE ANALYSIS

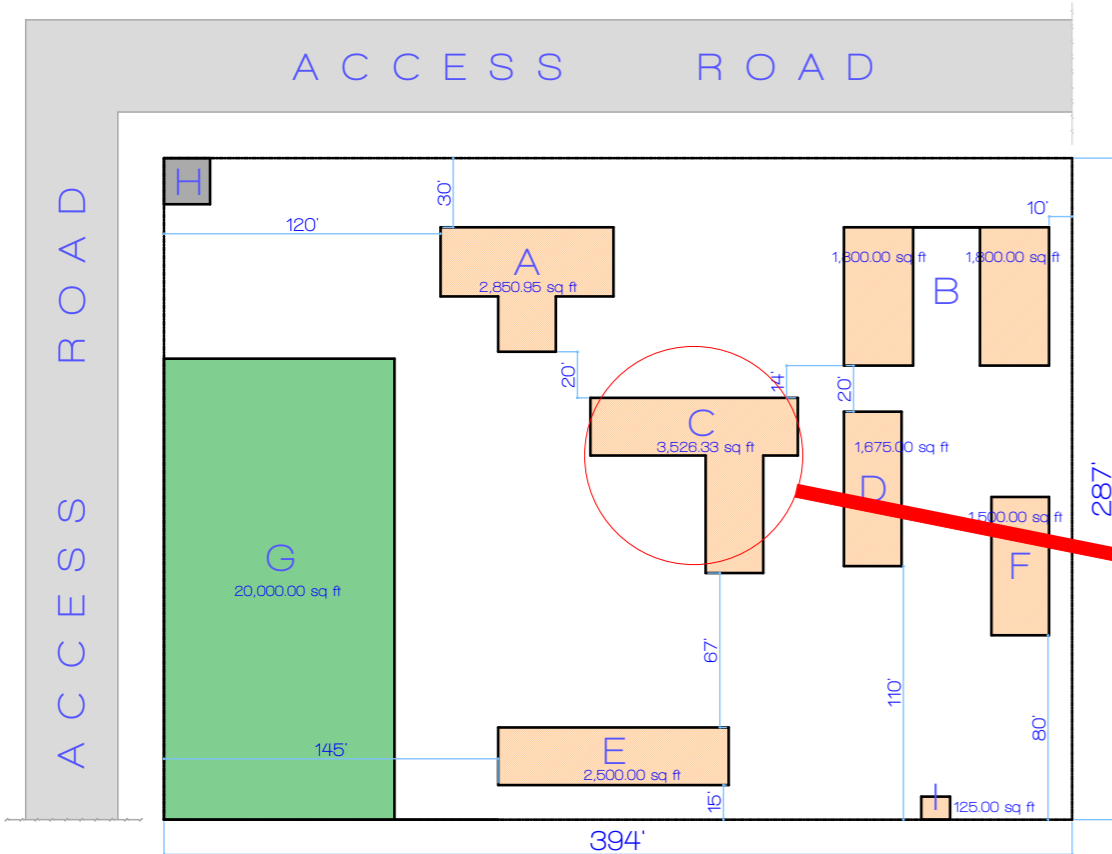
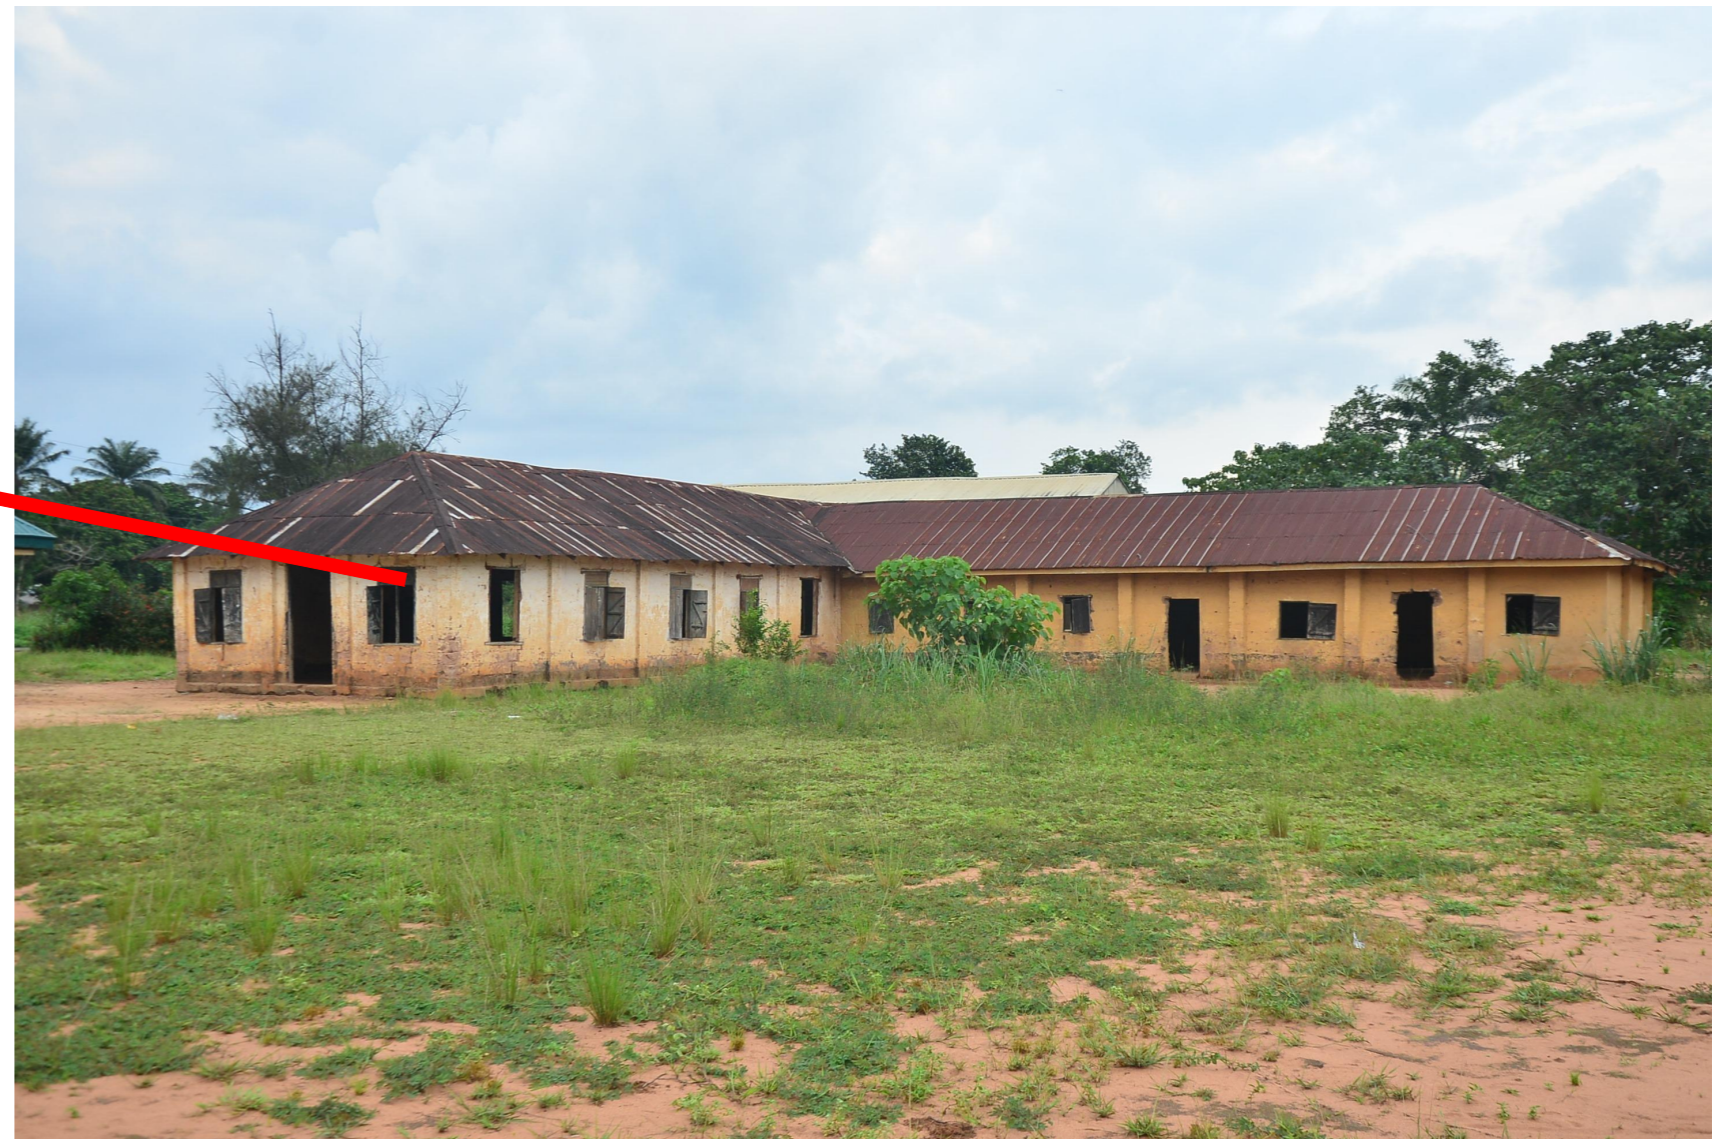
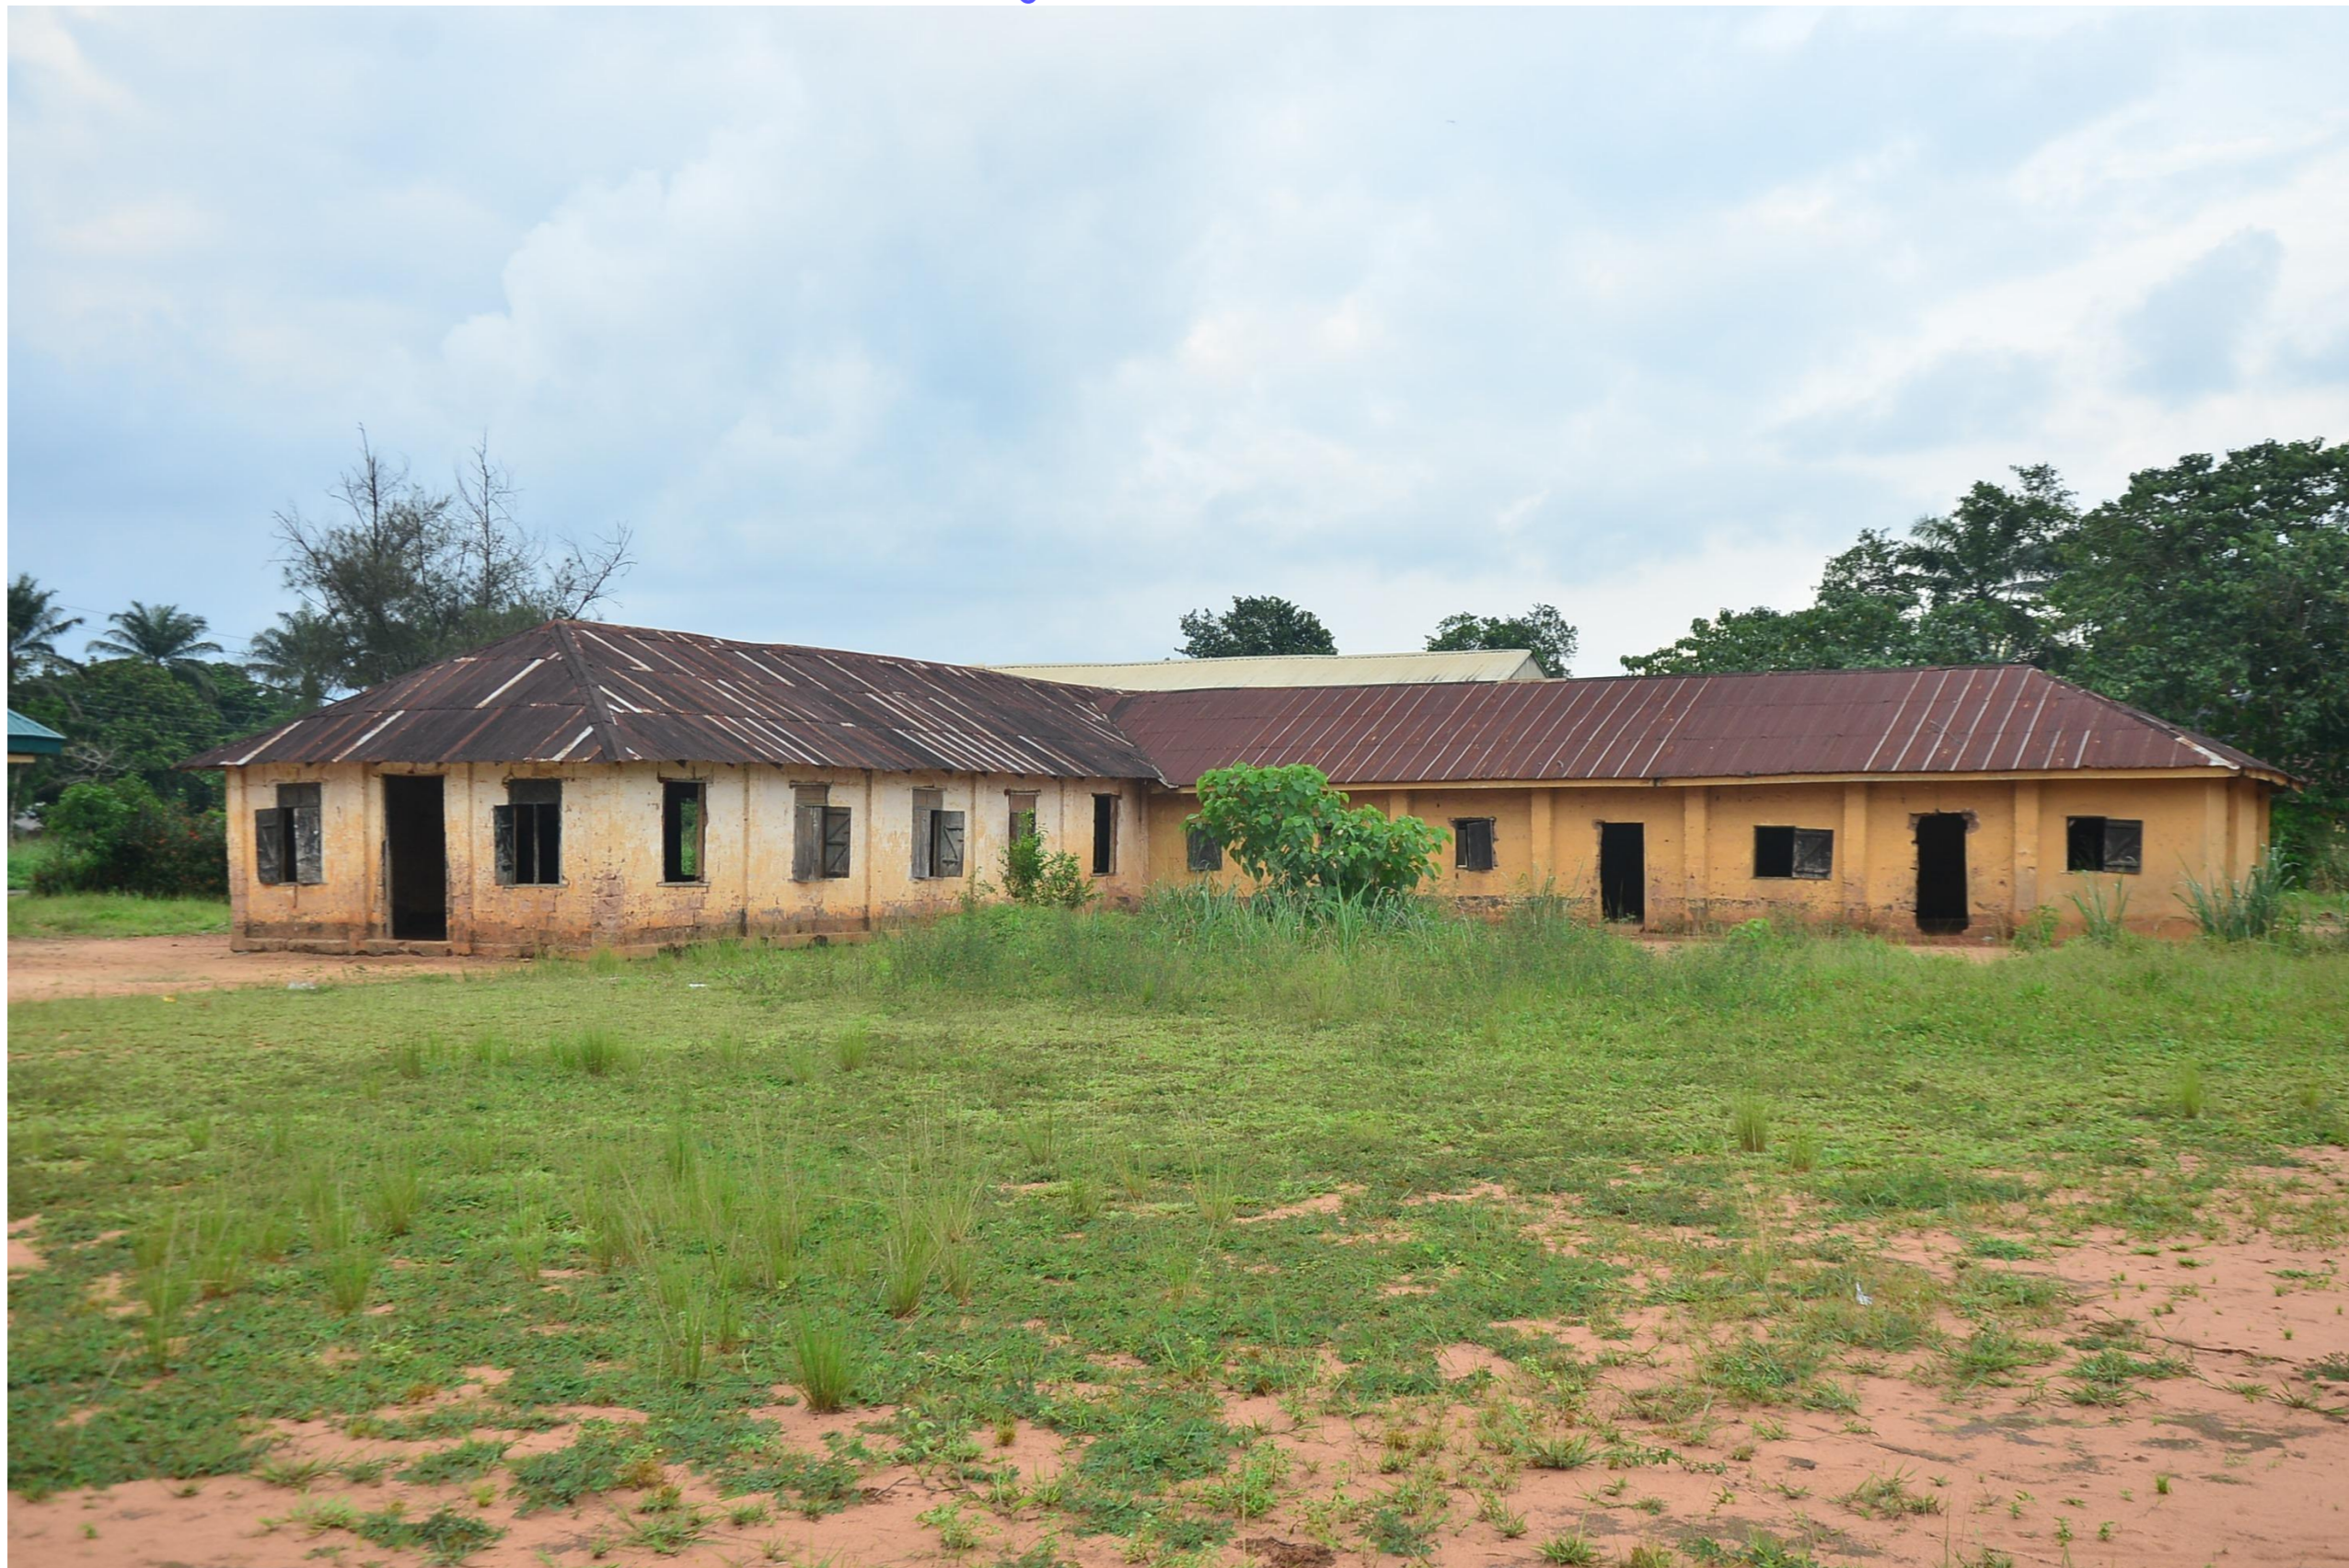
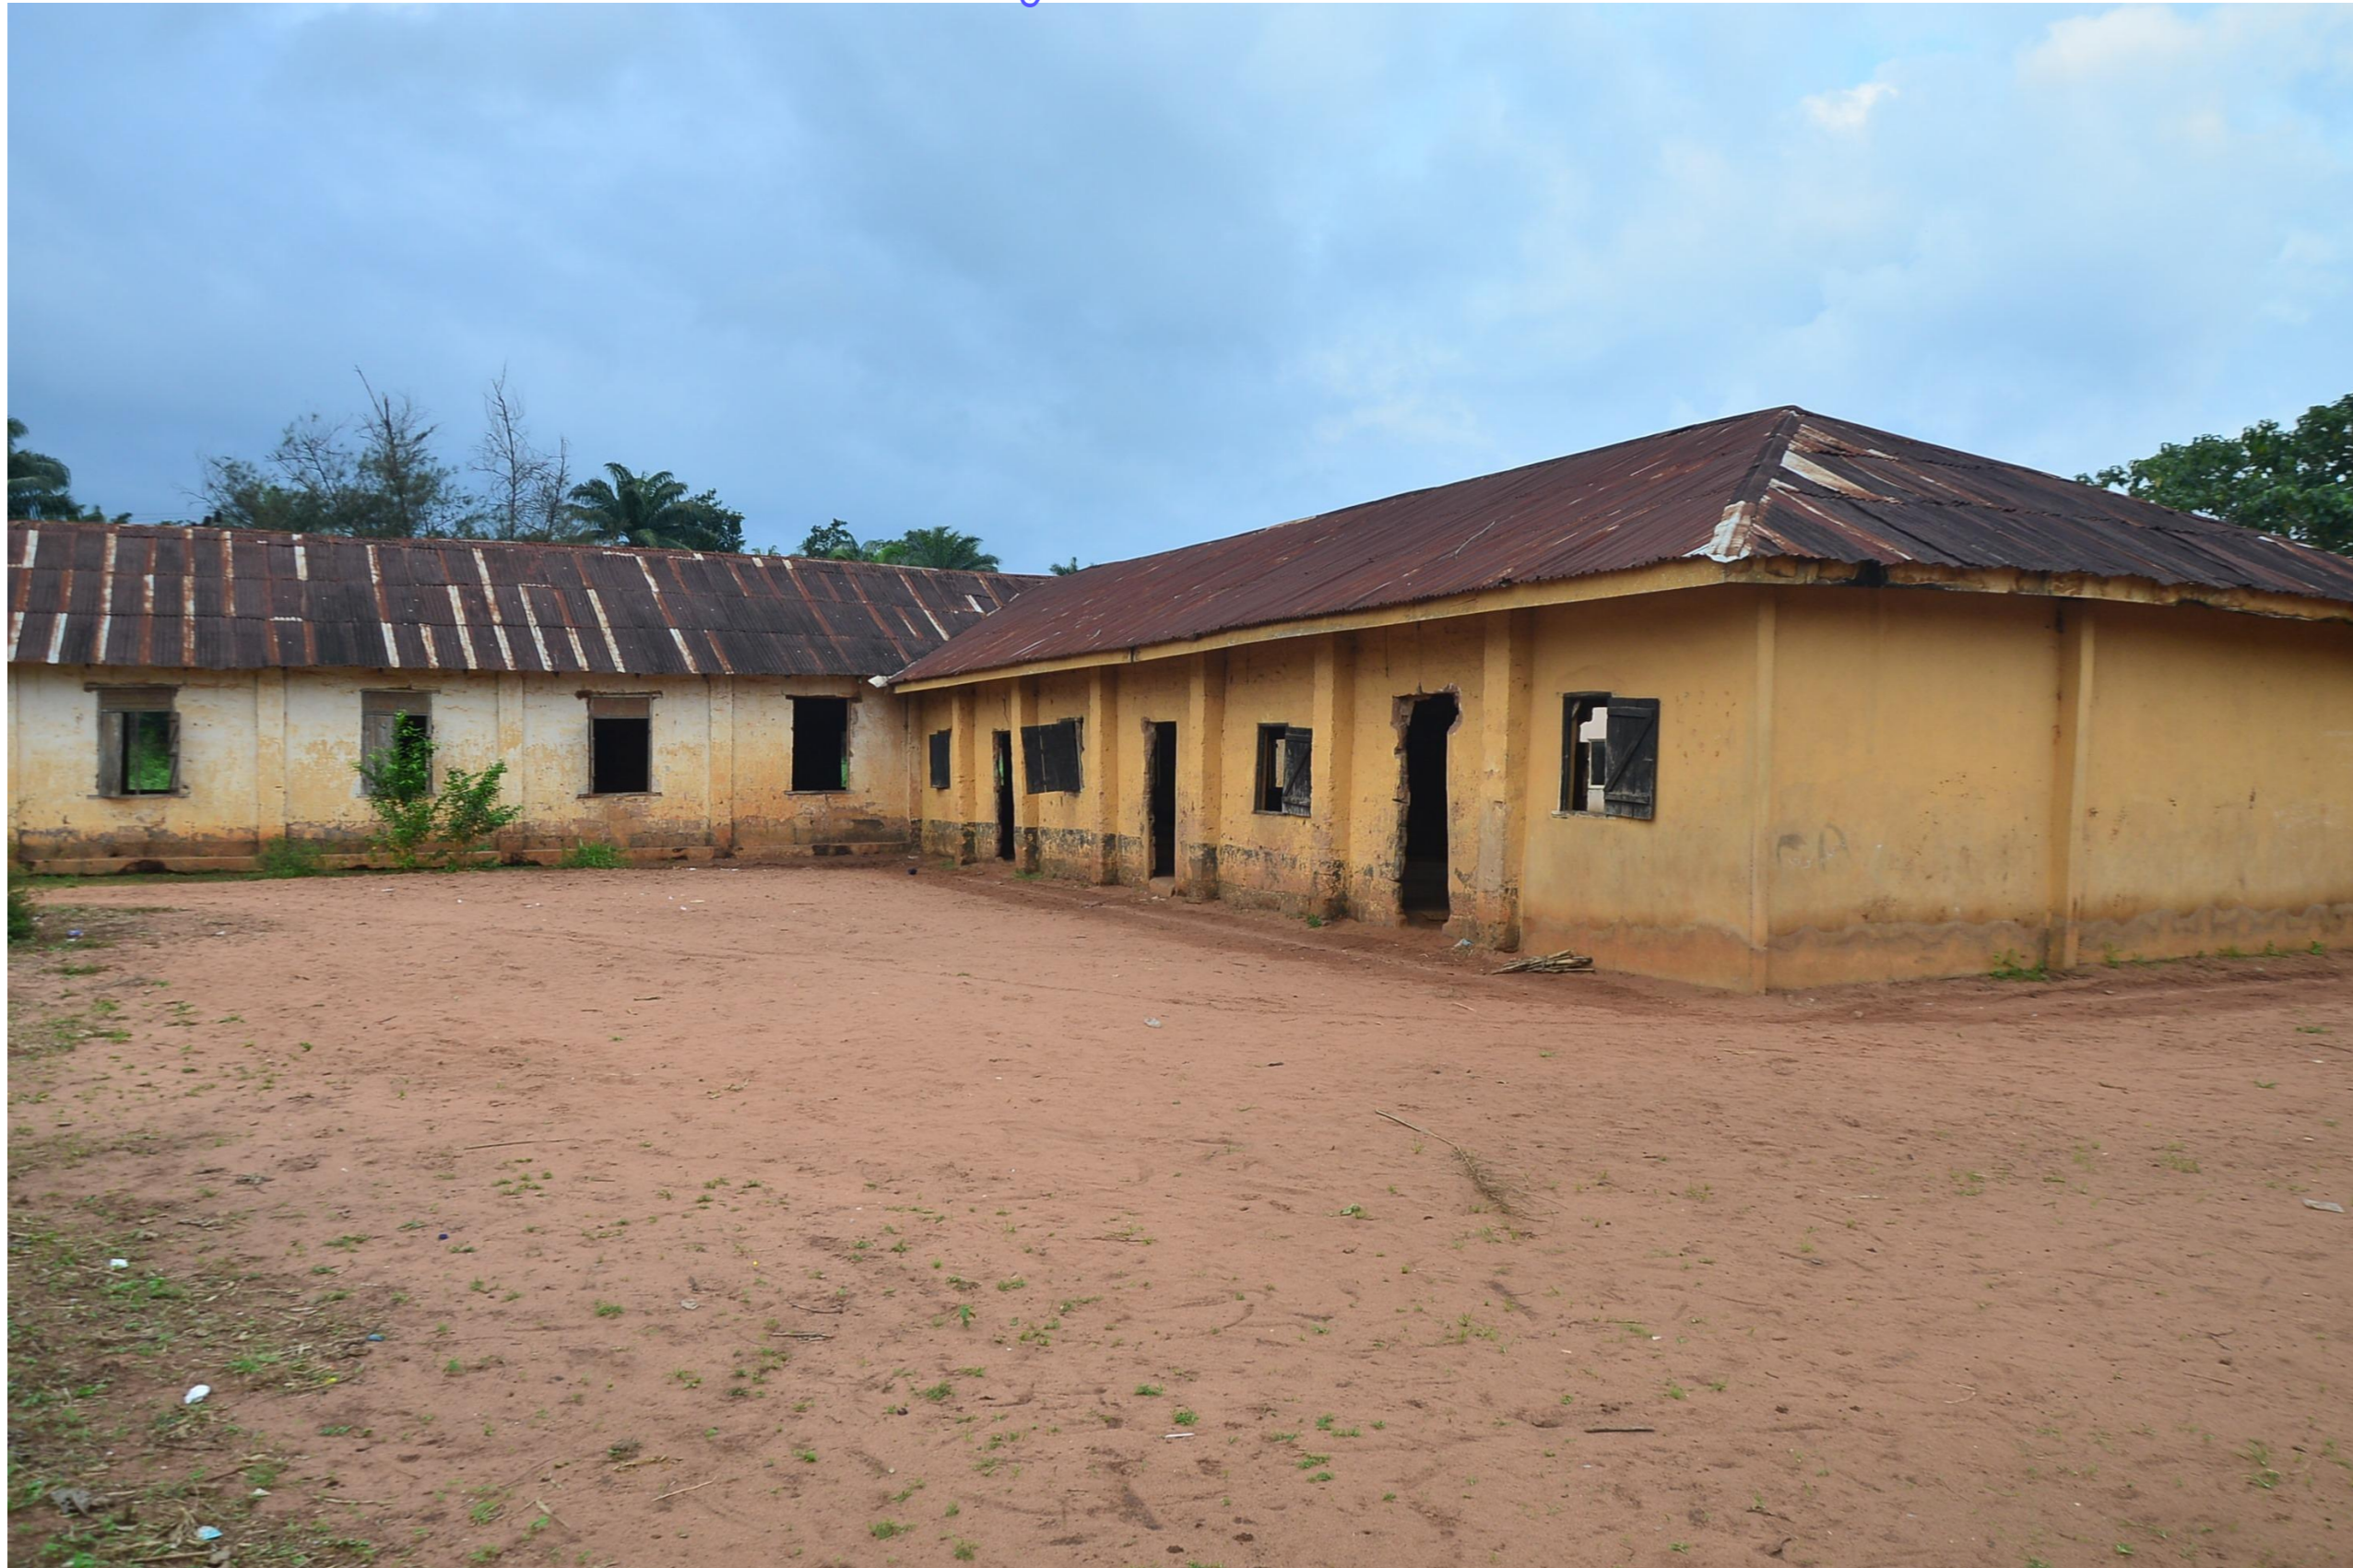
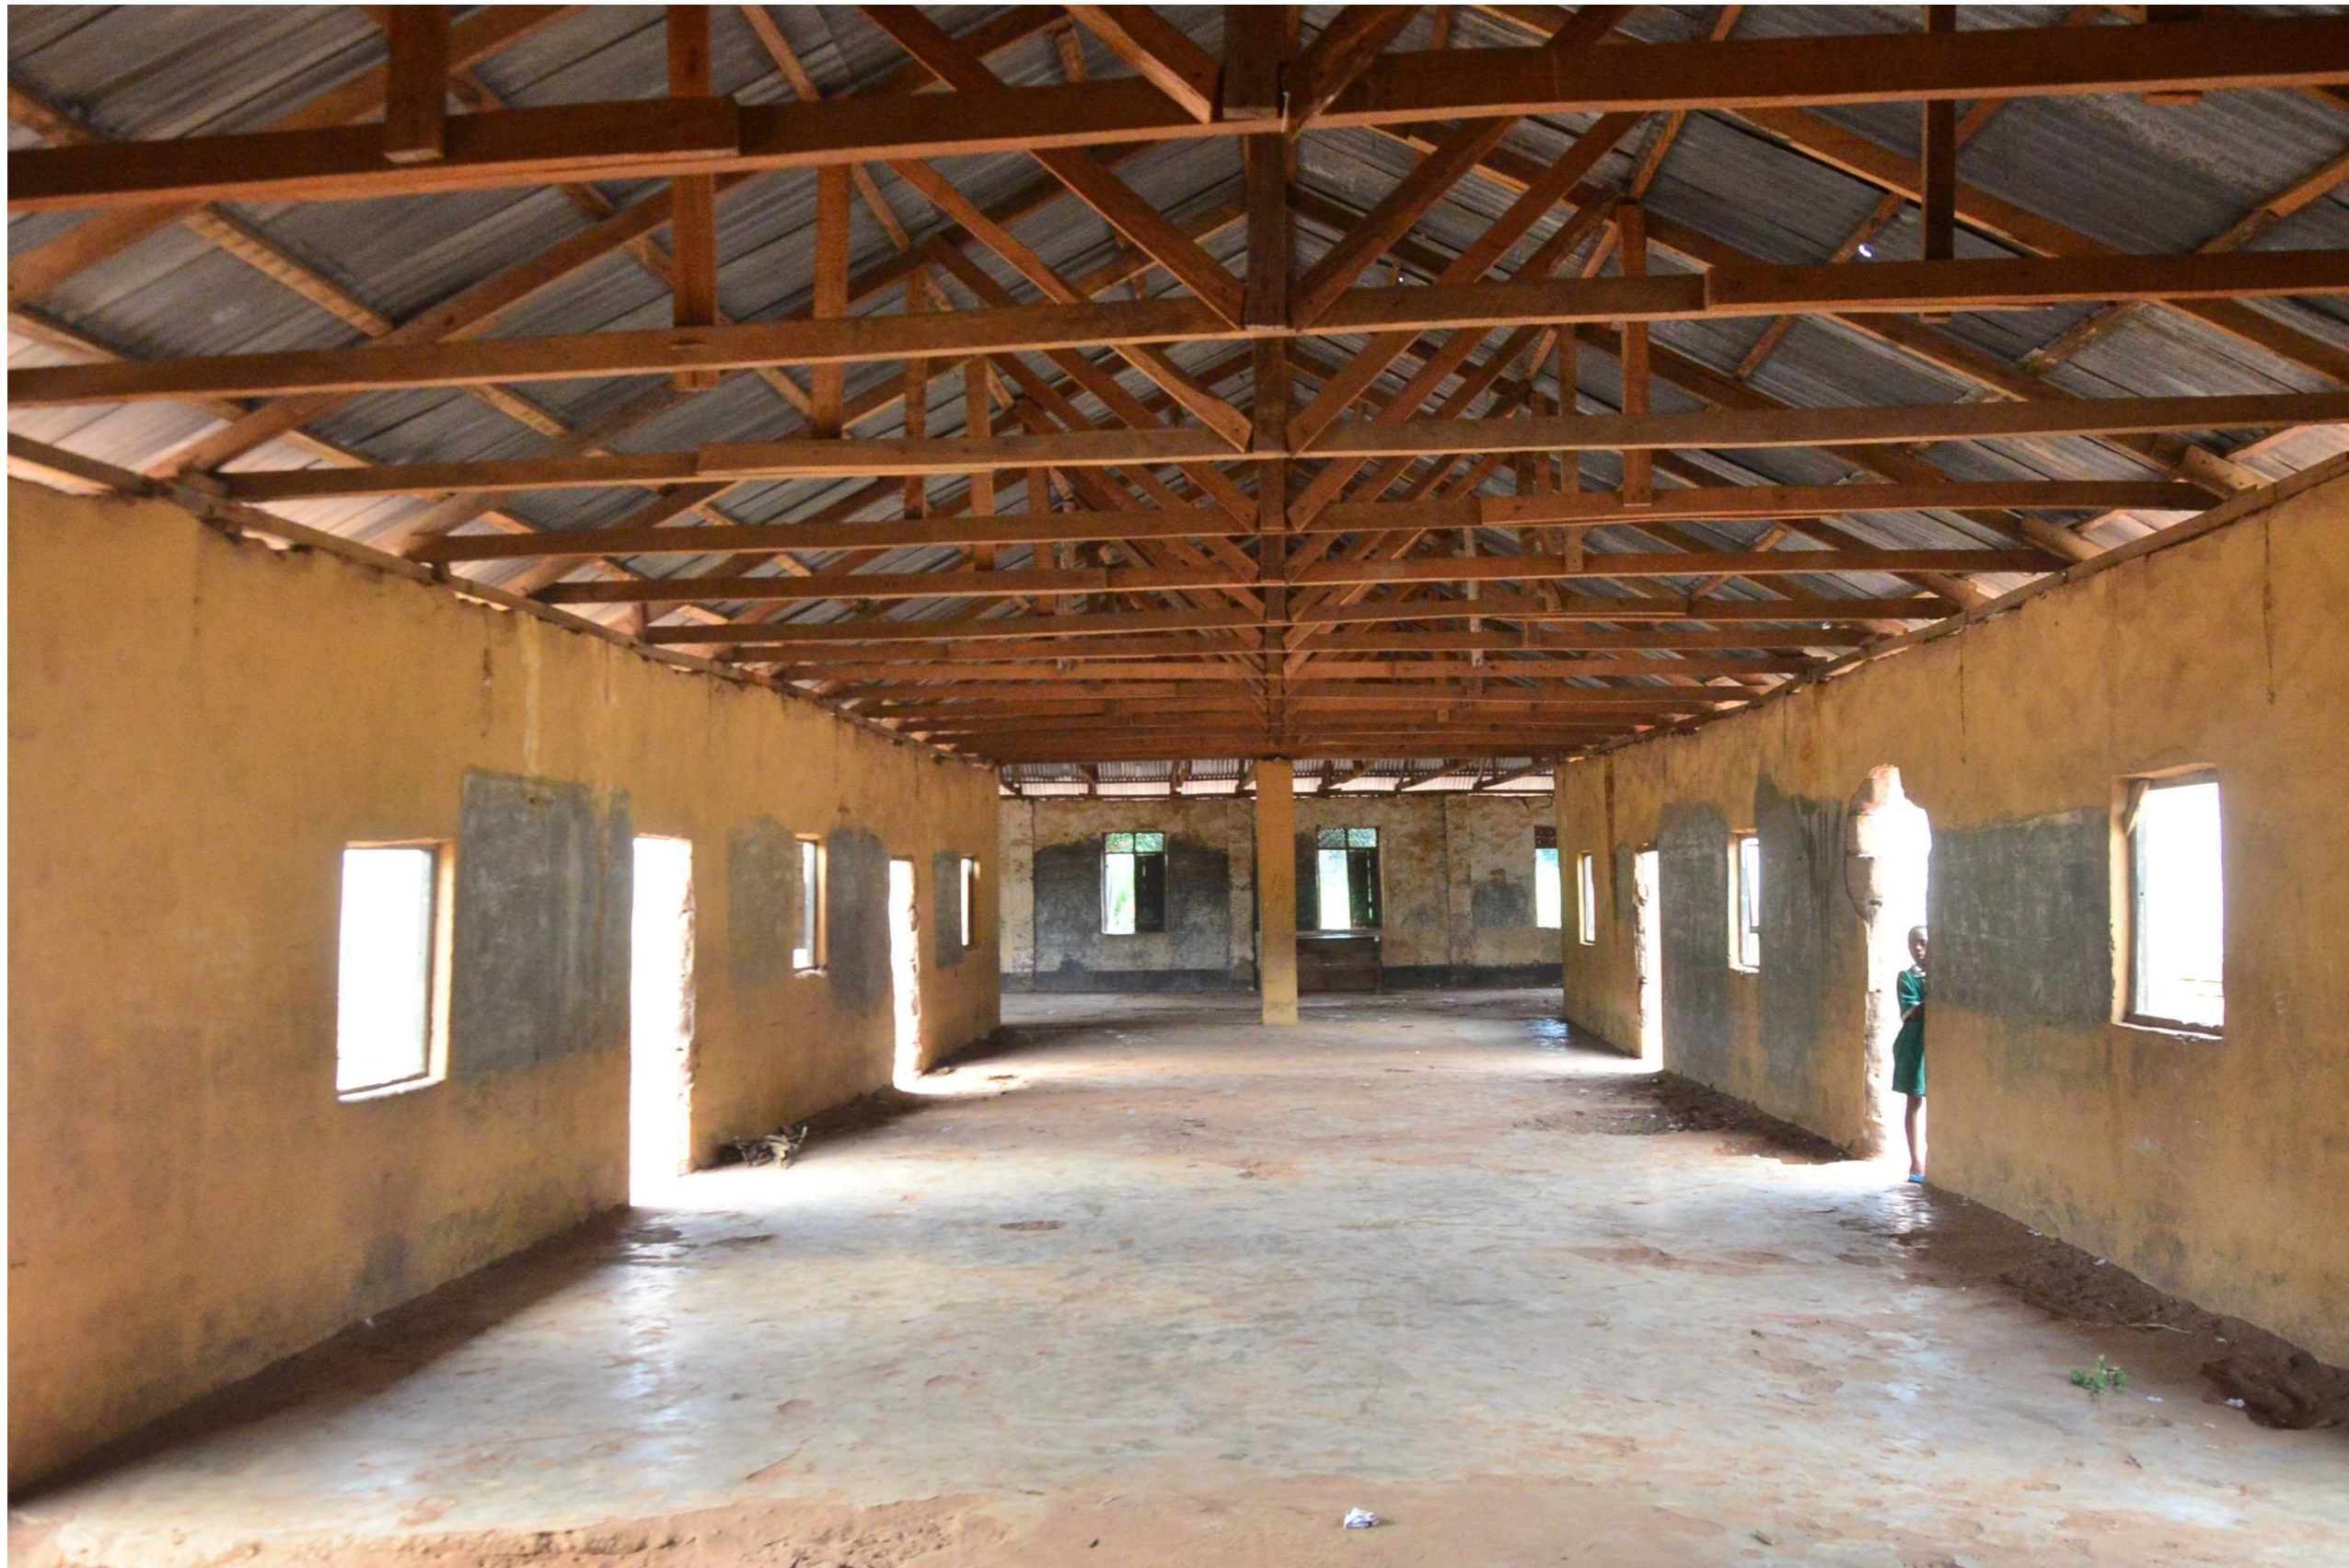
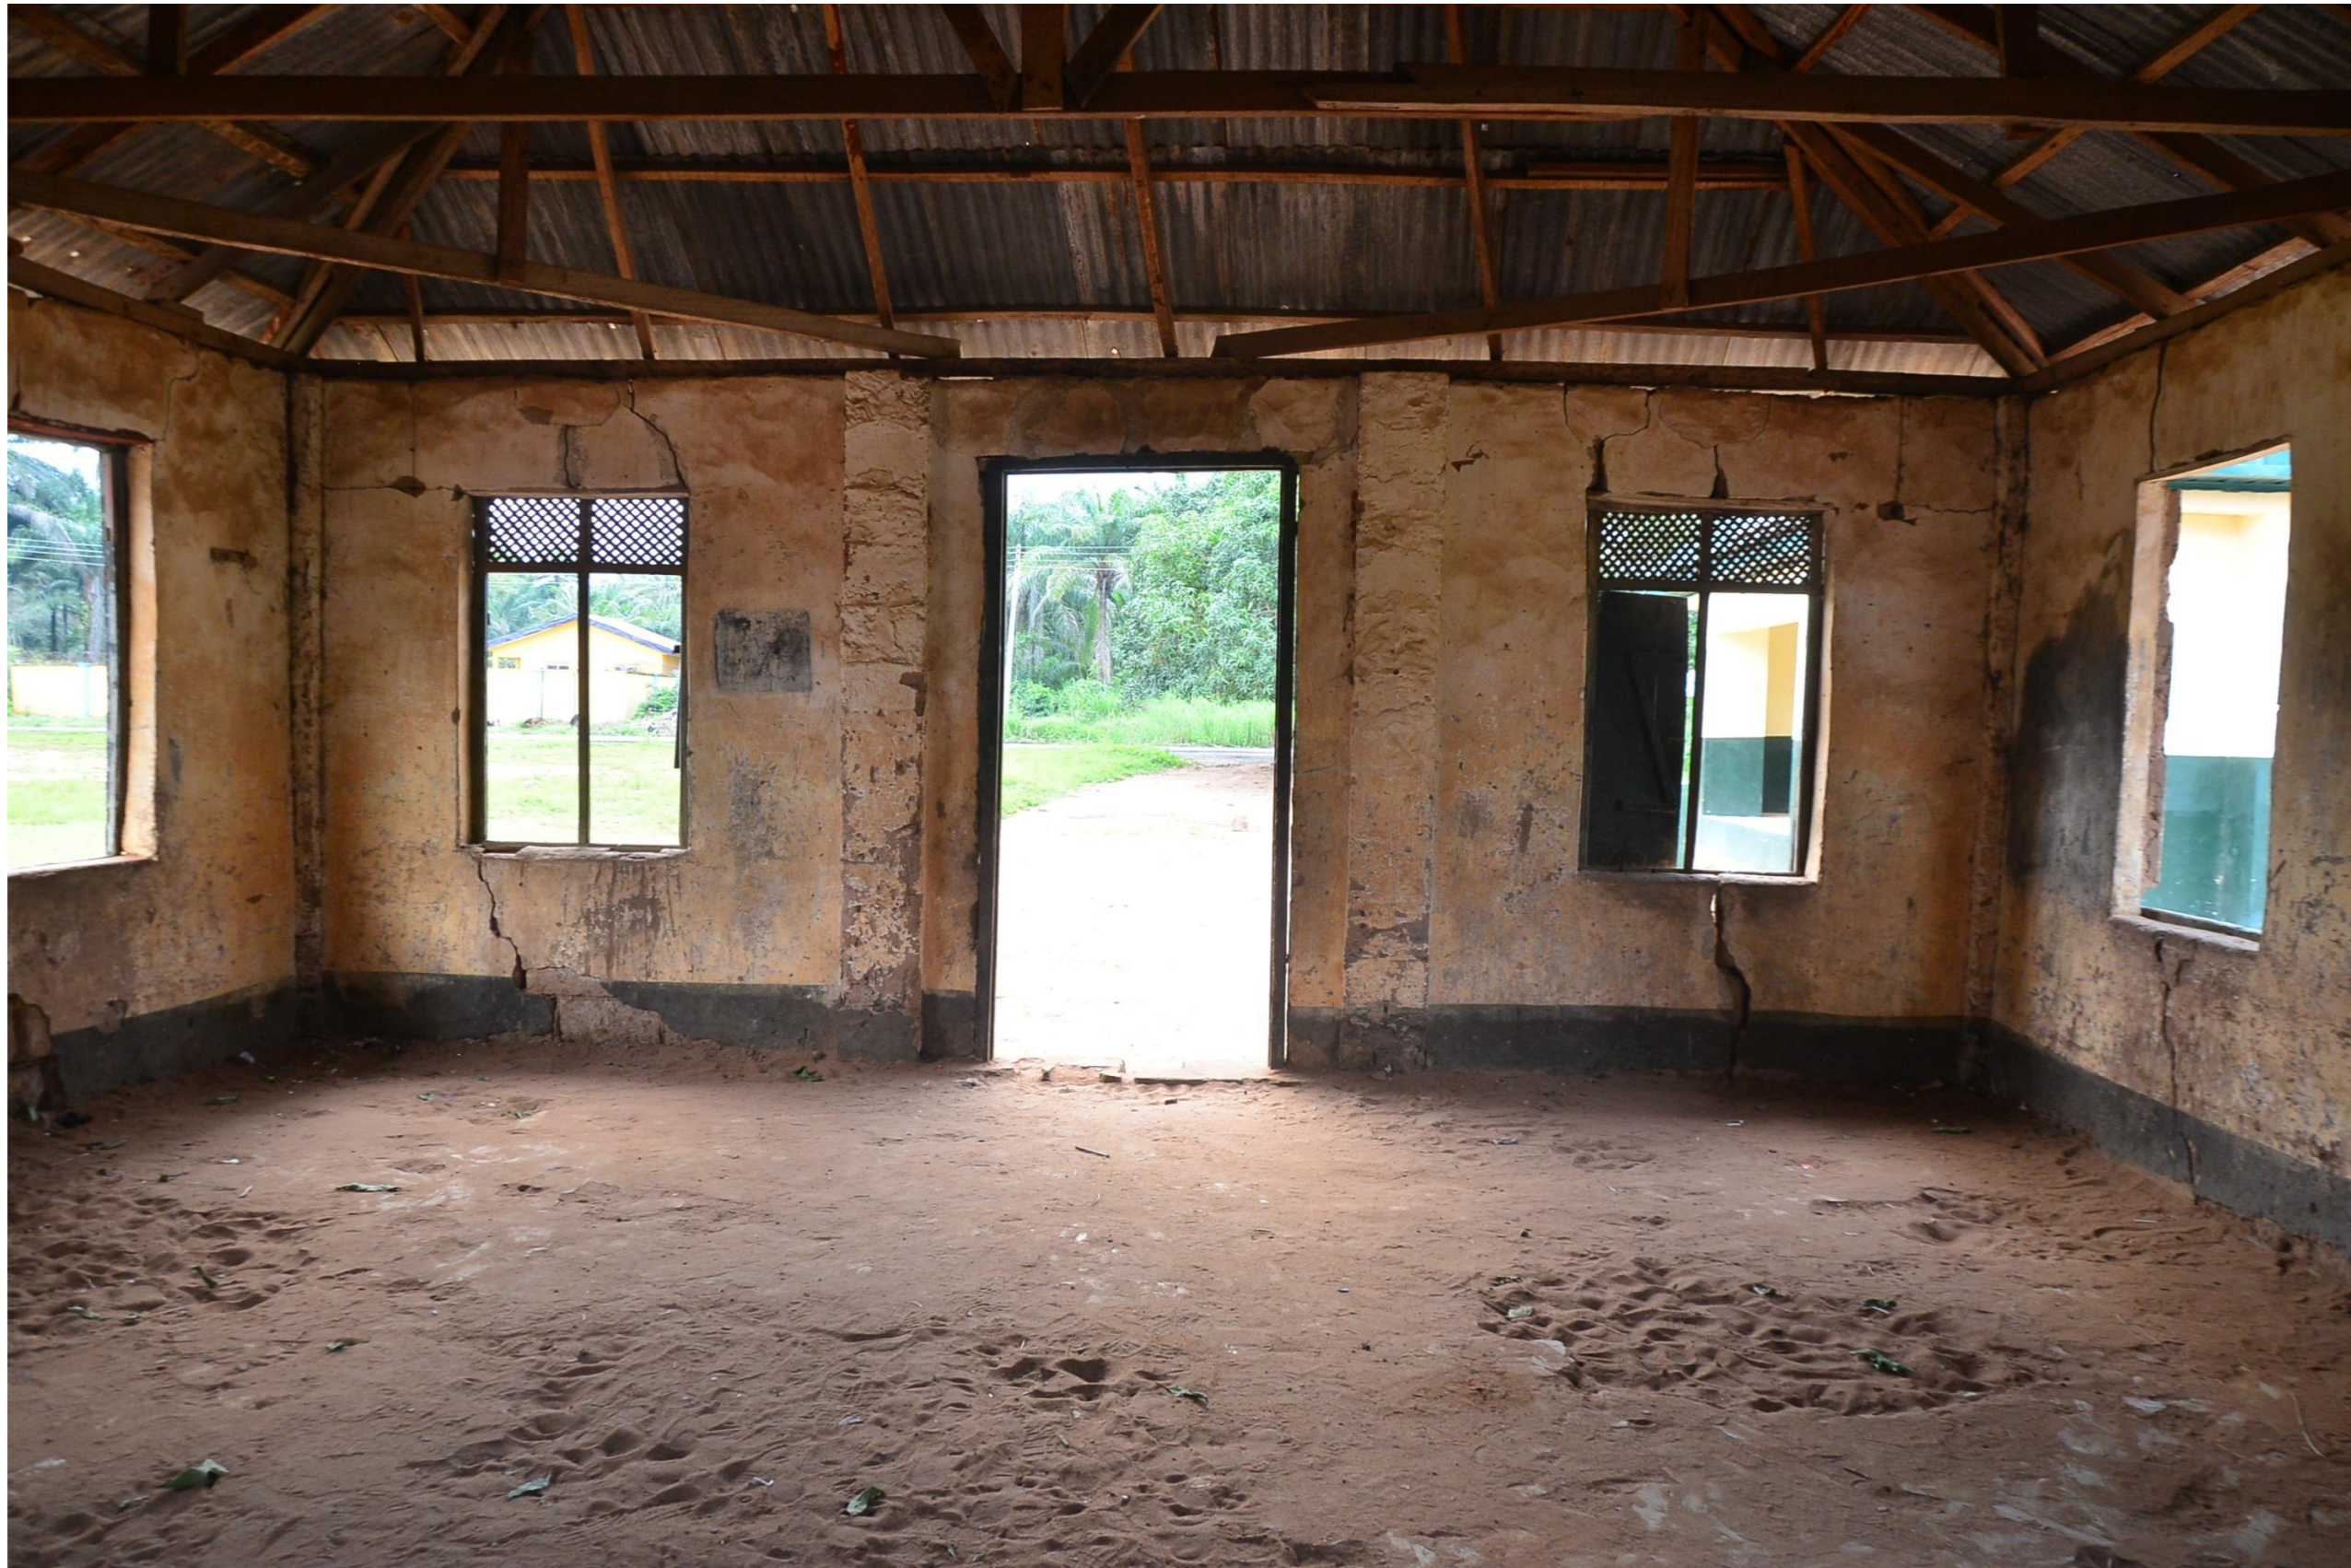
BLOCK C: OLD SCHOOL

ENVIRONMENTAL ASSESSMENT	
	<ul style="list-style-type: none"> - Surrounding premises, very unkempt, with overgrown bushes. - Surrounding Premises, susceptible to flood.
STRUCTURAL ASSESSMENT	
	<ul style="list-style-type: none"> - Dilapidating. Expired roofing sheets and trusses. Broken Floors. Cracked Walls. - Broken and Open Windows - No Doors - Structural Integrity very suspect.
FACILITIES ASSESSMENT	
	<ul style="list-style-type: none"> - Facilities grossly inadequate. Barely even present.

SAFETY ASSESSMENT	
	<ul style="list-style-type: none"> - Classrooms not adequately burglarproof - Block not adequately protected from unfavourable weather conditions. - Structural Integrity very suspect.
