**OHAKPU COMMUNITY
PRIMARY SCHOOL,
ORU WEST,
IMO STATE, NIGERIA.**

CHARIS LEARNING FOUNDATION

SITE ANALYSIS

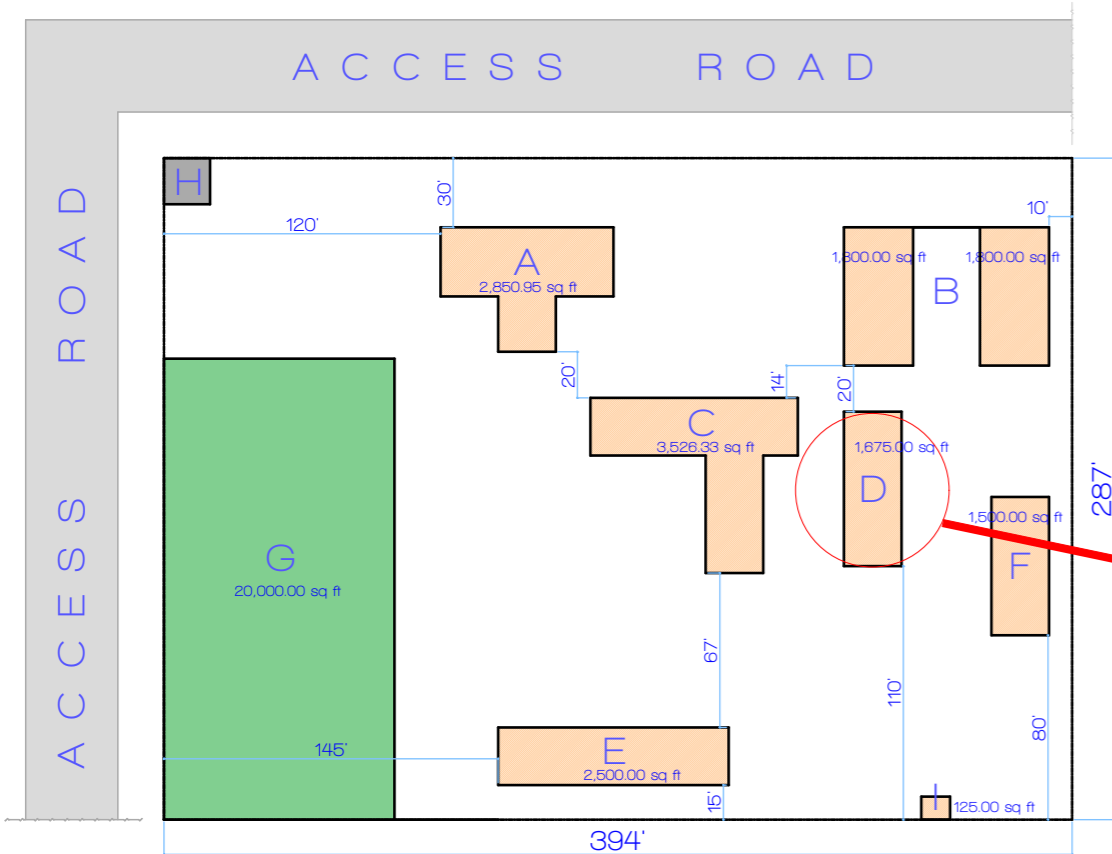
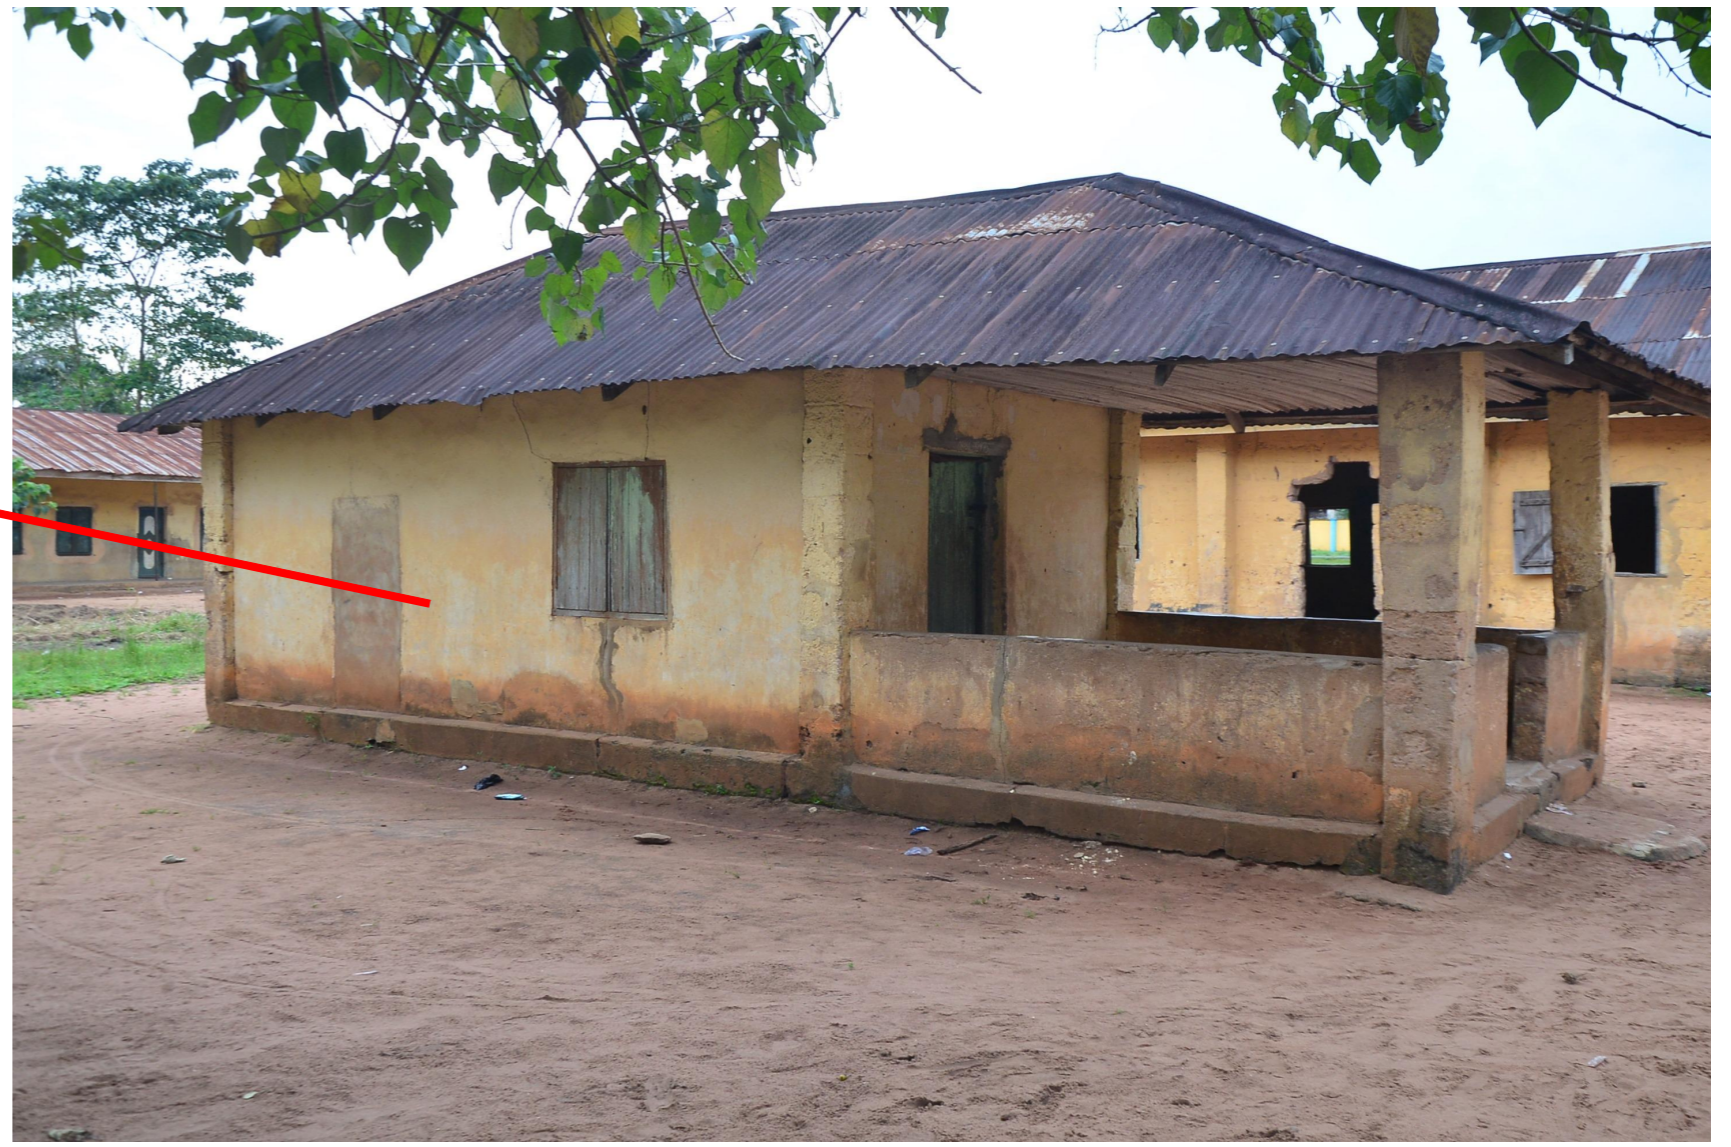
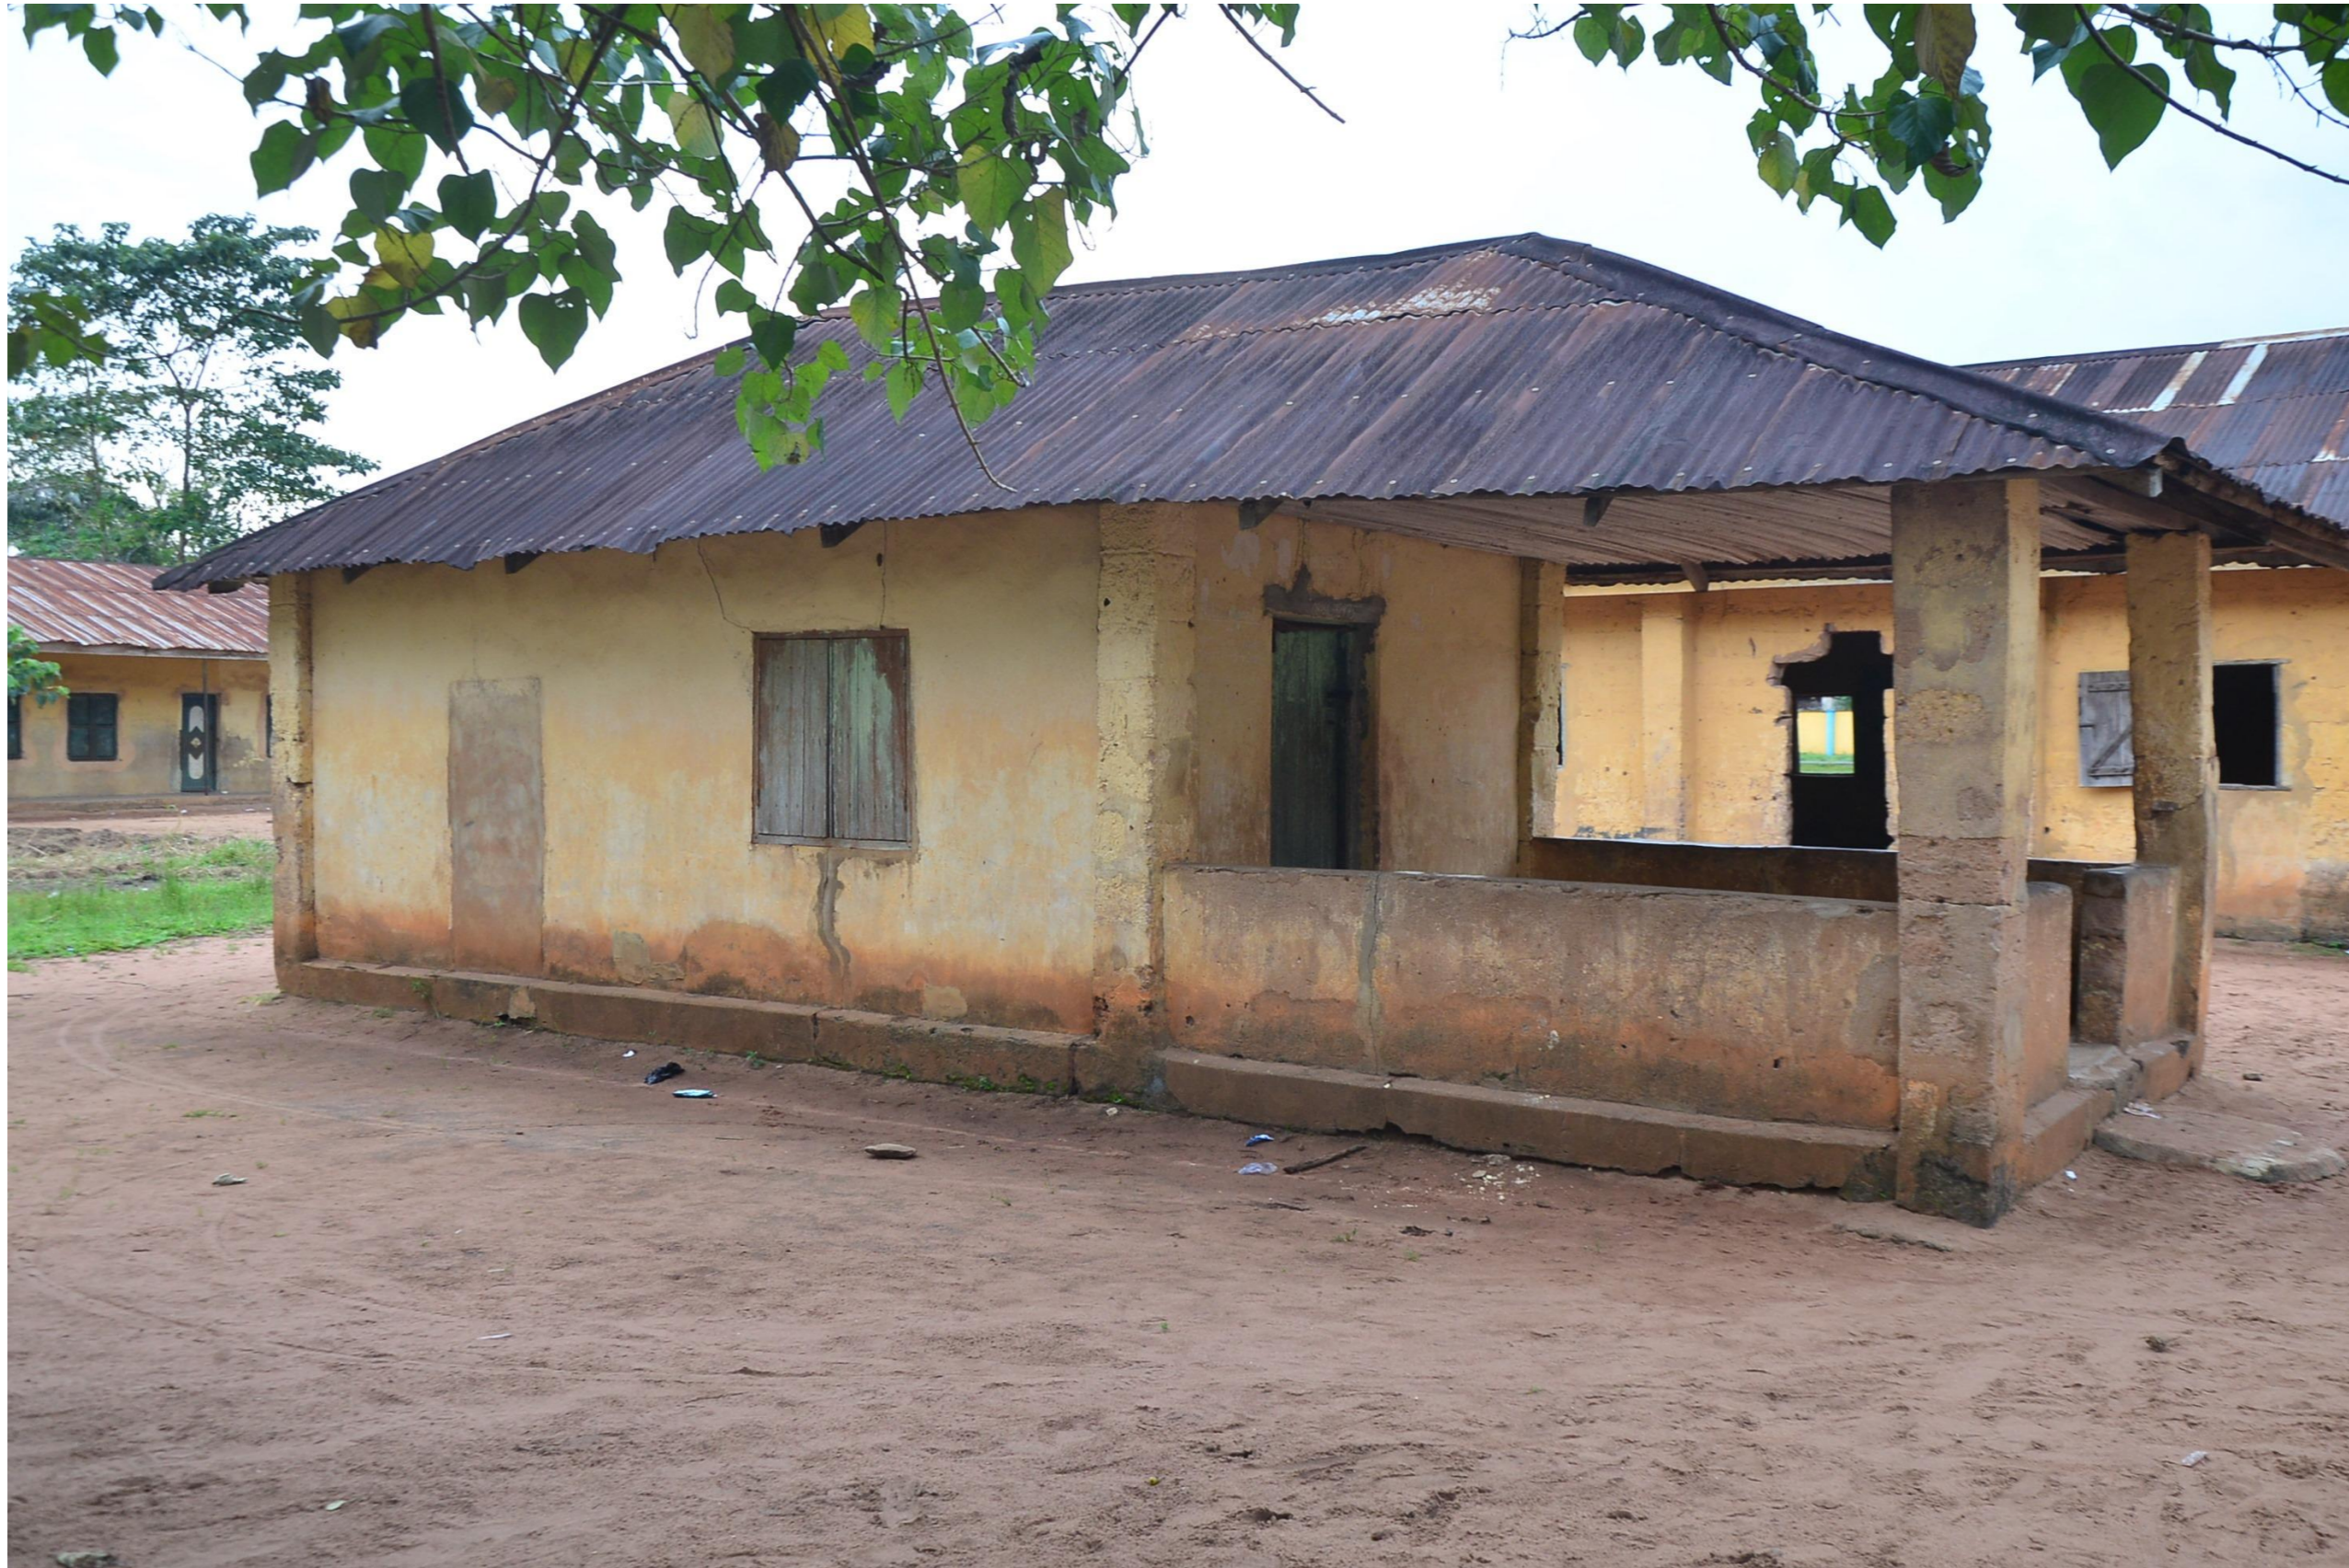
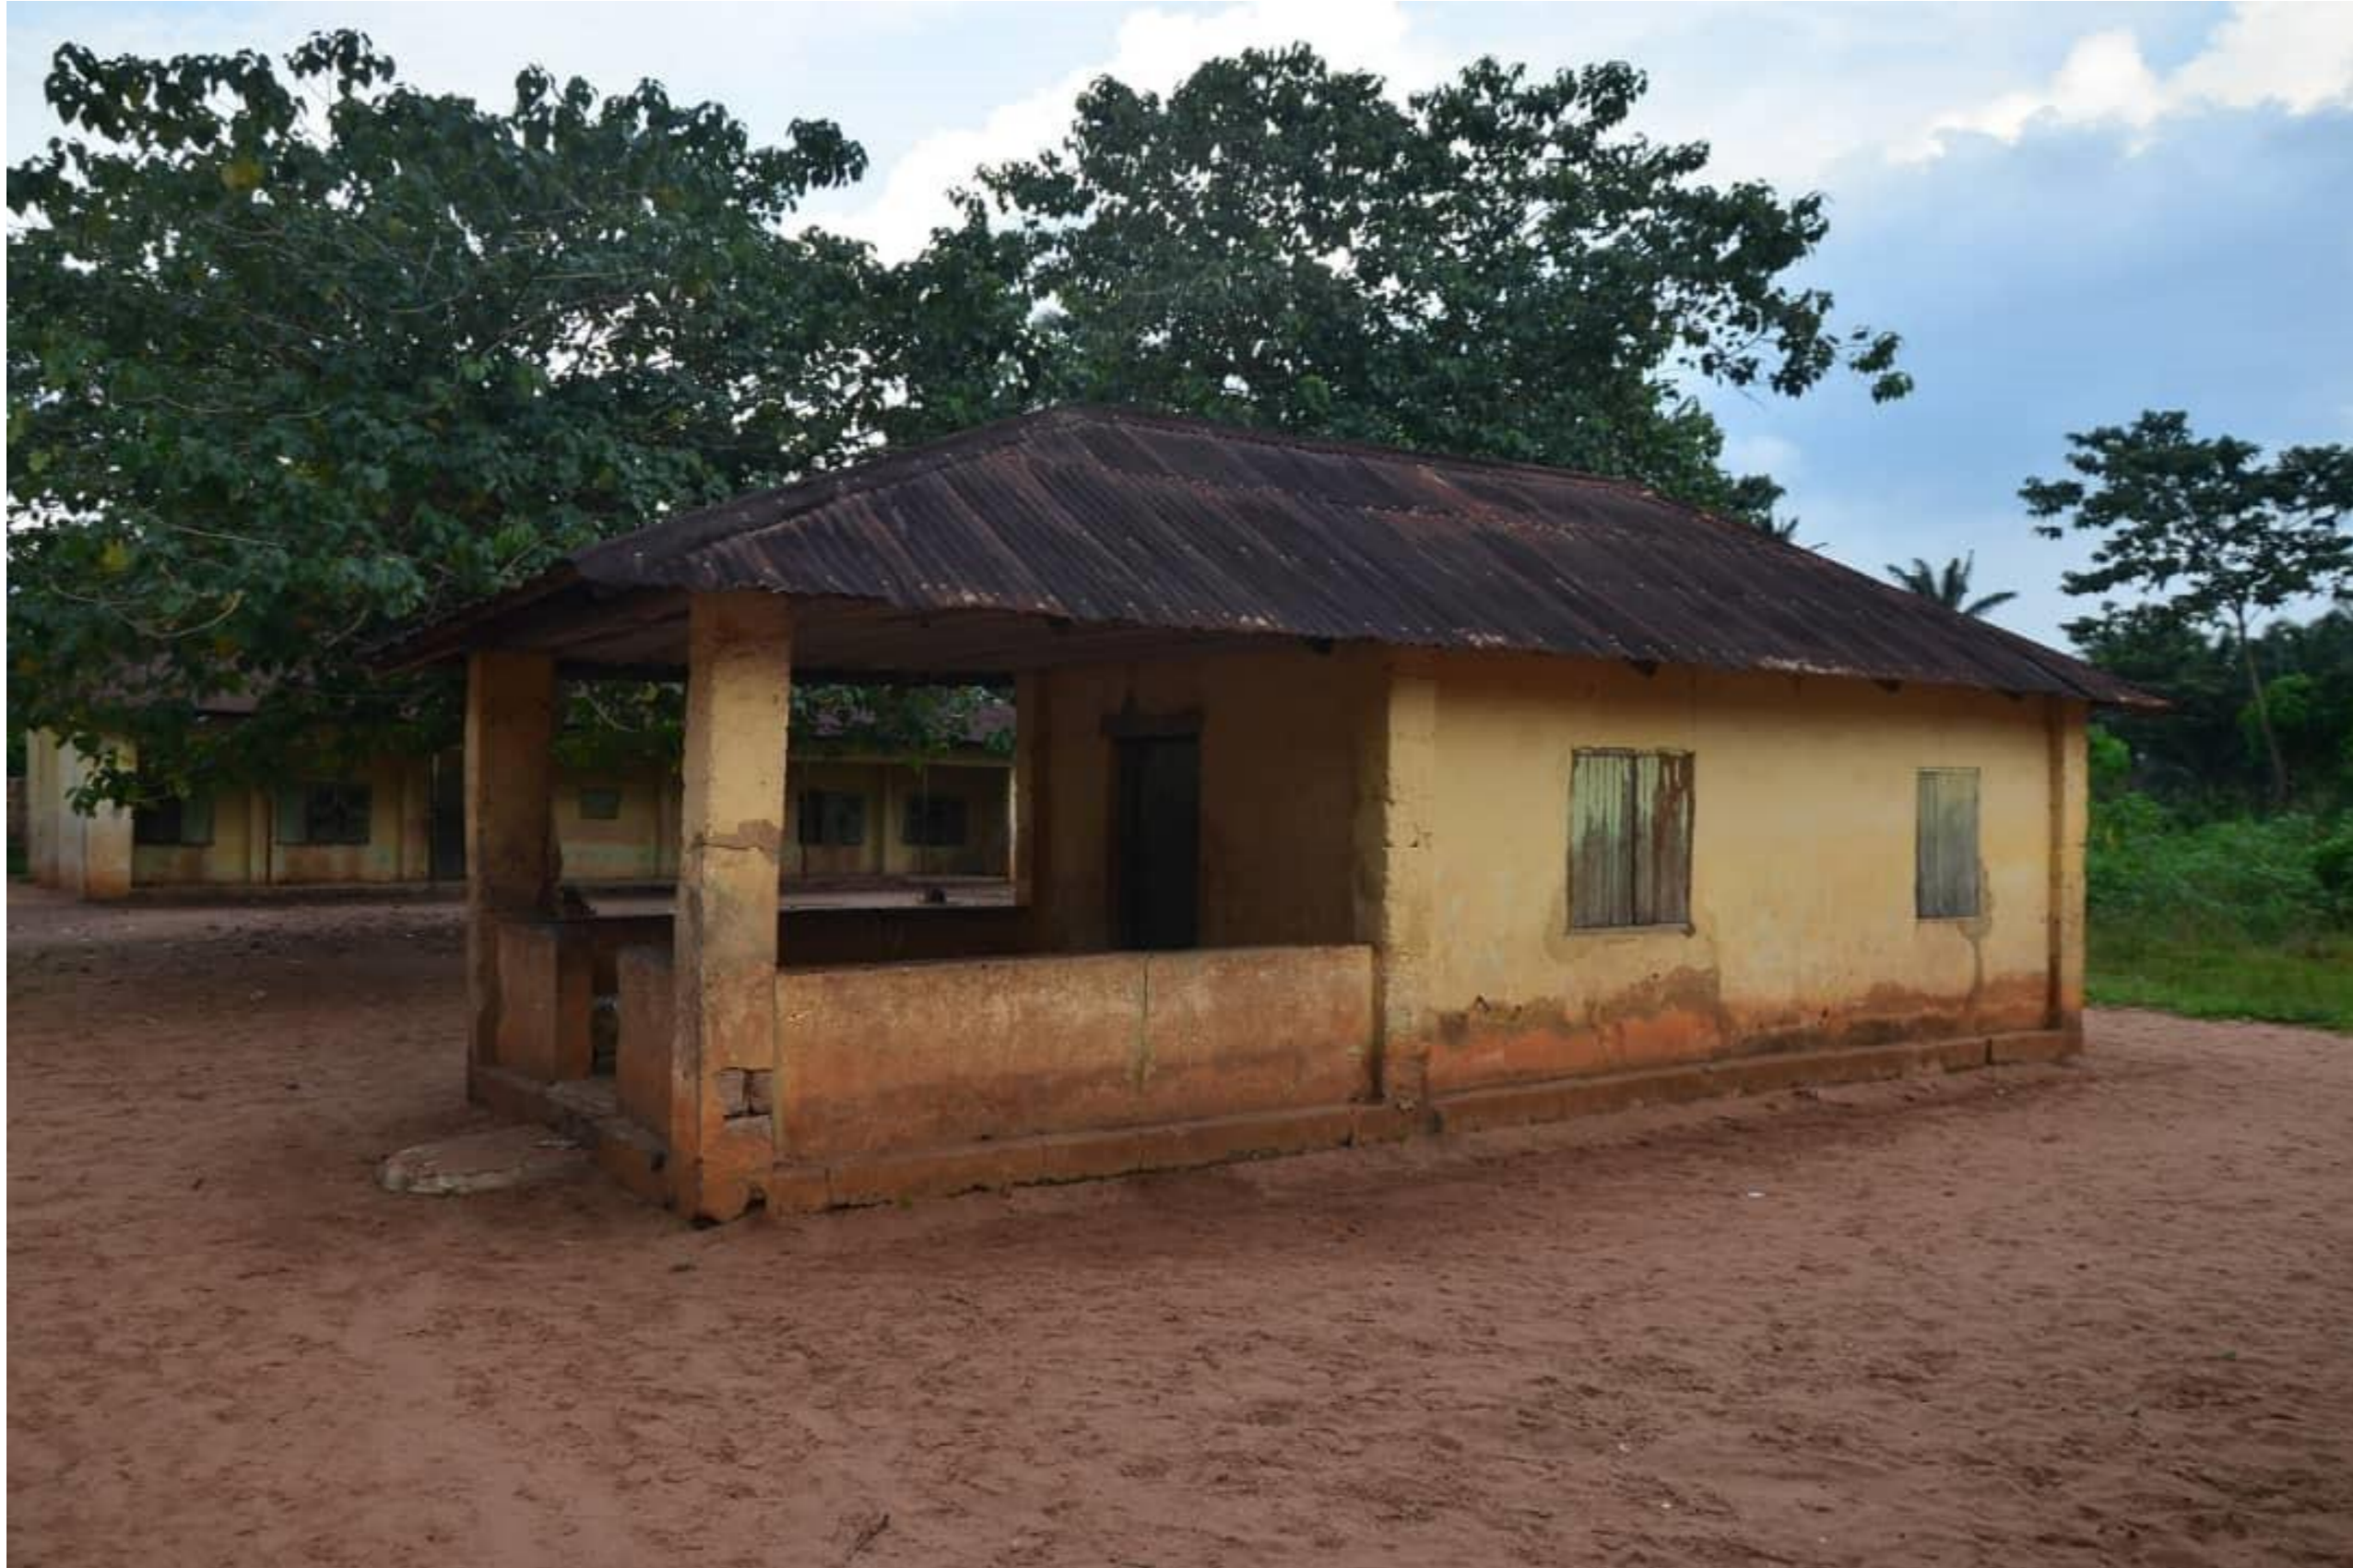
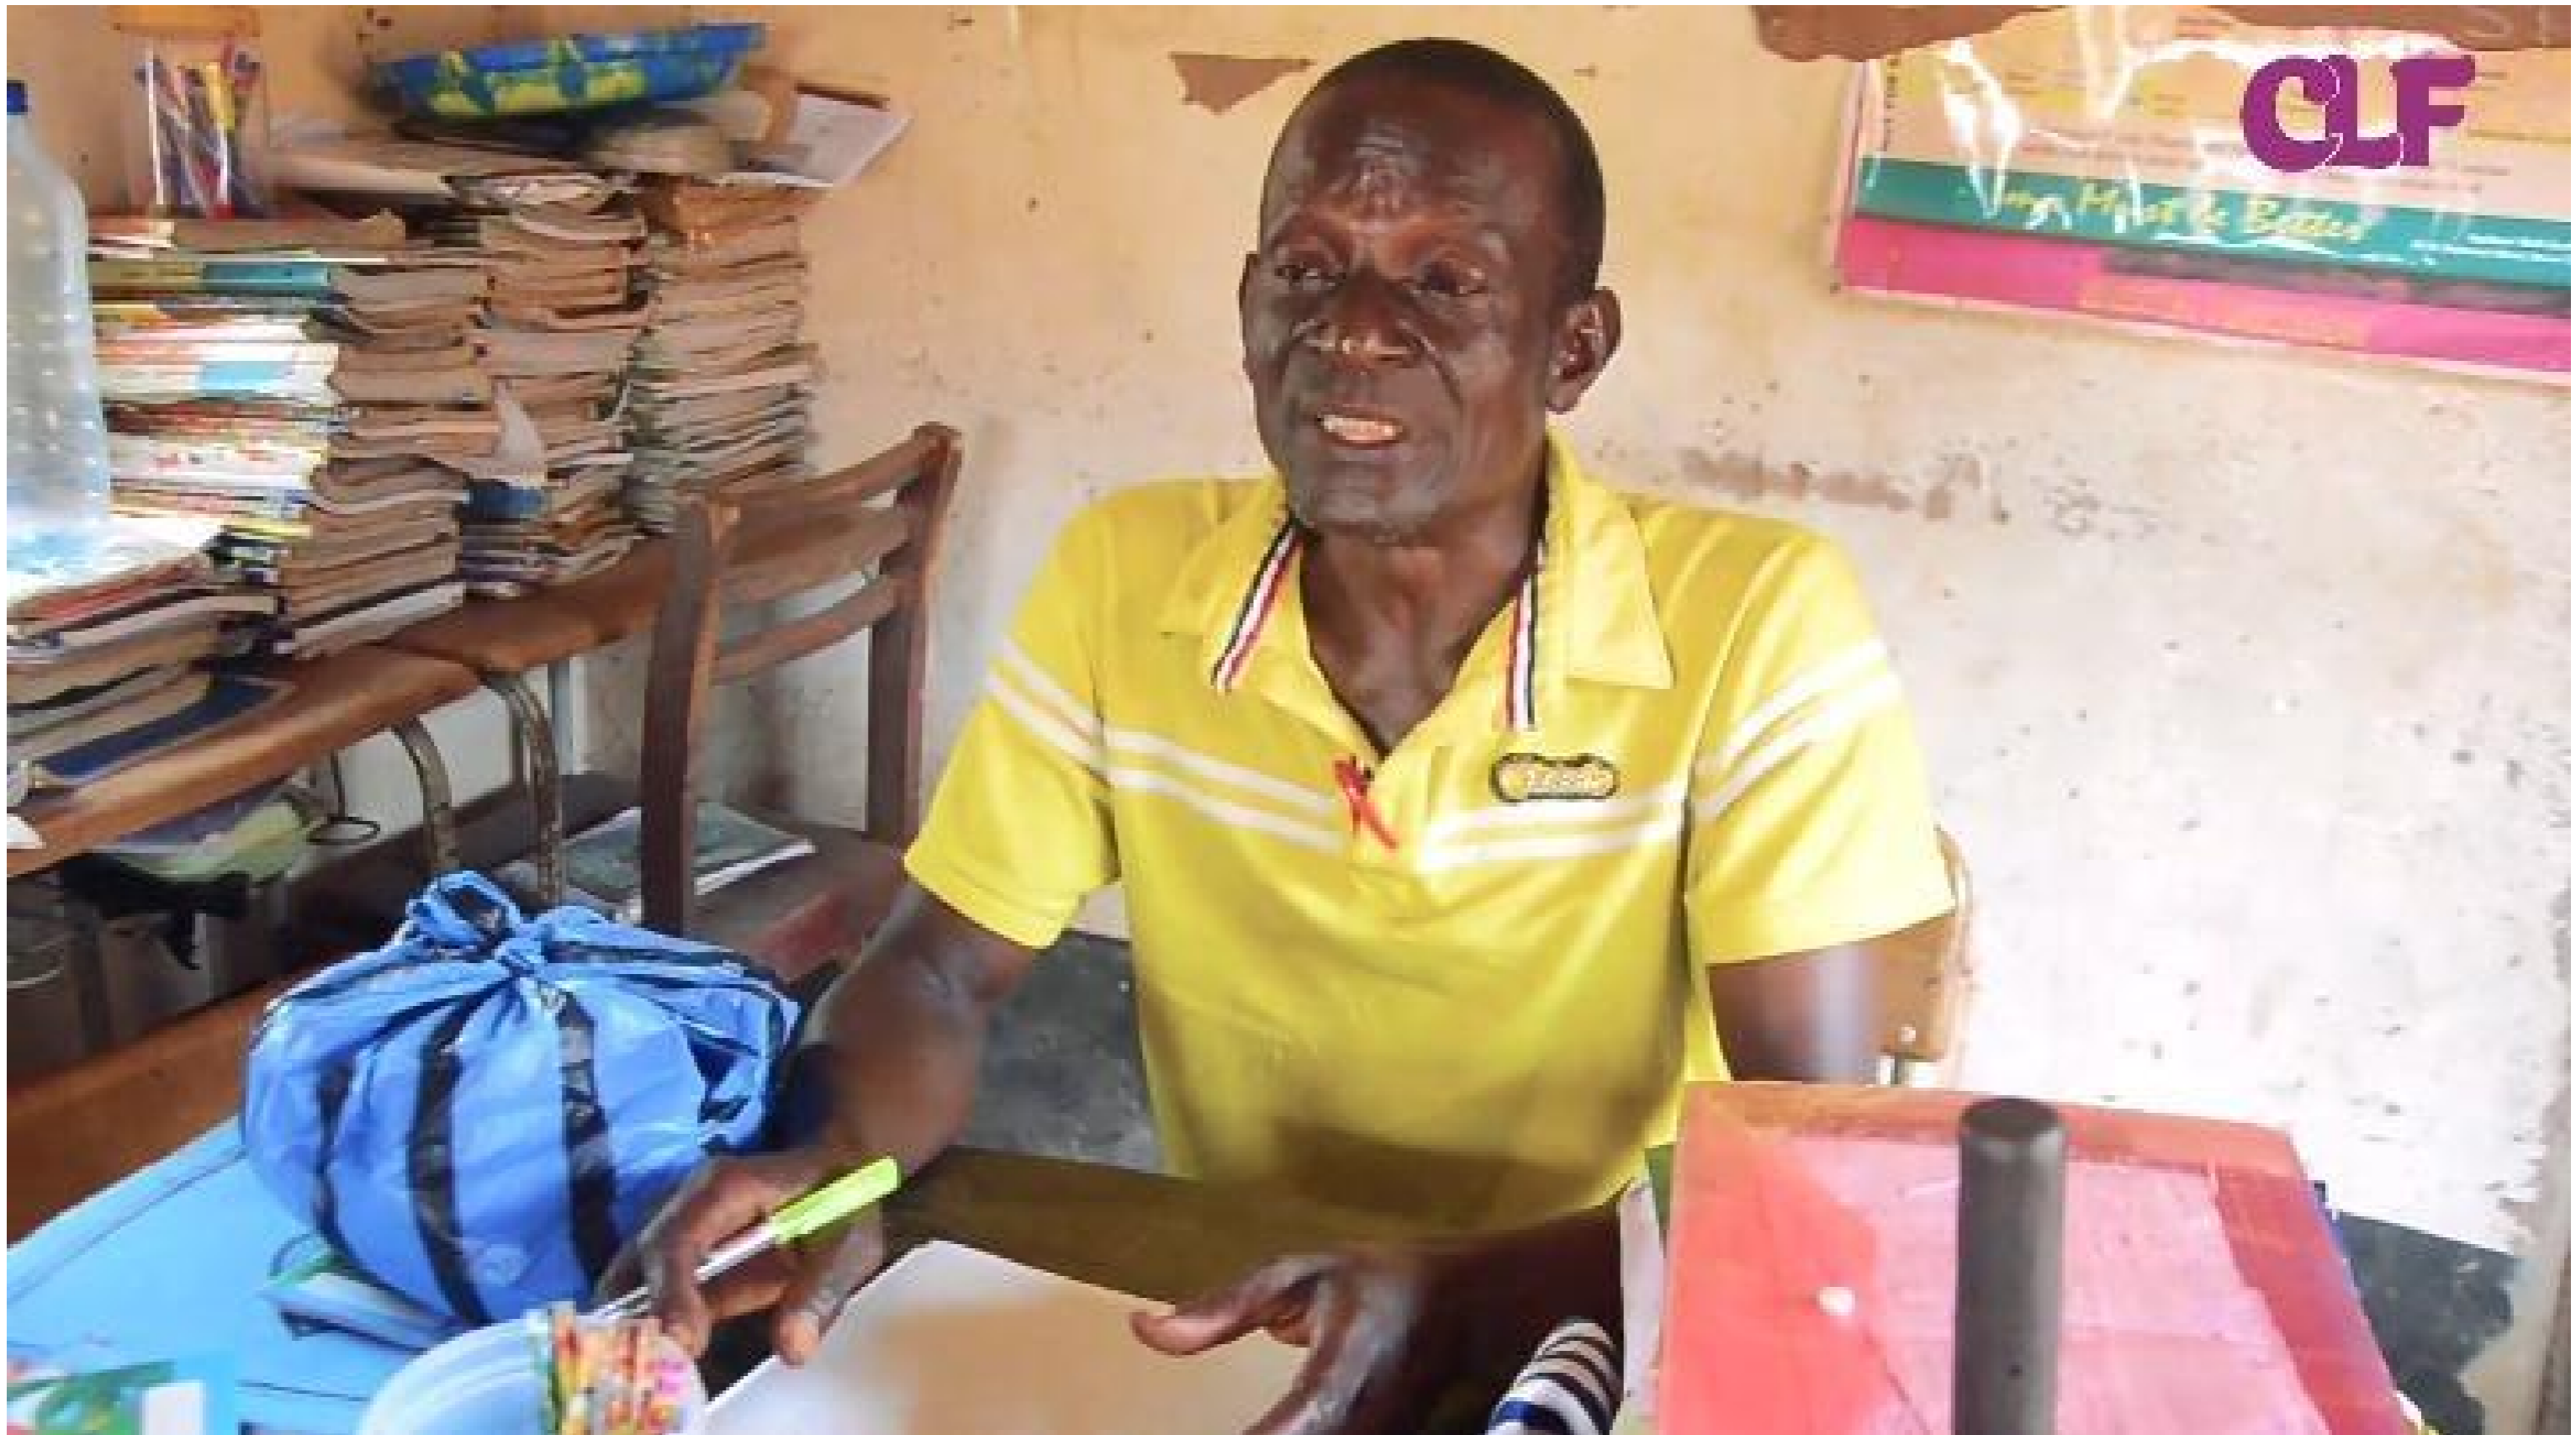
BLOCK D: HEADMASTER'S OFFICE

ENVIRONMENTAL ASSESSMENT	
	<ul style="list-style-type: none"> - Surrounding premises, very unkempt, with overgrown bushes. - Surrounding Premises, susceptible to flood.
STRUCTURAL ASSESSMENT	
	<ul style="list-style-type: none"> - Dilapidating. Expired roofing sheets and trusses. Broken Floors. Cracked Walls. - Worn out doors and windows - Requires urgent maintenance
FACILITIES ASSESSMENT	
	<ul style="list-style-type: none"> - Facilities grossly inadequate. Barely even present.

SAFETY ASSESSMENT	
	<ul style="list-style-type: none"> - Block not adequately burglarproof - Block not adequately protected from unfavourable weather conditions. - Structural Integrity suspect. -
