**OHAKPU COMMUNITY
PRIMARY SCHOOL,
ORU WEST,
IMO STATE, NIGERIA.**

CHARIS LEARNING FOUNDATION

SITE ANALYSIS

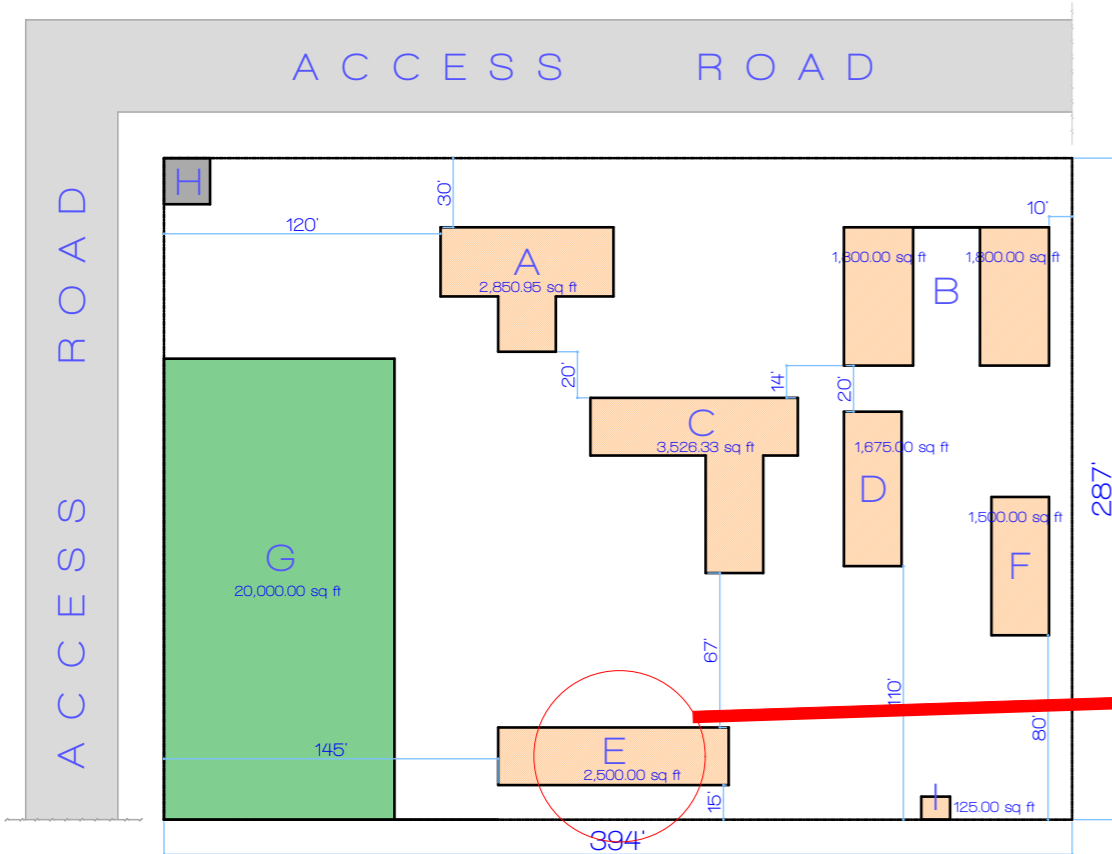
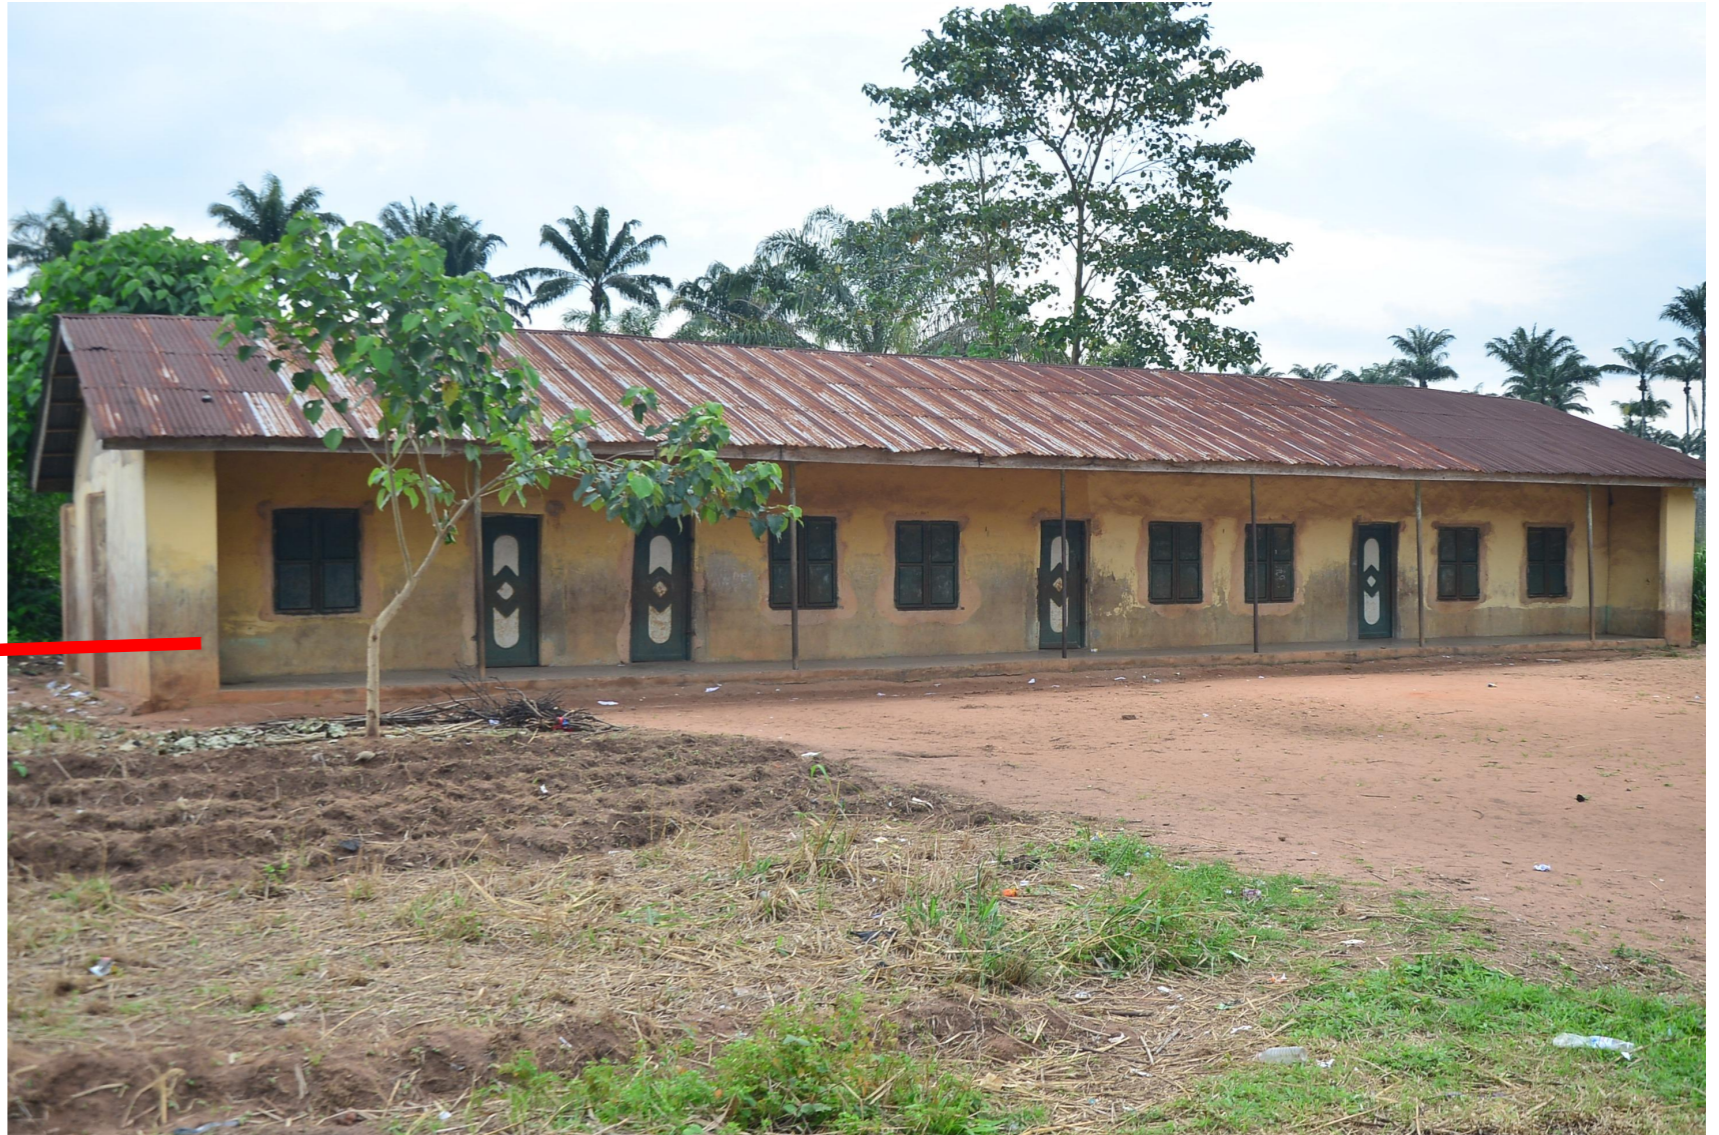
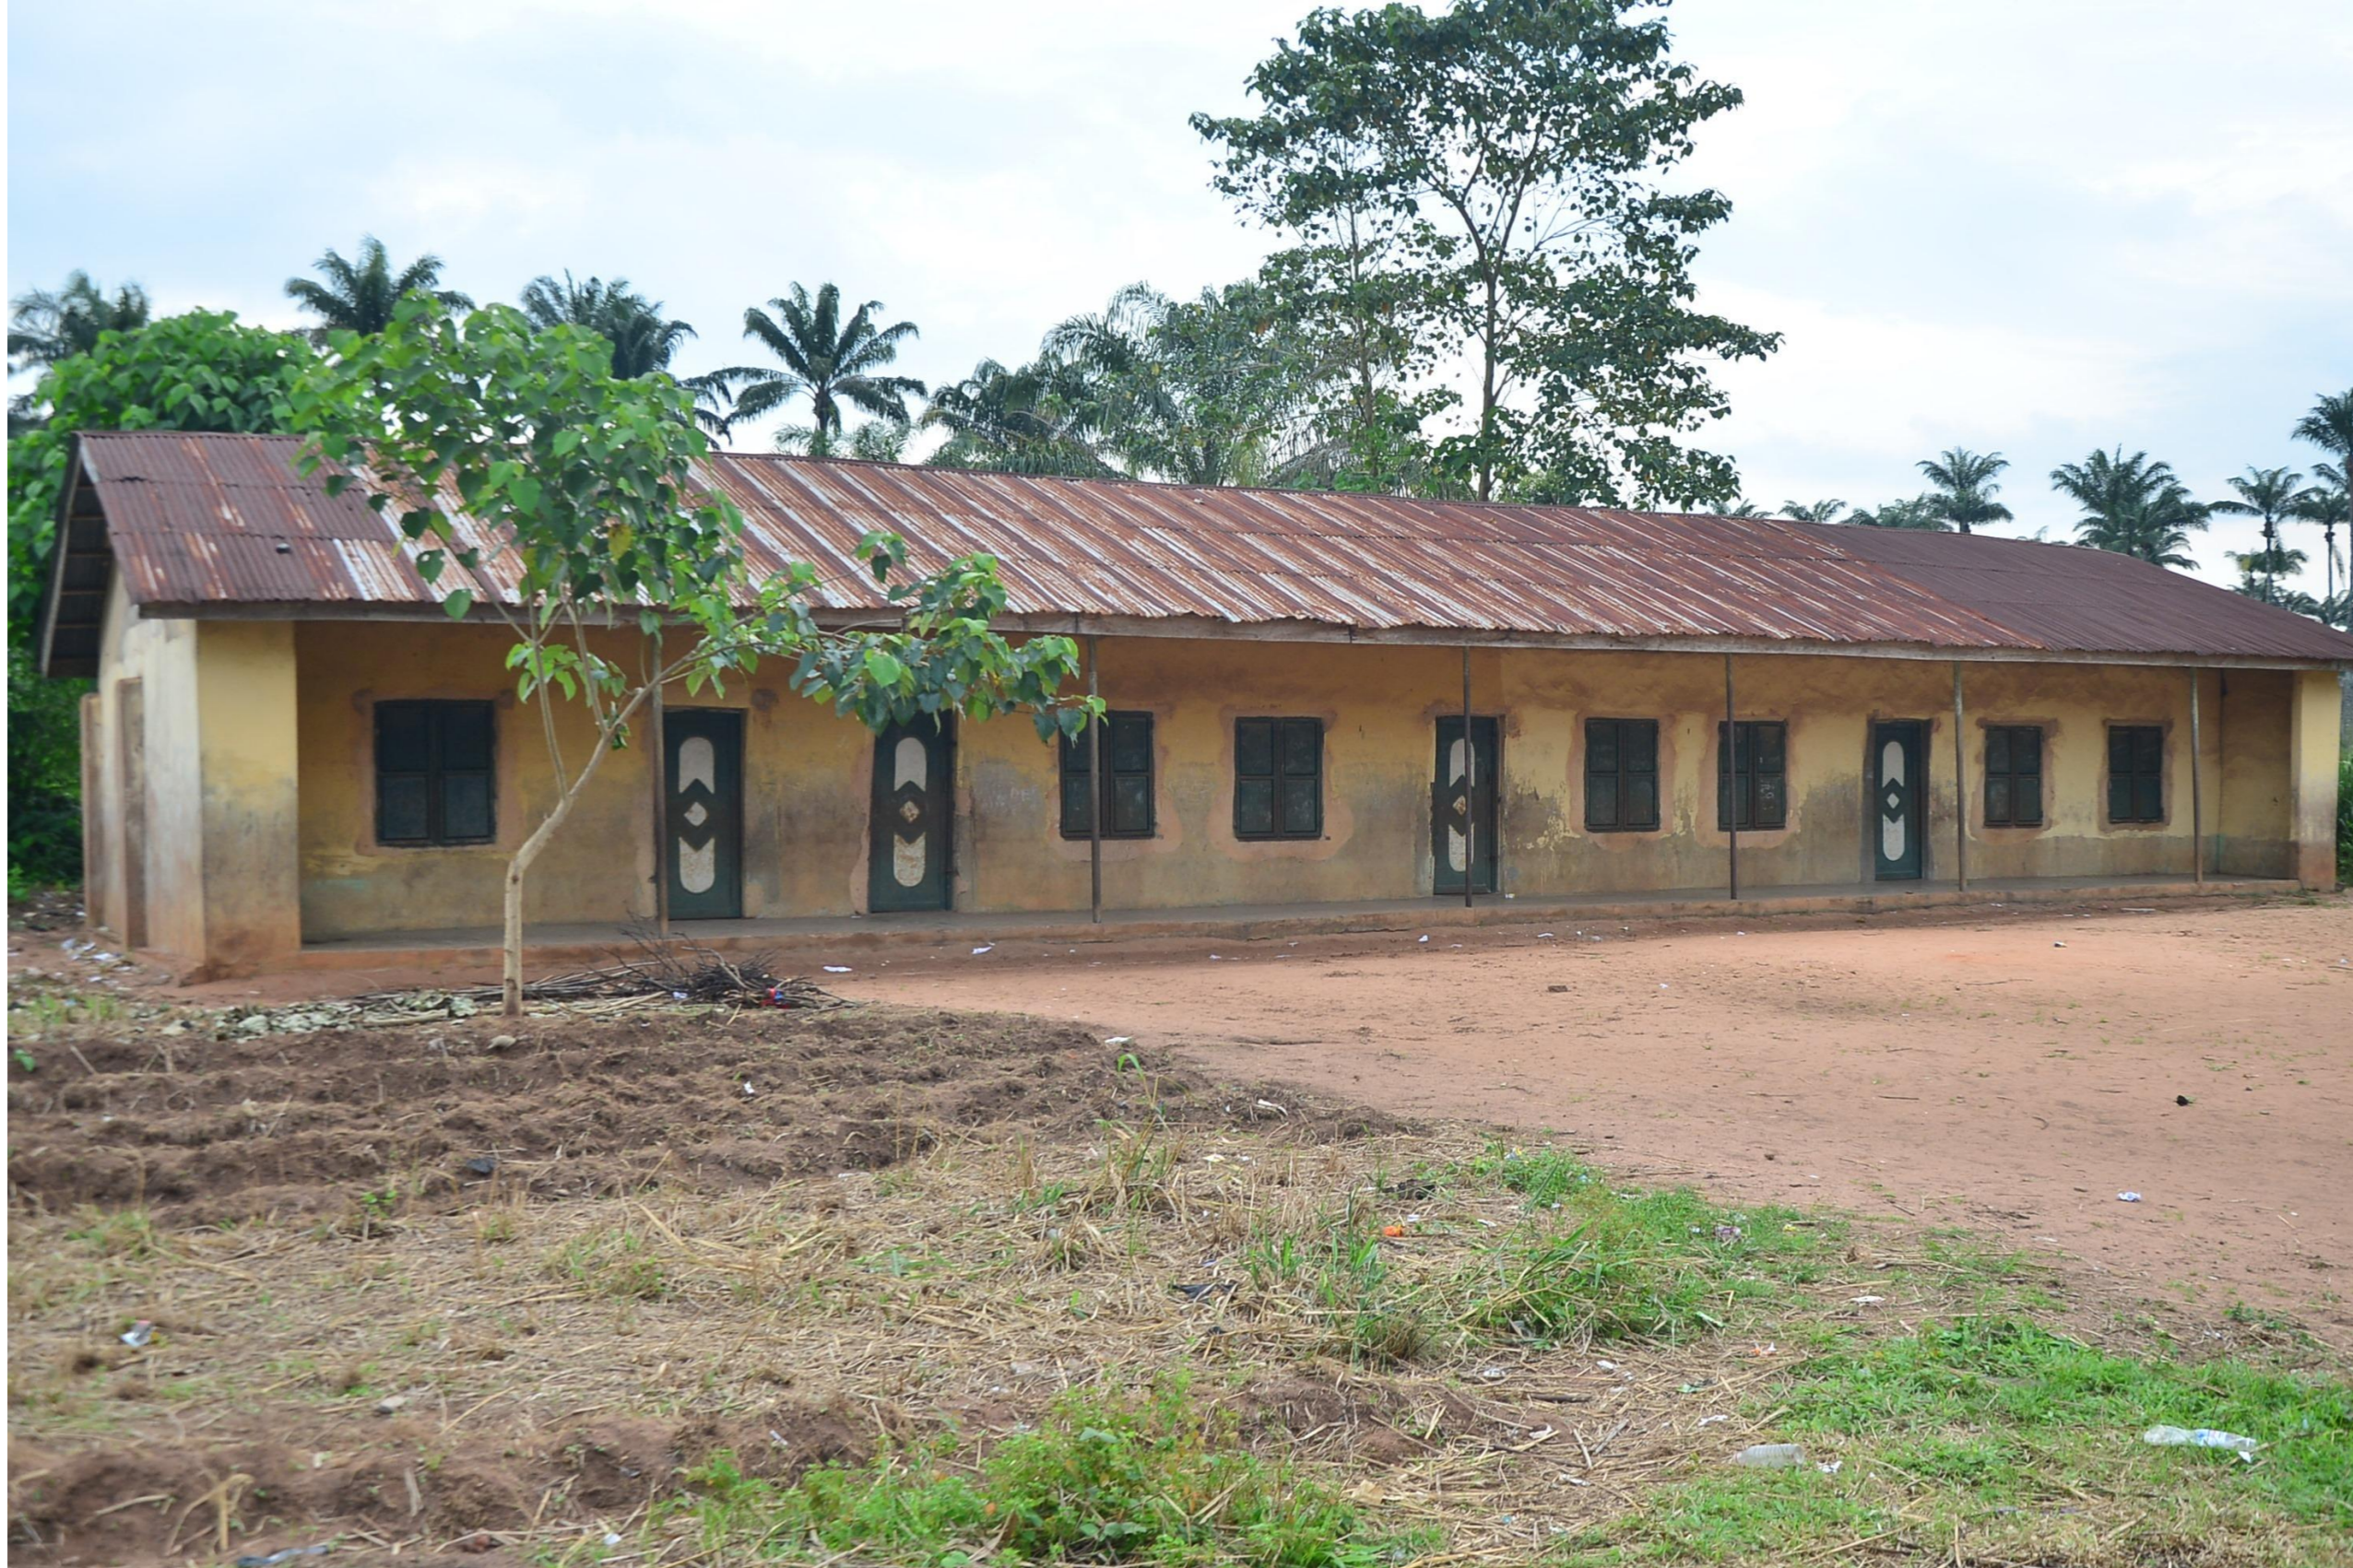
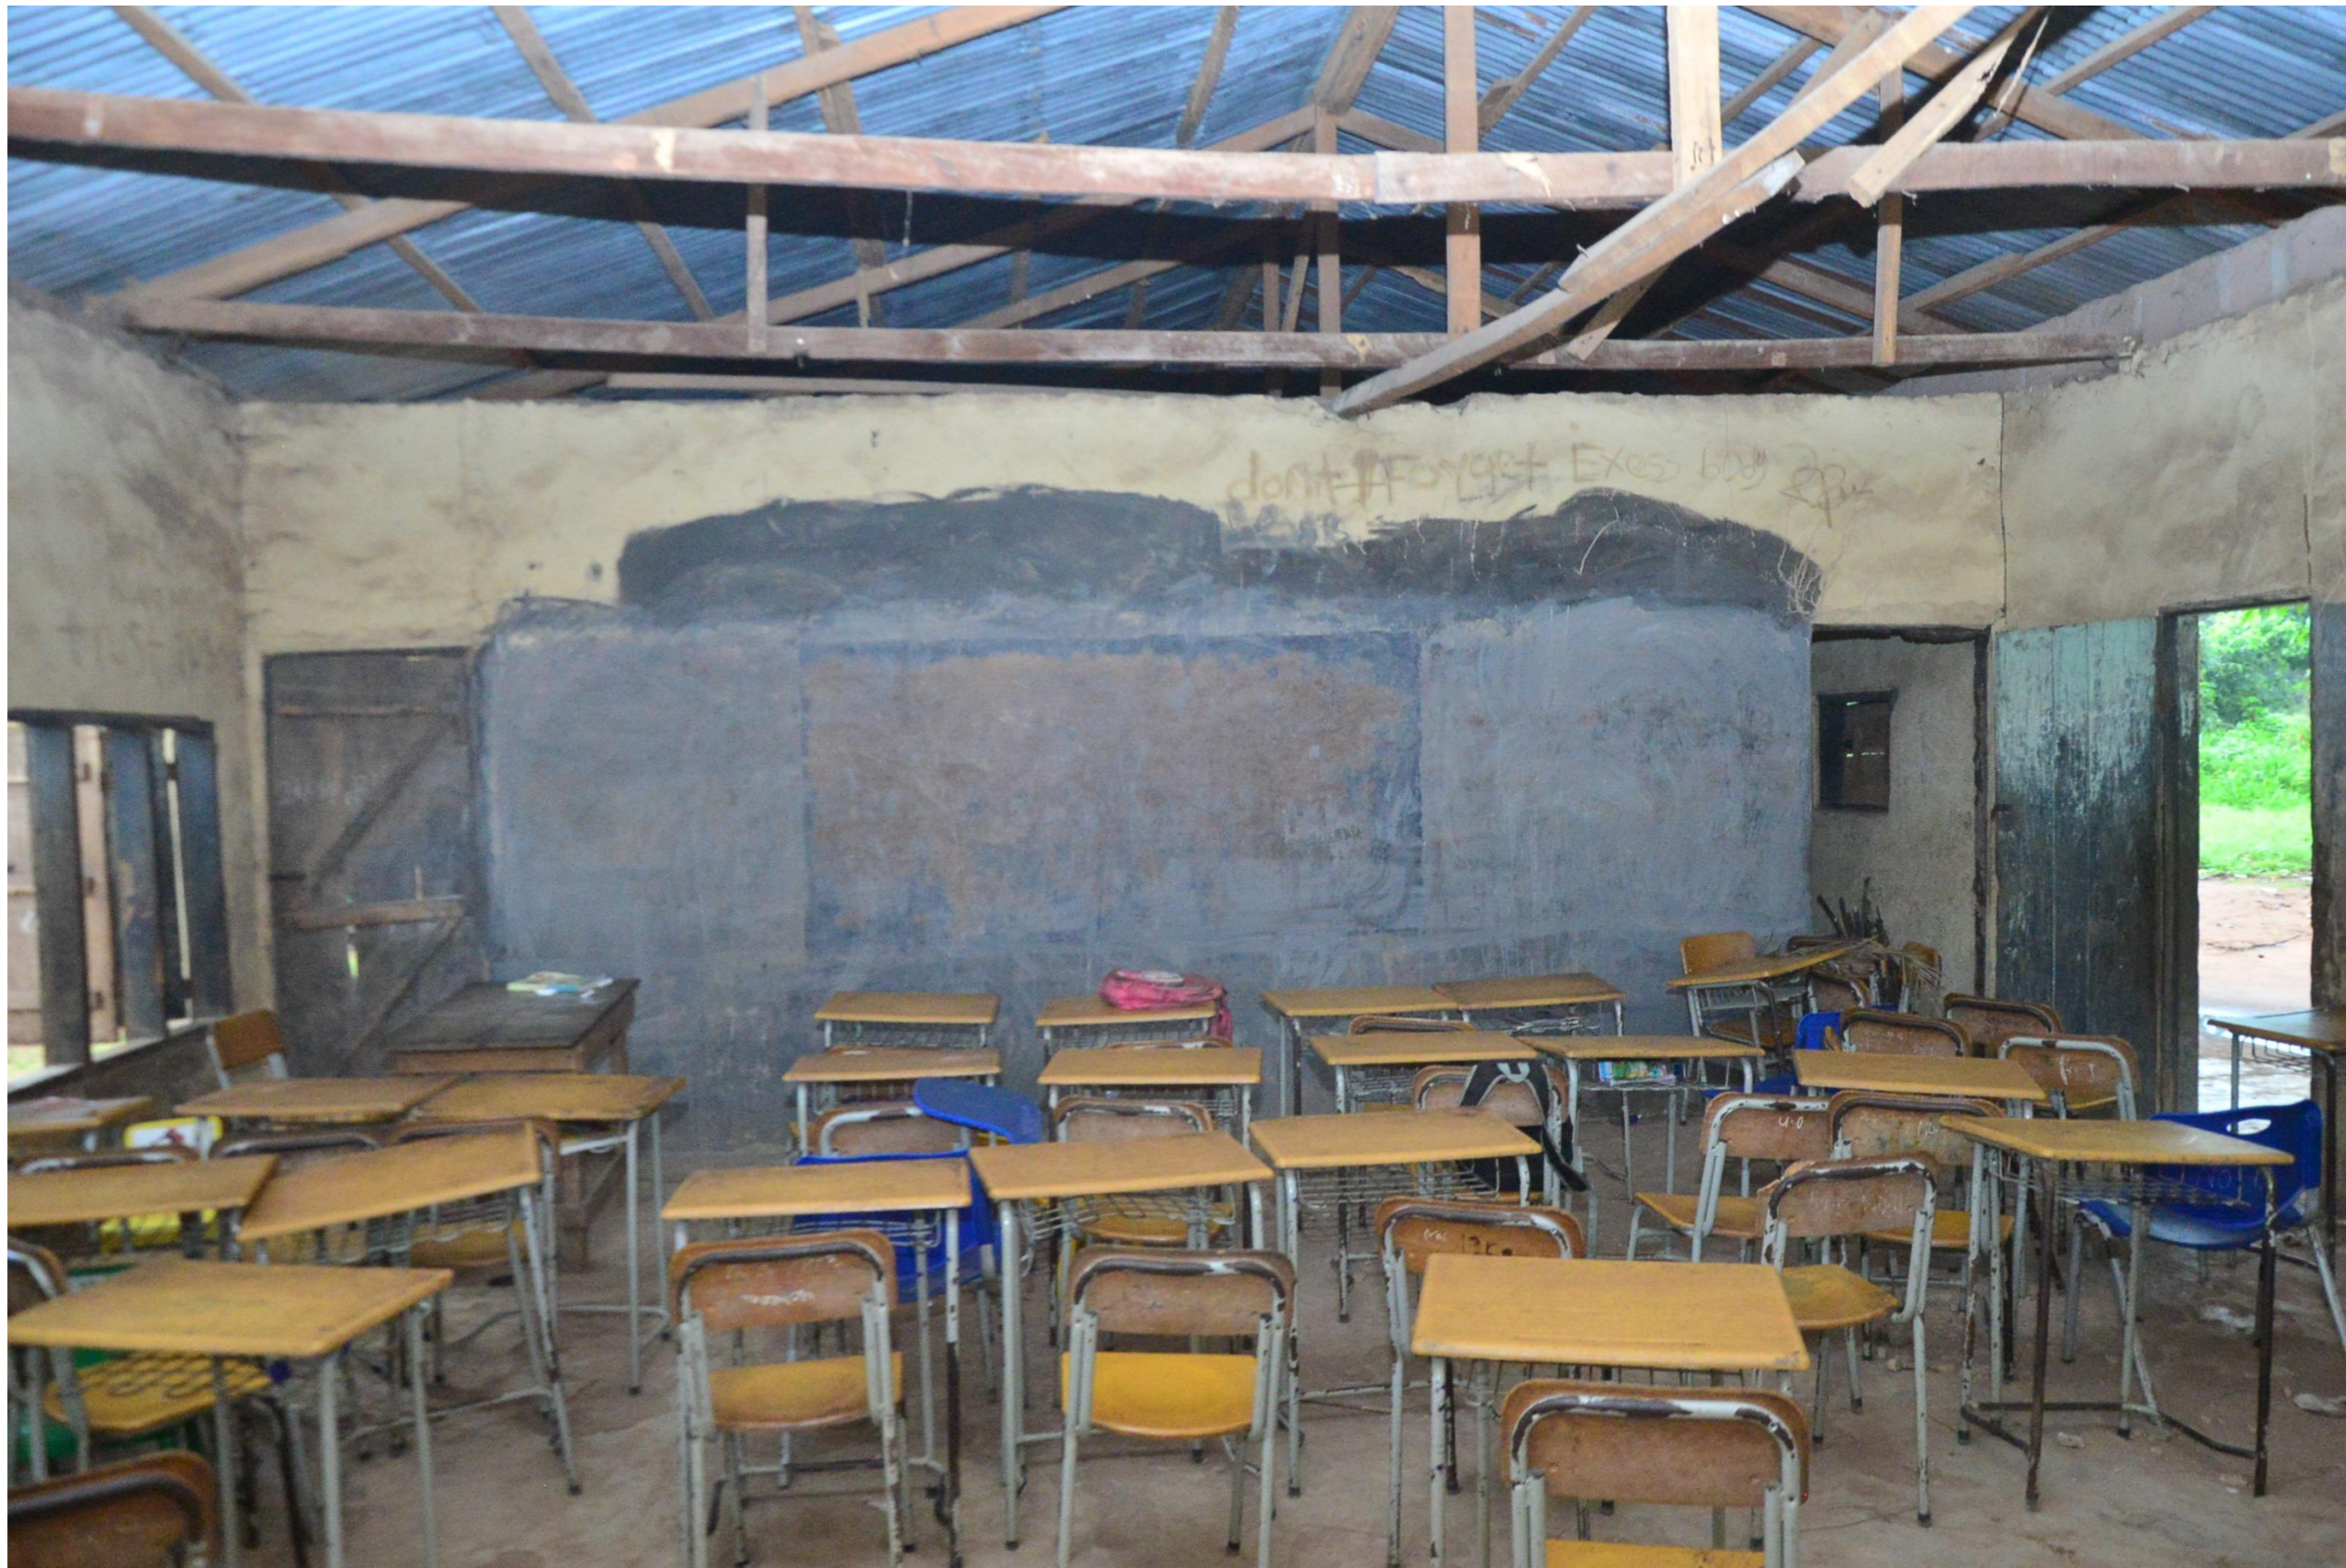
BLOCK E: CLASSROOM

ENVIRONMENTAL ASSESSMENT	
	<ul style="list-style-type: none"> - Surrounding premises, very unkempt, with overgrown bushes. - Surrounding Premises, susceptible to flood.
STRUCTURAL ASSESSMENT	
	<ul style="list-style-type: none"> - Expired roofing sheets and trusses. - Requires maintenance and refurbishment.
FACILITIES ASSESSMENT	
	<ul style="list-style-type: none"> - Facilities grossly inadequate. Barely even present.

SAFETY ASSESSMENT	
	<ul style="list-style-type: none"> - Environment susceptible to environmental predators, such as snakes.
