**OHAKPU COMMUNITY
PRIMARY SCHOOL,
ORU WEST,
IMO STATE, NIGERIA.**

CHARIS LEARNING FOUNDATION

SITE ANALYSIS

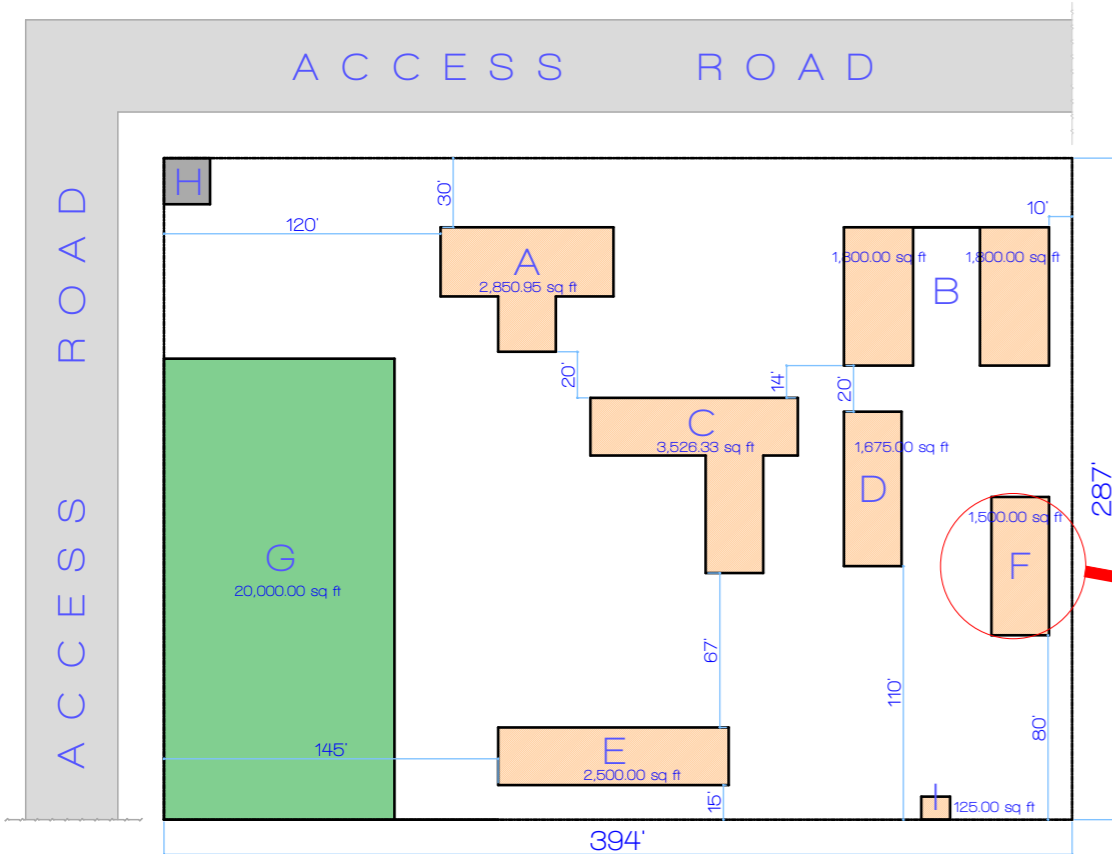
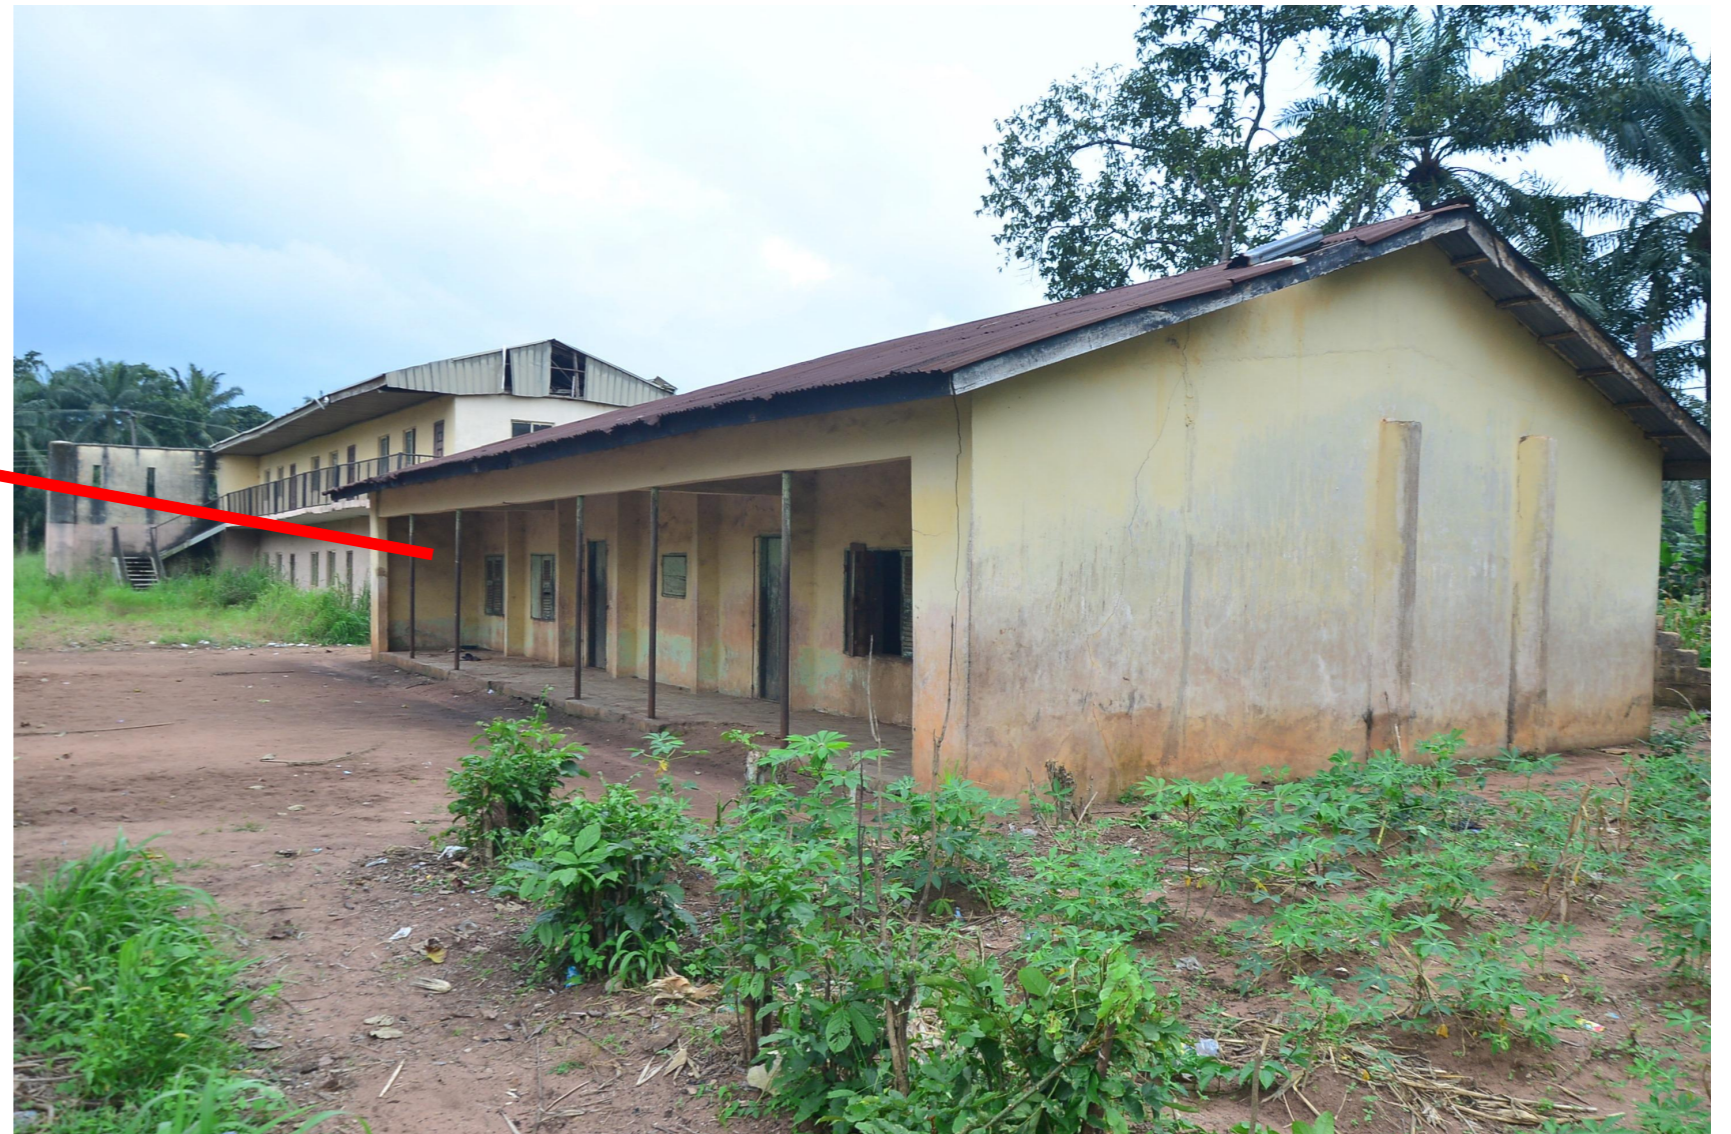
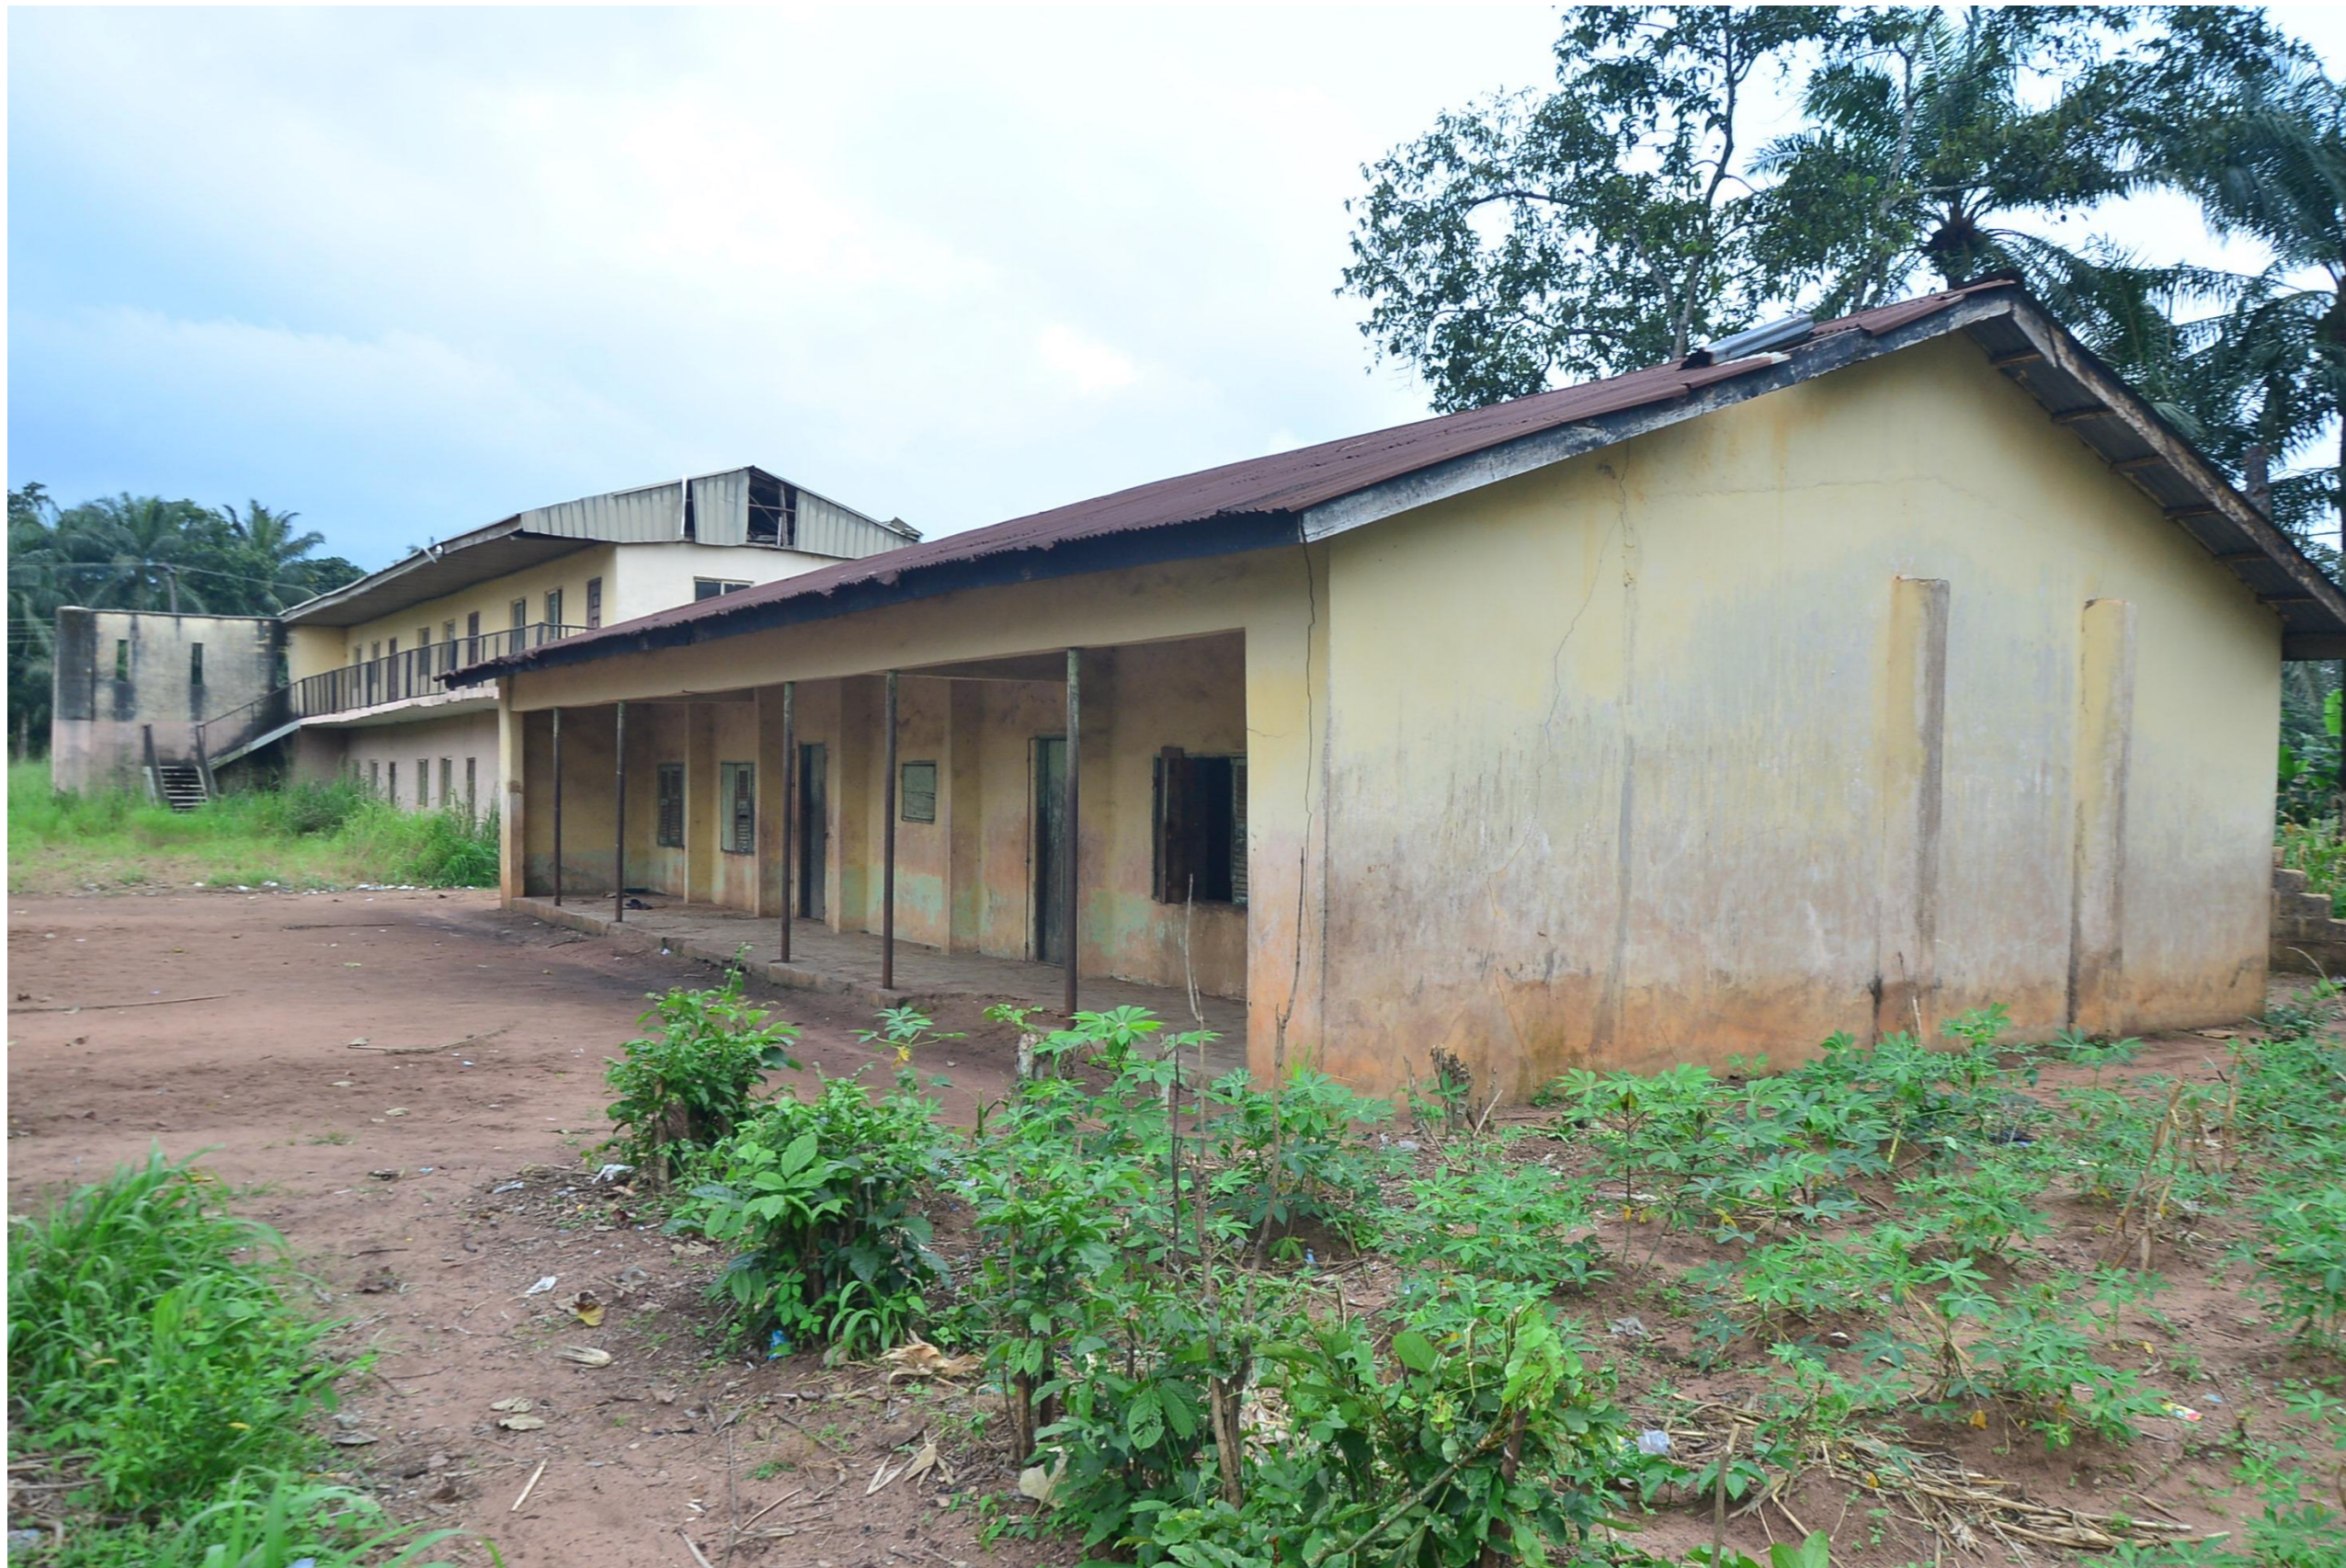
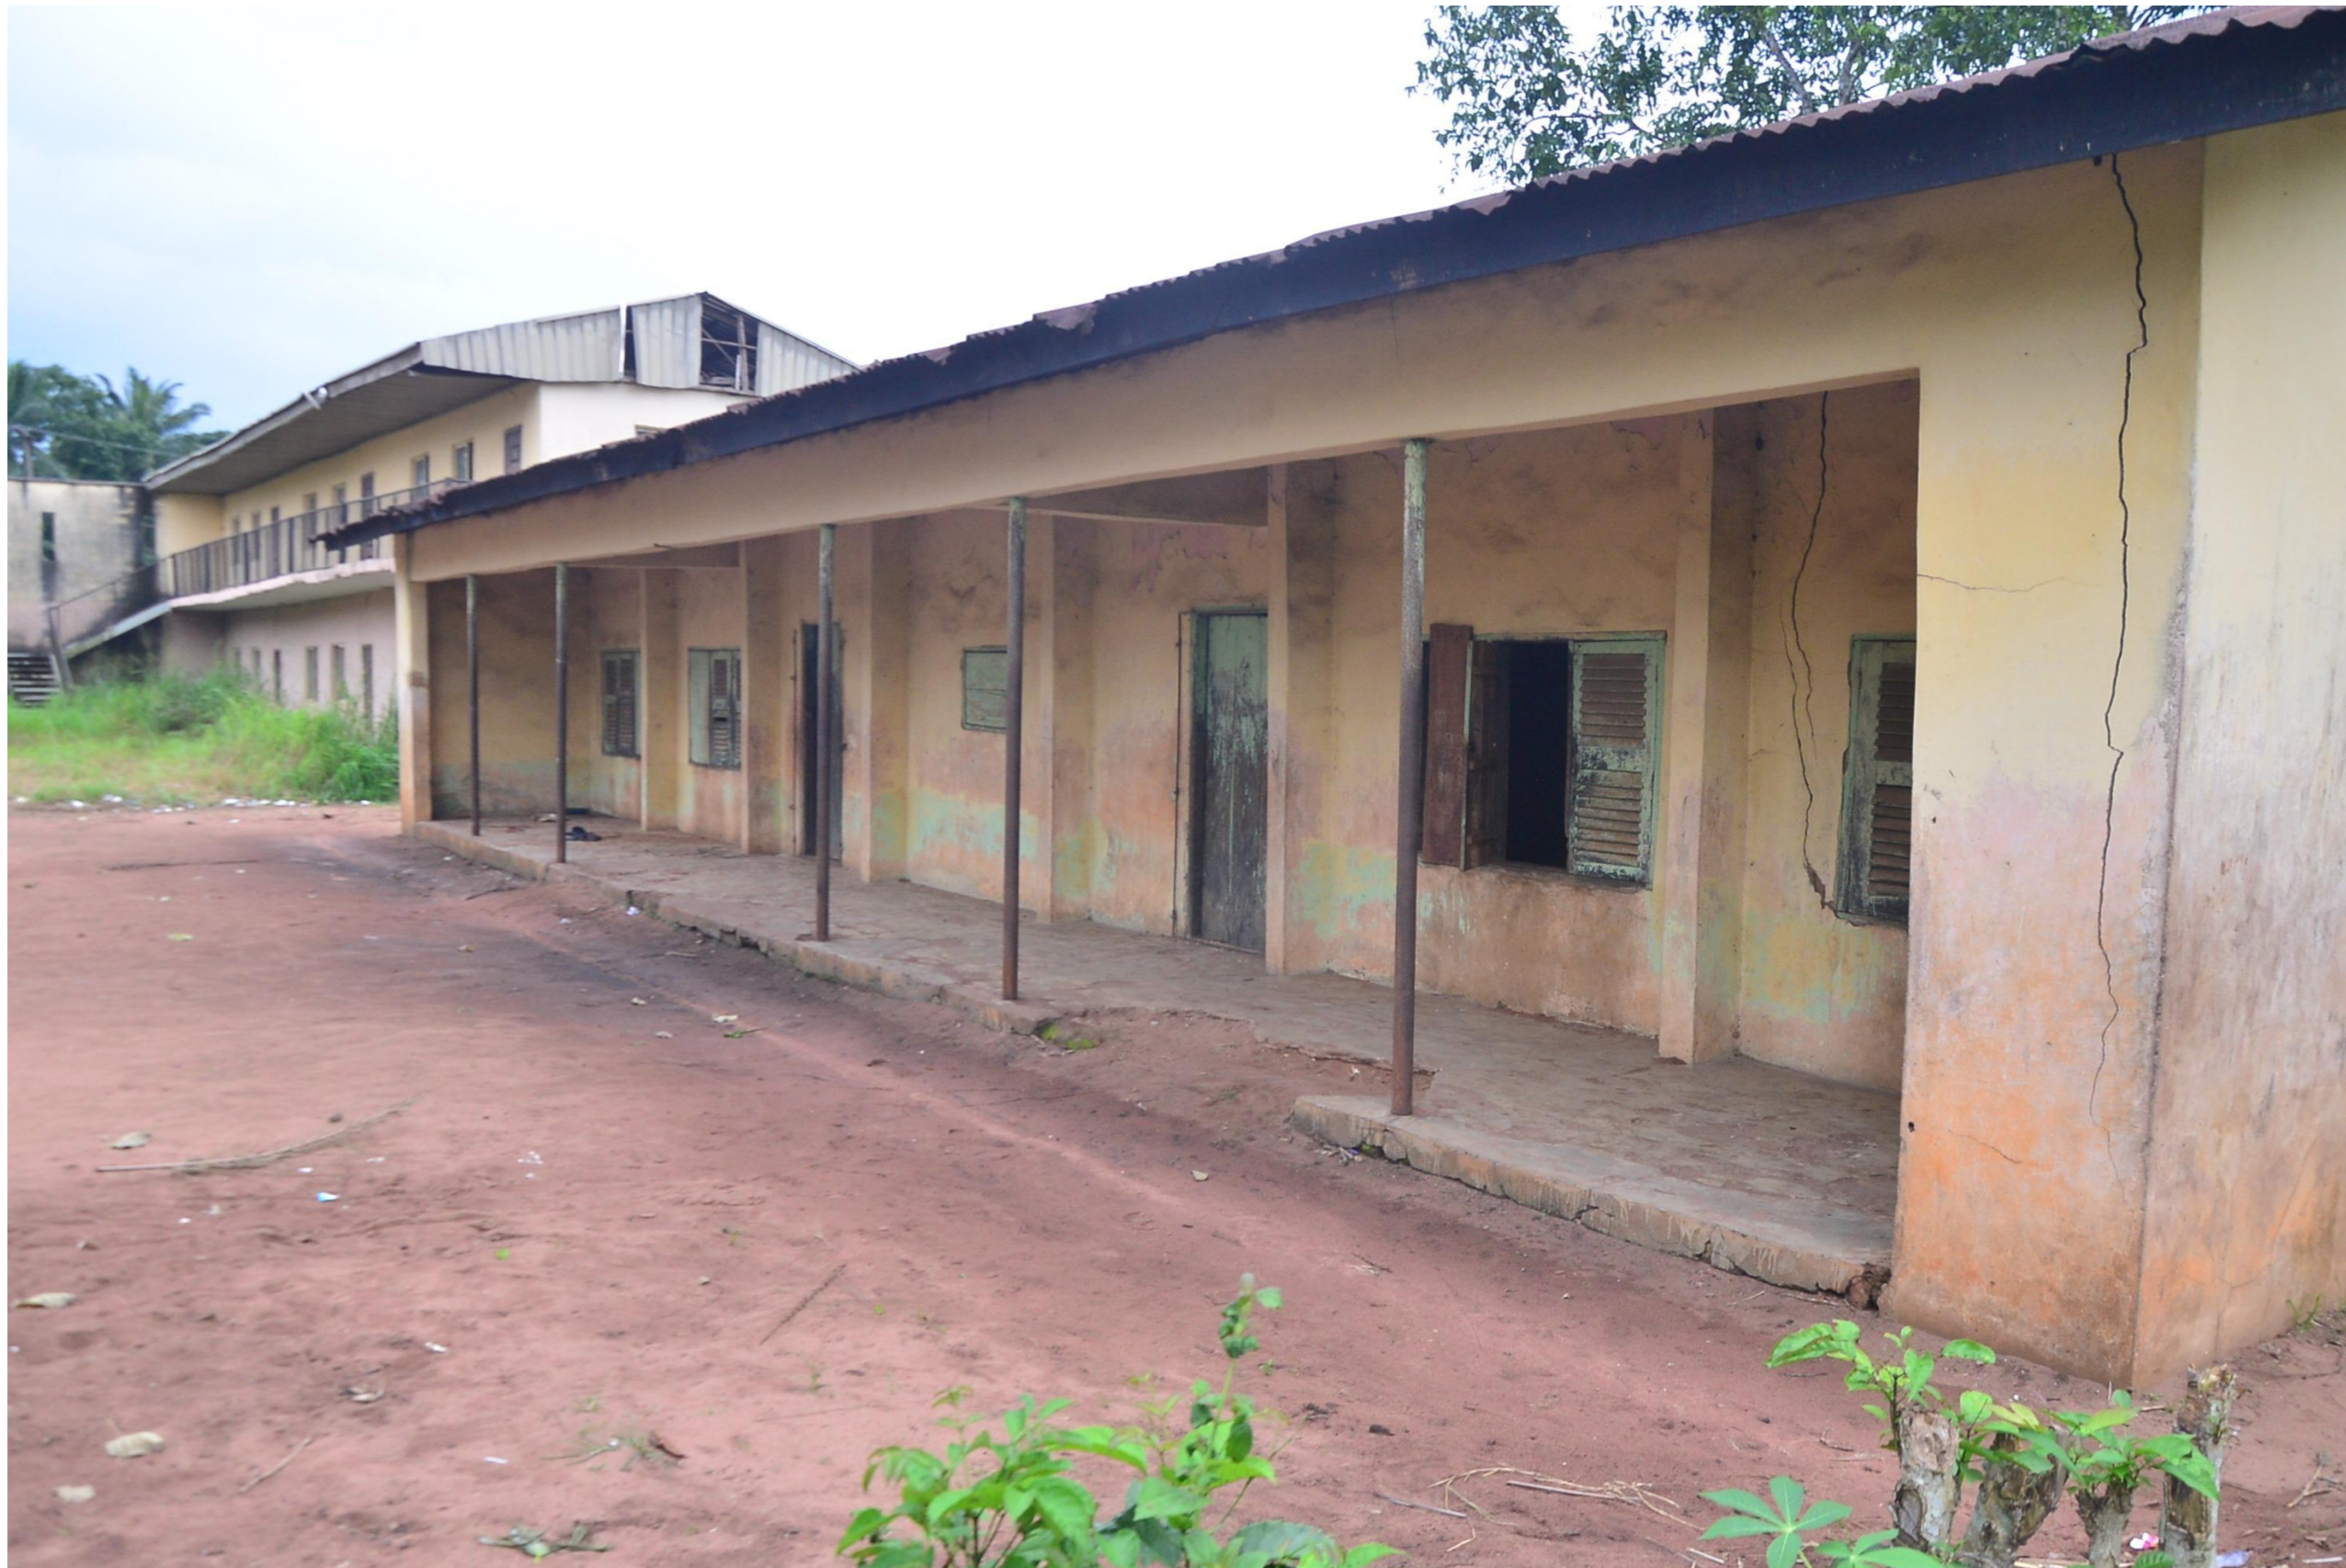
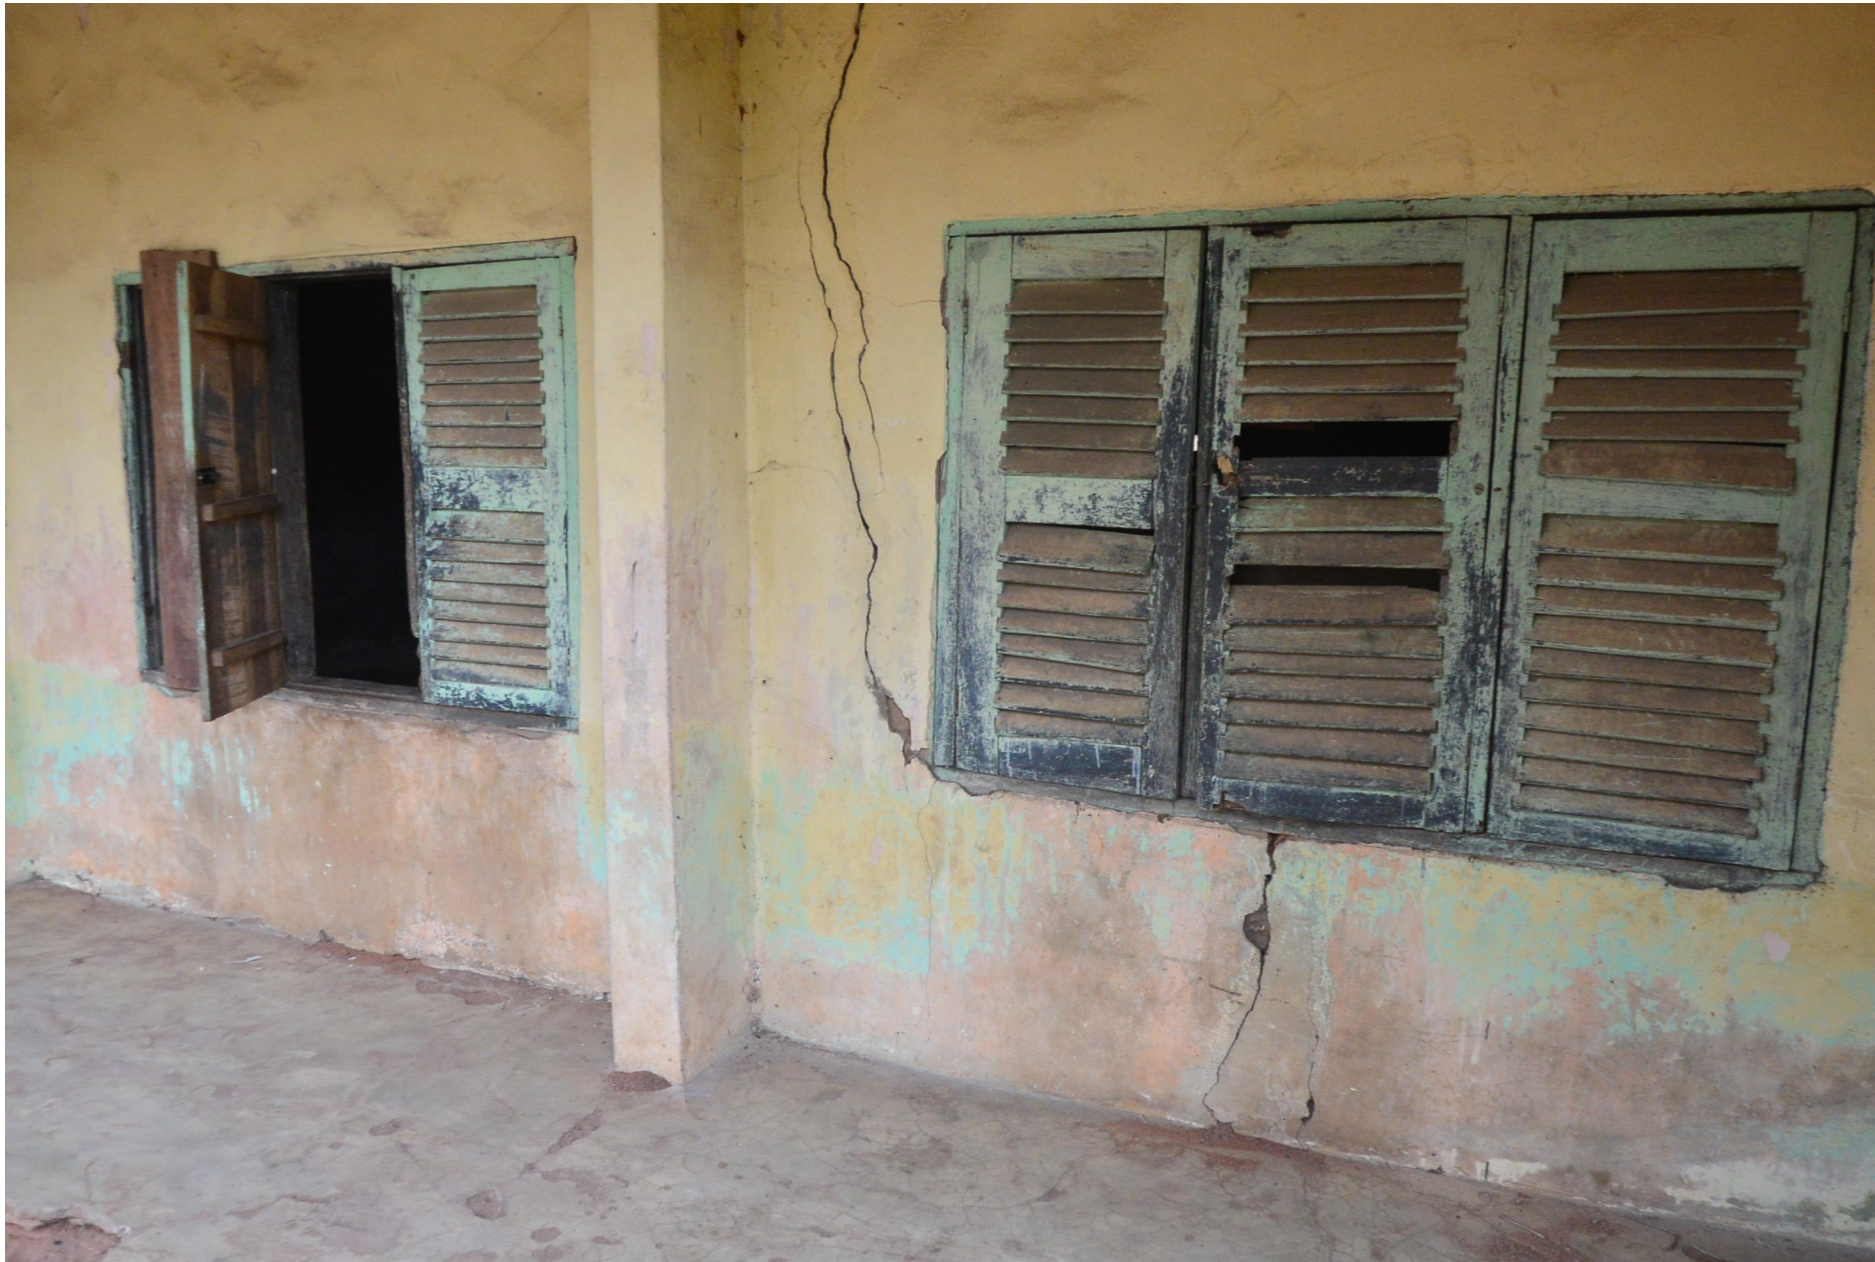
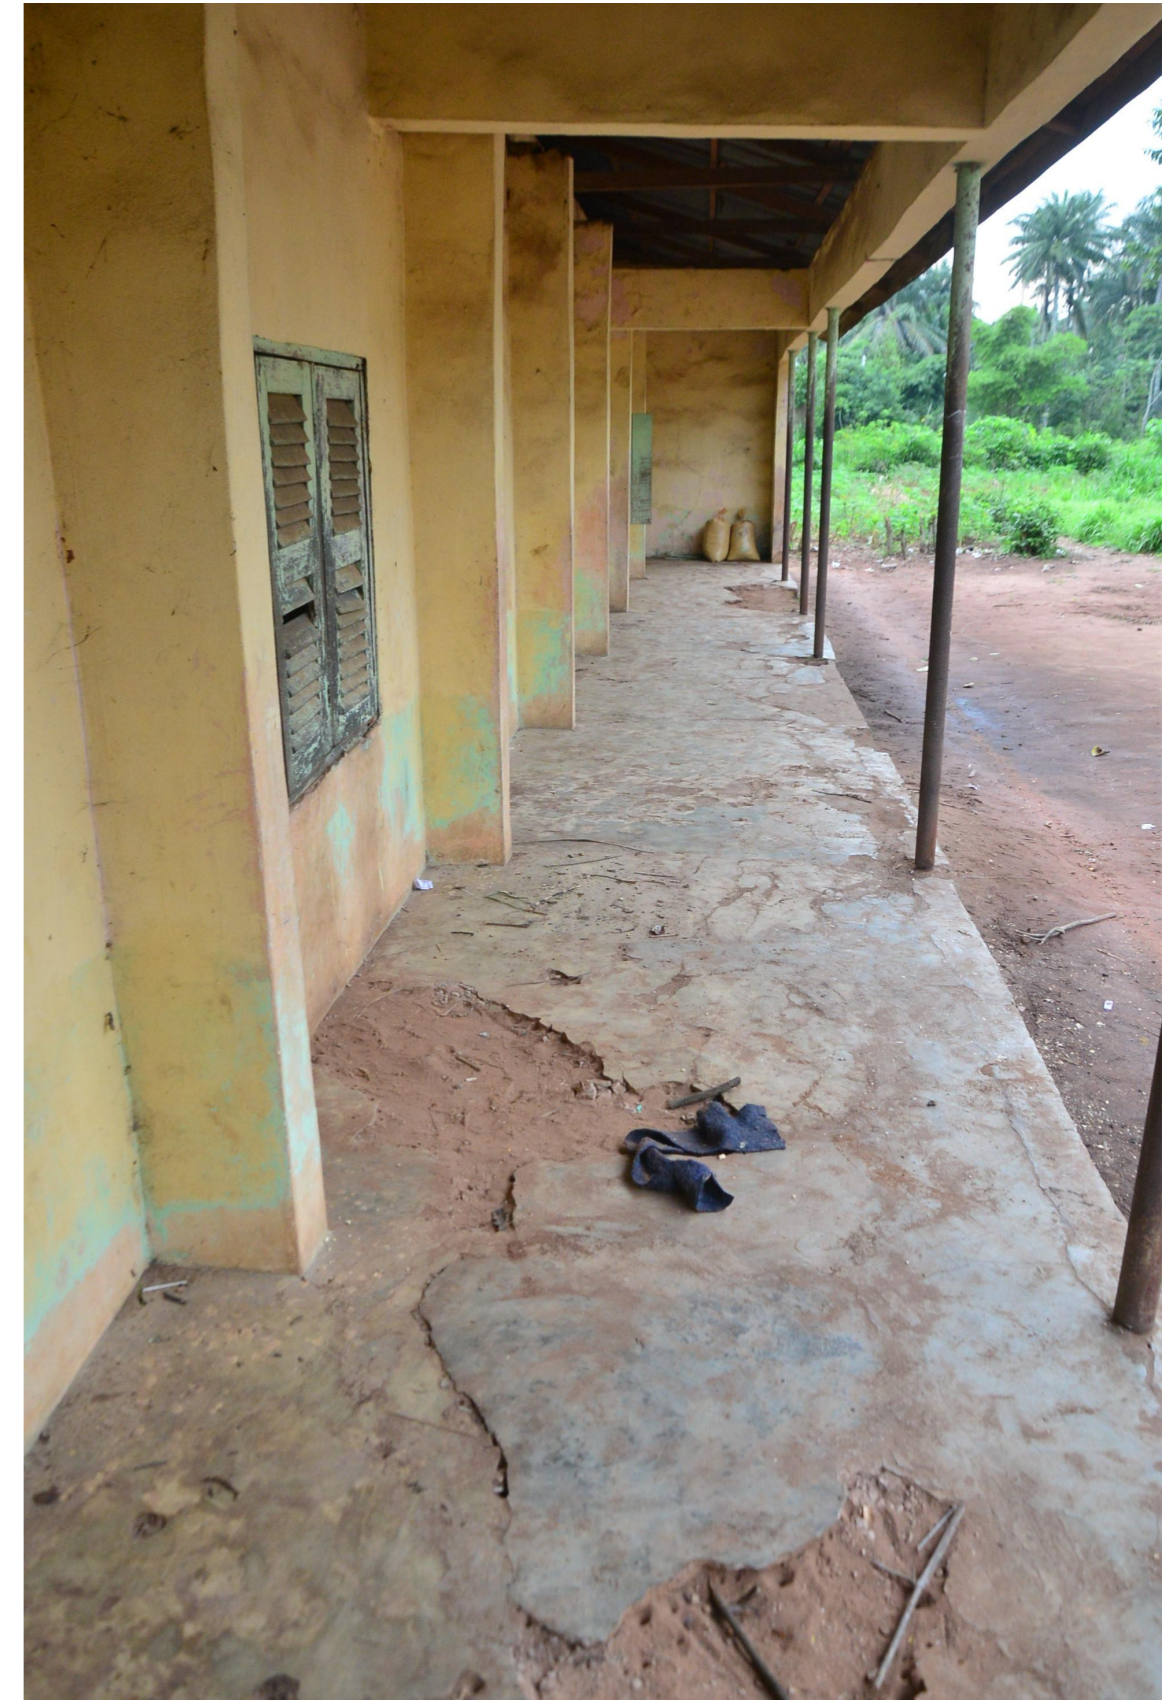
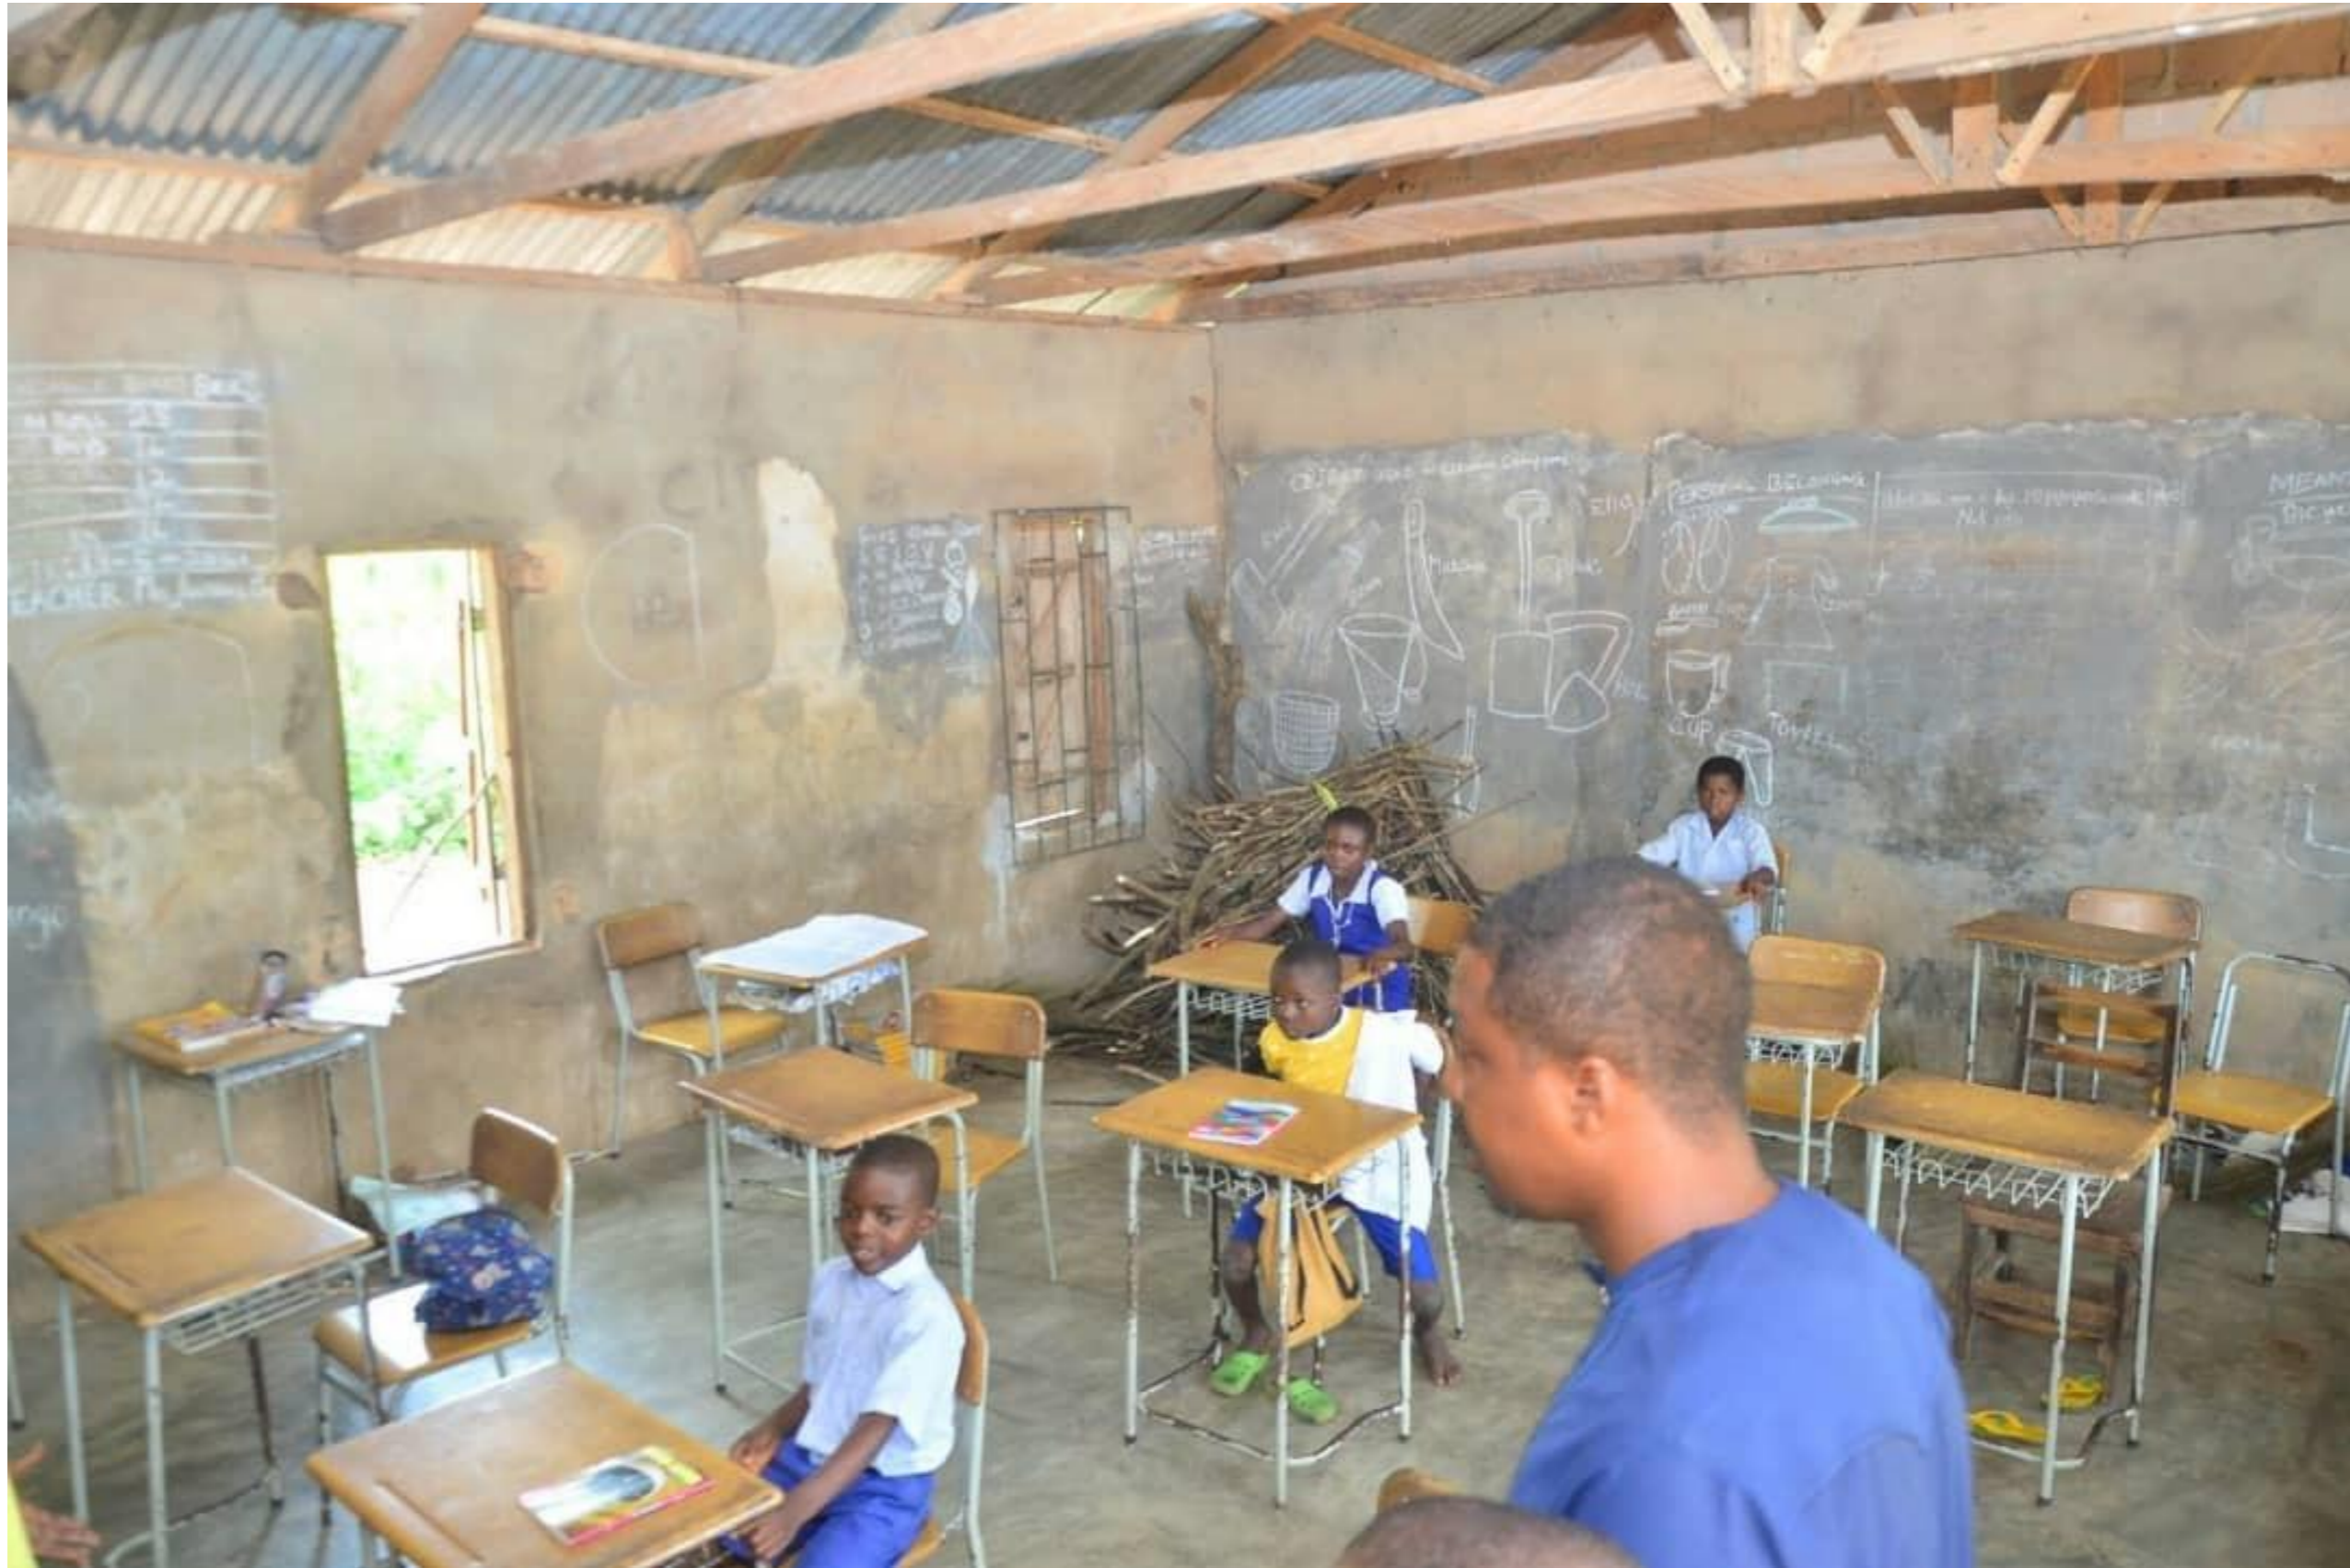
BLOCK F: CLASSROOM

ENVIRONMENTAL ASSESSMENT	
	<ul style="list-style-type: none"> - Surrounding premises, very unkempt, with overgrown bushes. - Surrounding Premises, susceptible to flood.
STRUCTURAL ASSESSMENT	
	<ul style="list-style-type: none"> - Dilapidating. Expired roofing sheets and trusses. Broken Floors. Cracked Walls. - Expired doors and windows - Requires urgent maintenance
FACILITIES ASSESSMENT	
	<ul style="list-style-type: none"> - Facilities grossly inadequate. Barely even present.

SAFETY ASSESSMENT	
	<ul style="list-style-type: none"> - Block not adequately burglarproof - Block not adequately protected from unfavourable weather conditions. - Structural Integrity suspect.
