**OHAKPU COMMUNITY
PRIMARY SCHOOL,
ORU WEST,
IMO STATE, NIGERIA.**

CHARIS LEARNING FOUNDATION

SITE ANALYSIS

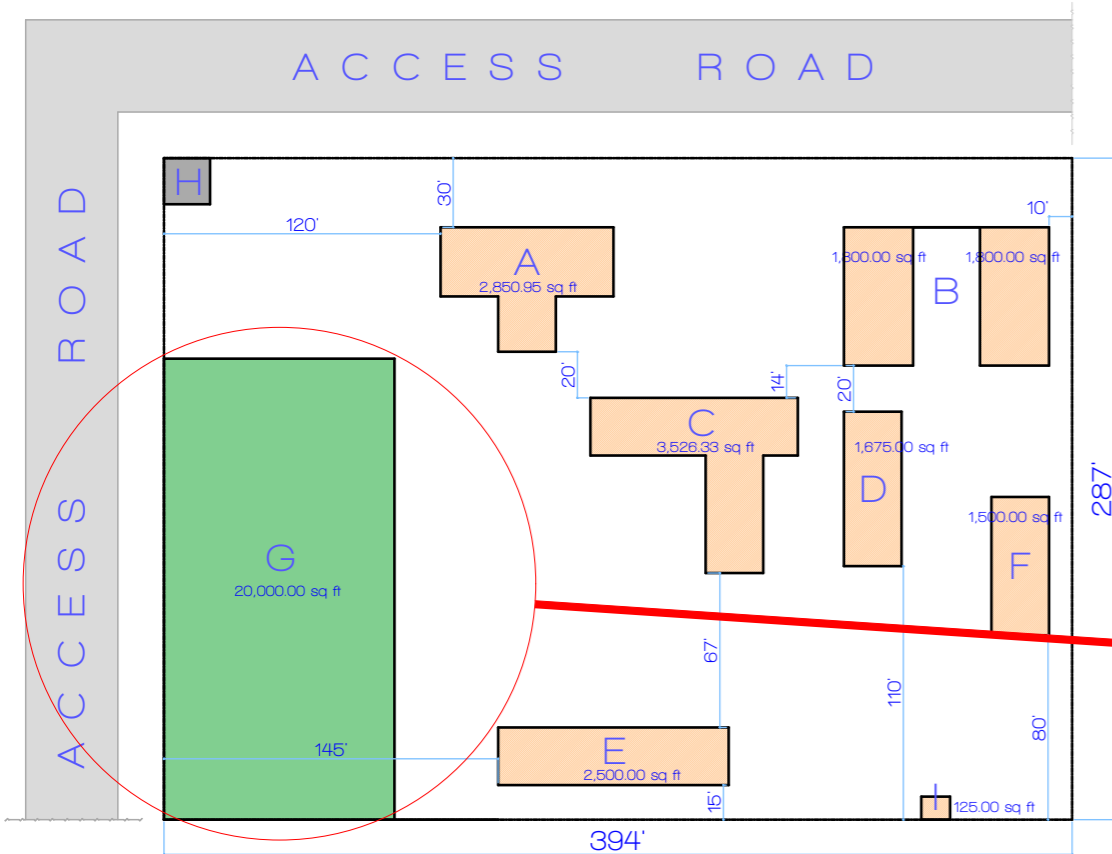
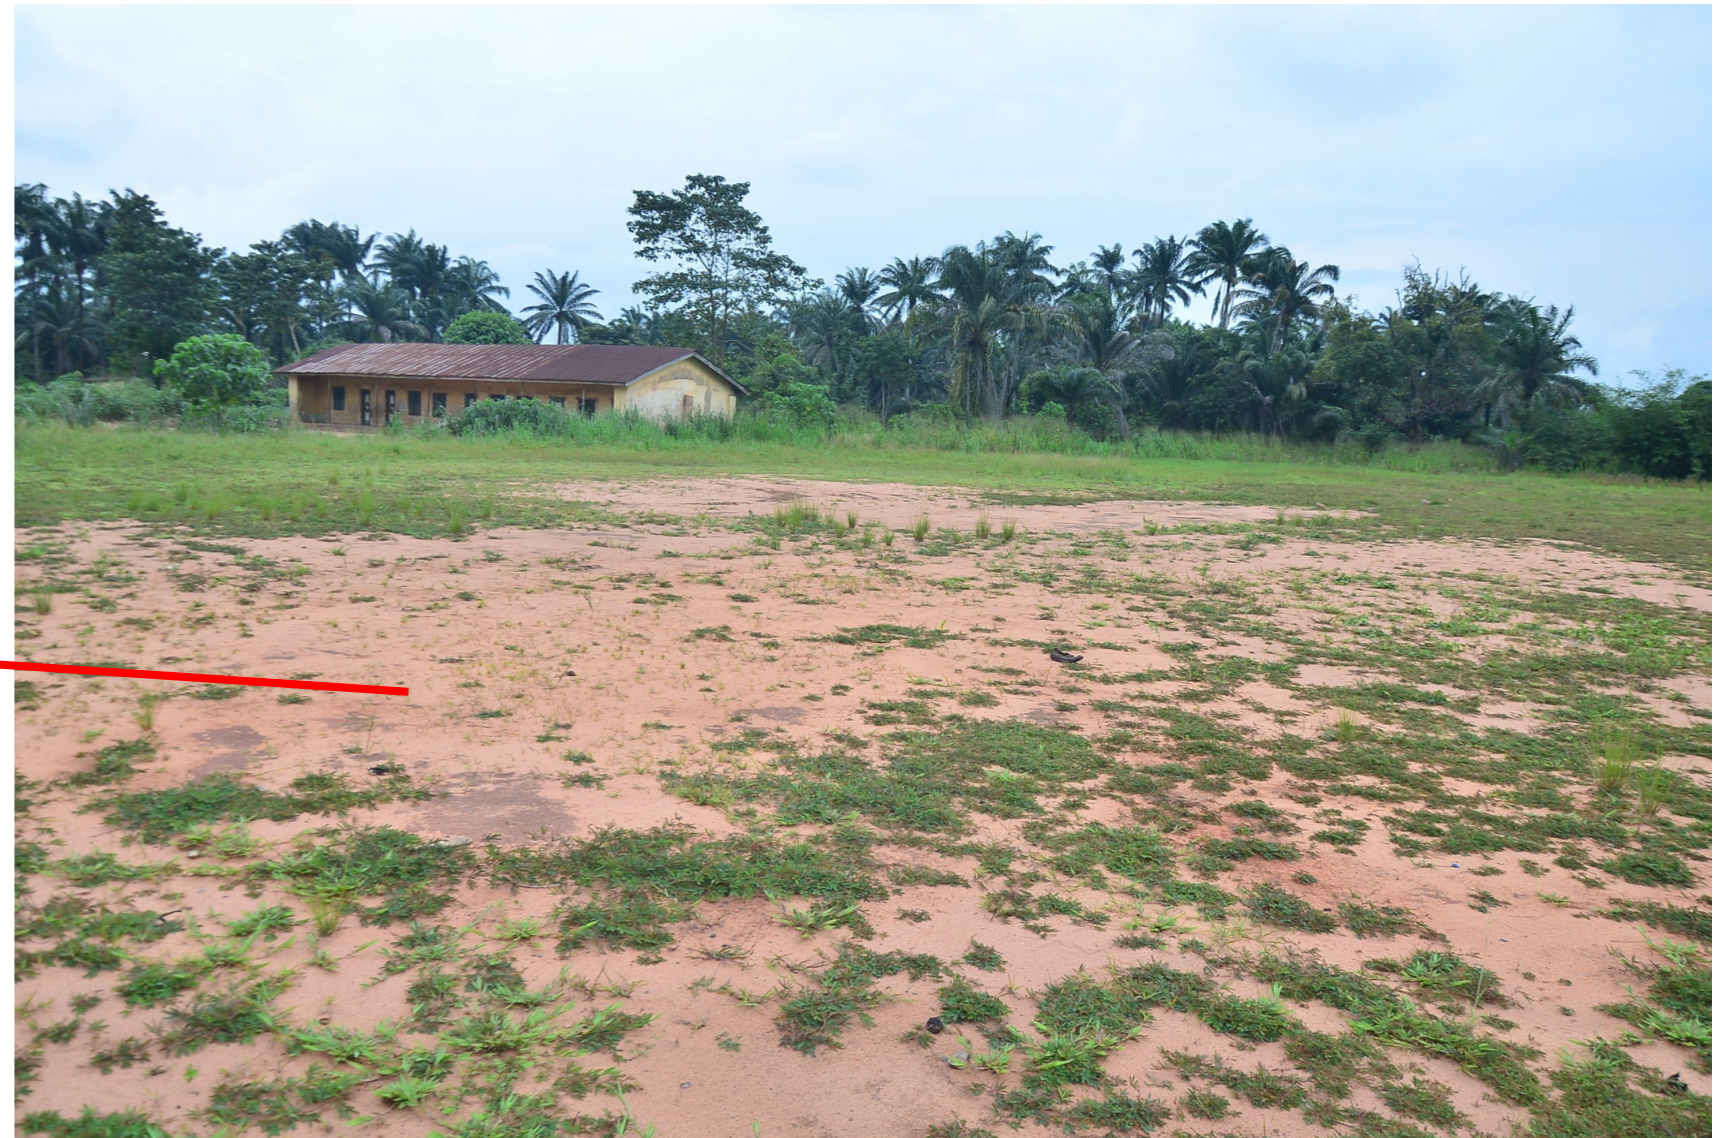
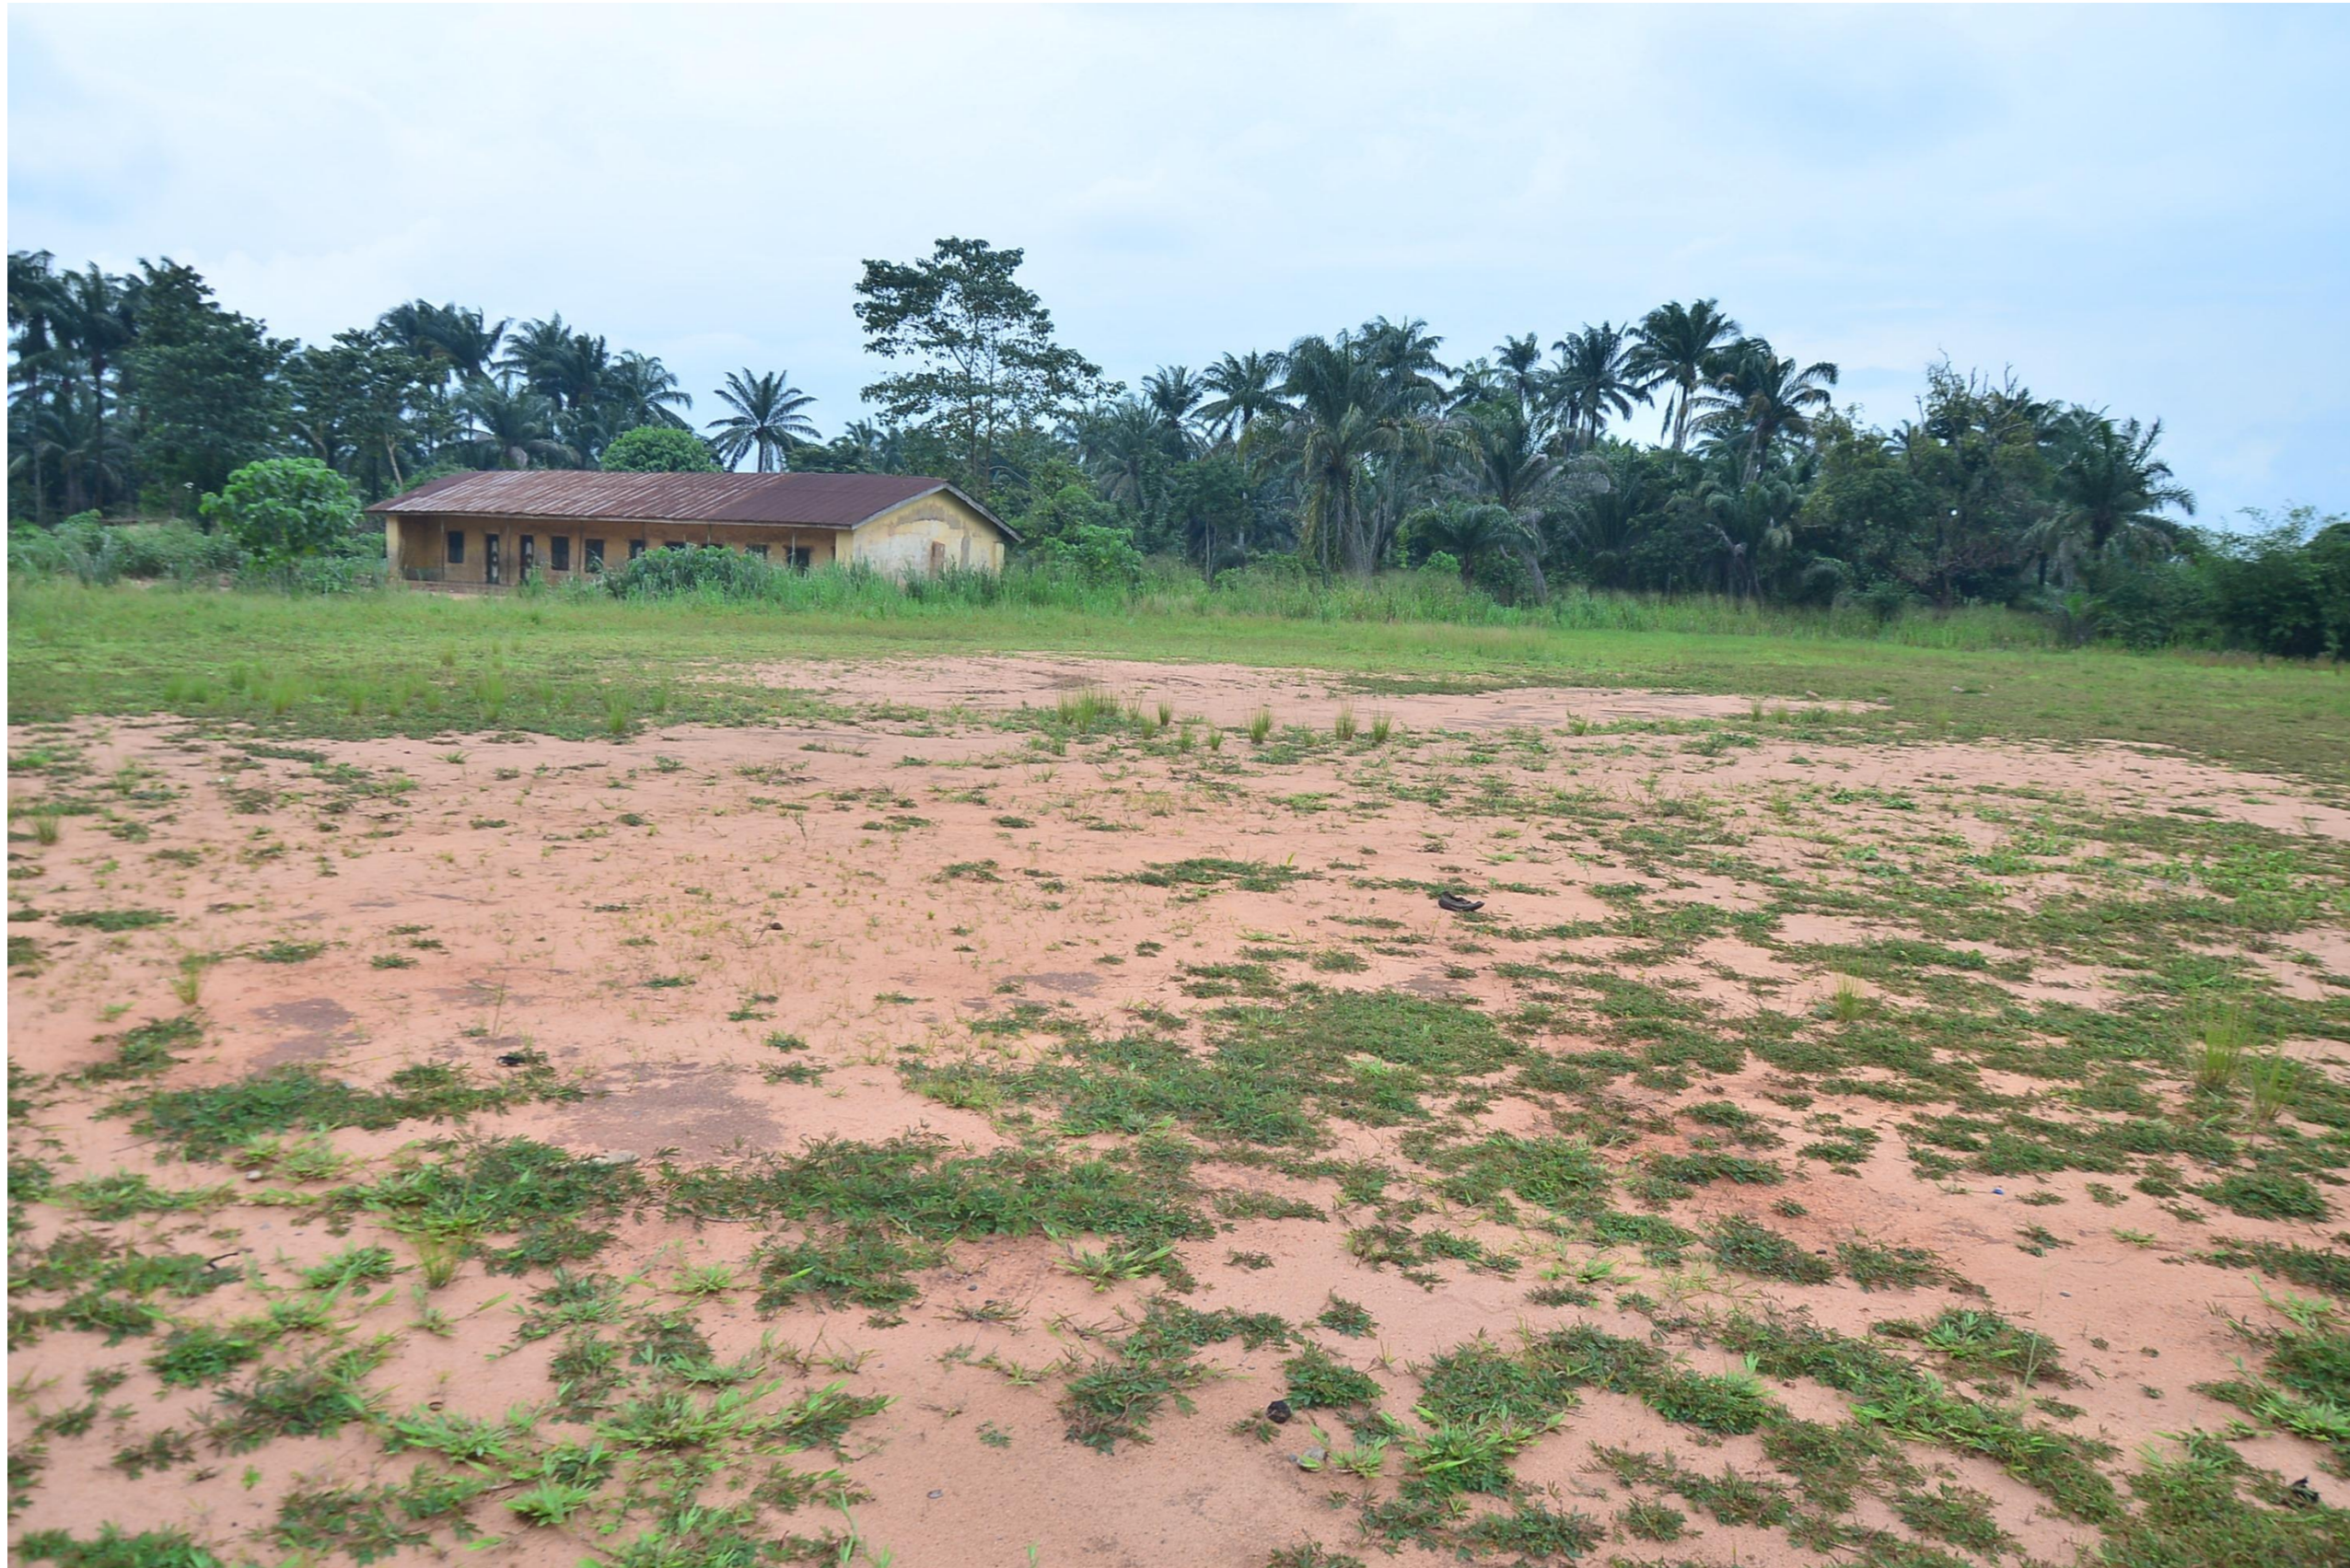
BLOCK G: PLAYGROUND

ENVIRONMENTAL ASSESSMENT	
	<ul style="list-style-type: none"> - Very unkempt; overgrown. - Playground not properly defined or landscaped.
STRUCTURAL ASSESSMENT	
	<ul style="list-style-type: none"> - Requires sustained maintenance.
FACILITIES ASSESSMENT	
	<ul style="list-style-type: none"> - No playground facilities.

SAFETY ASSESSMENT	
	<ul style="list-style-type: none"> - Unkempt playground, not conducive for games.

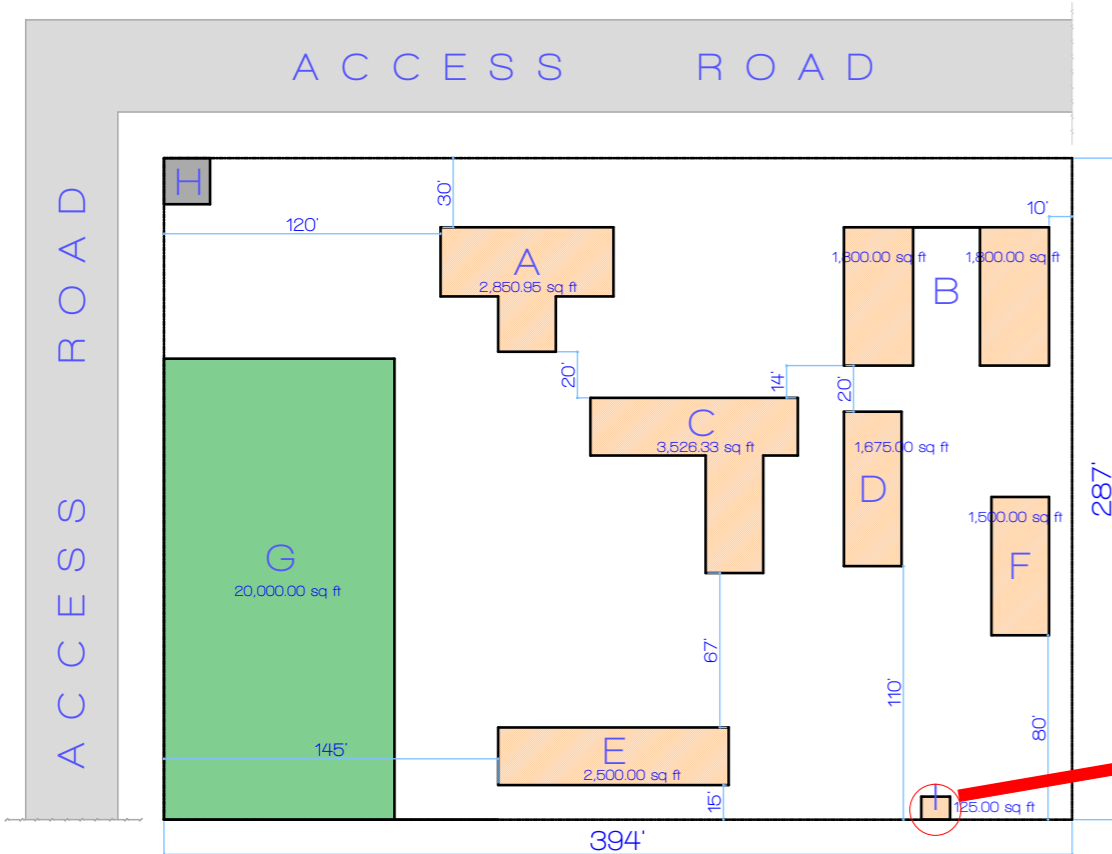
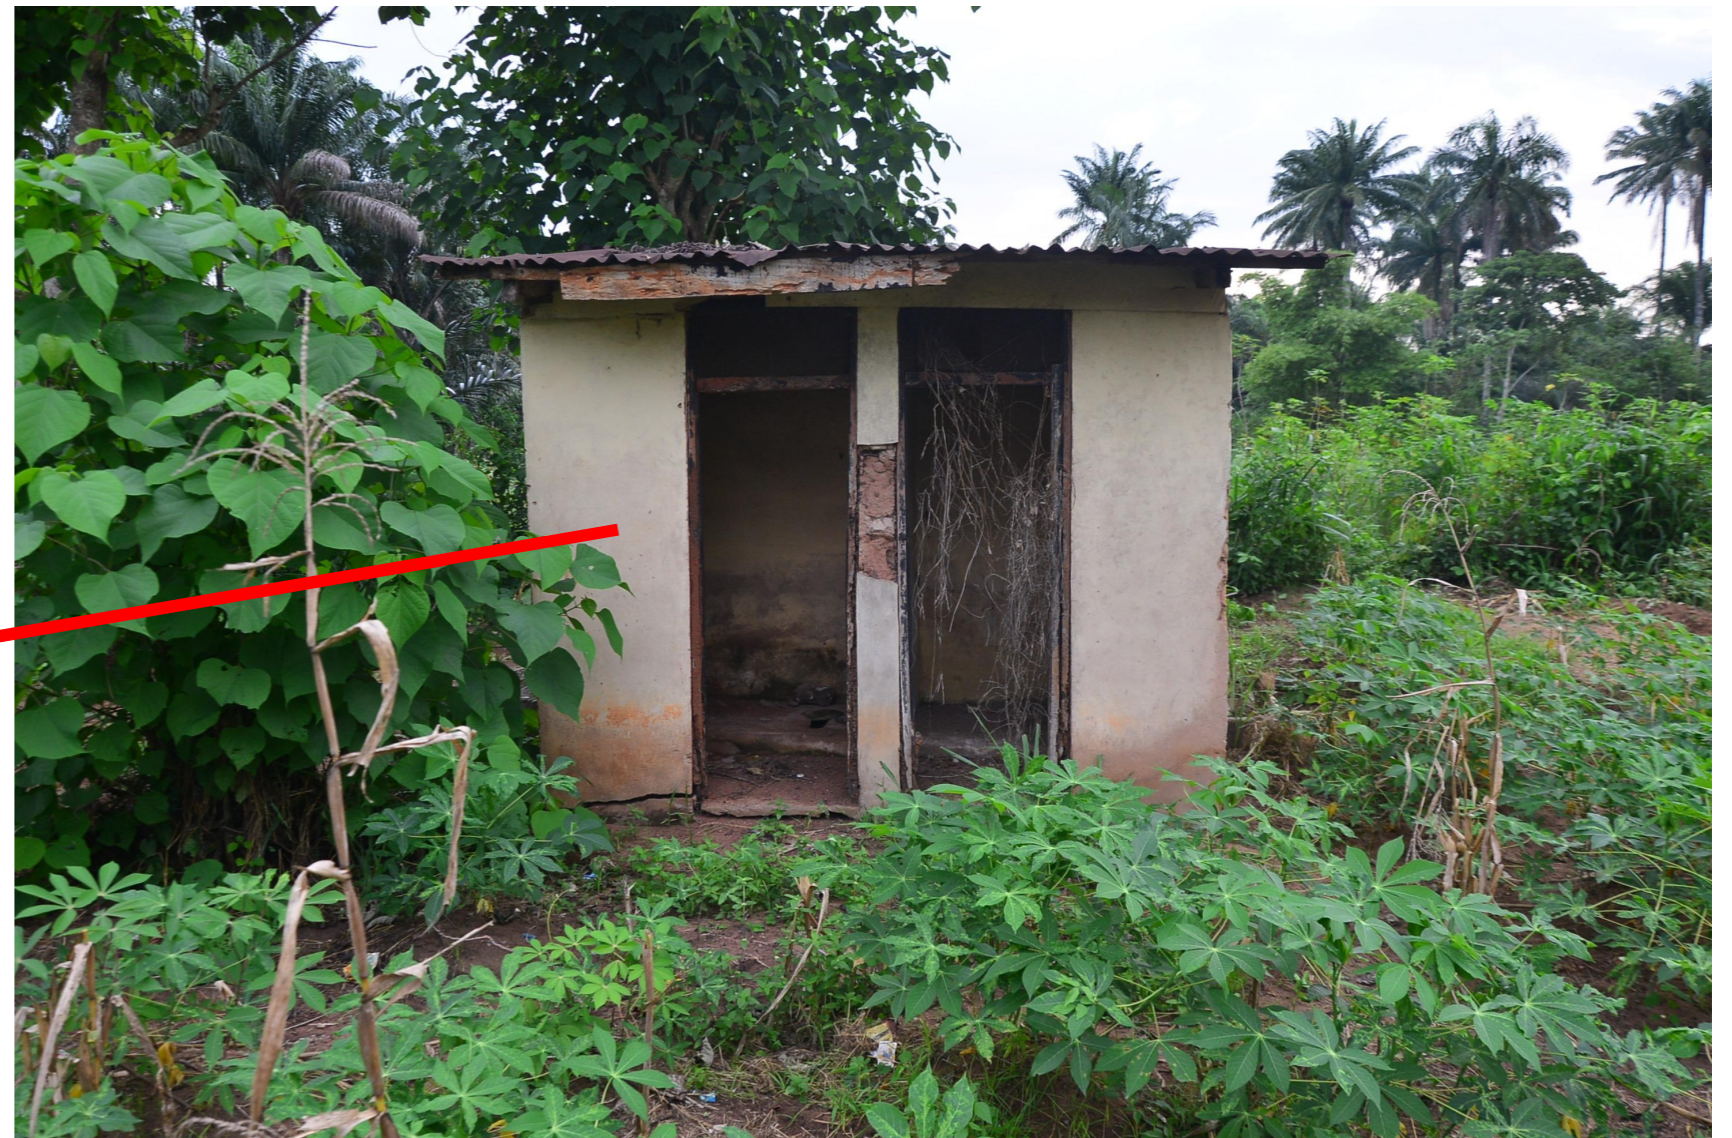
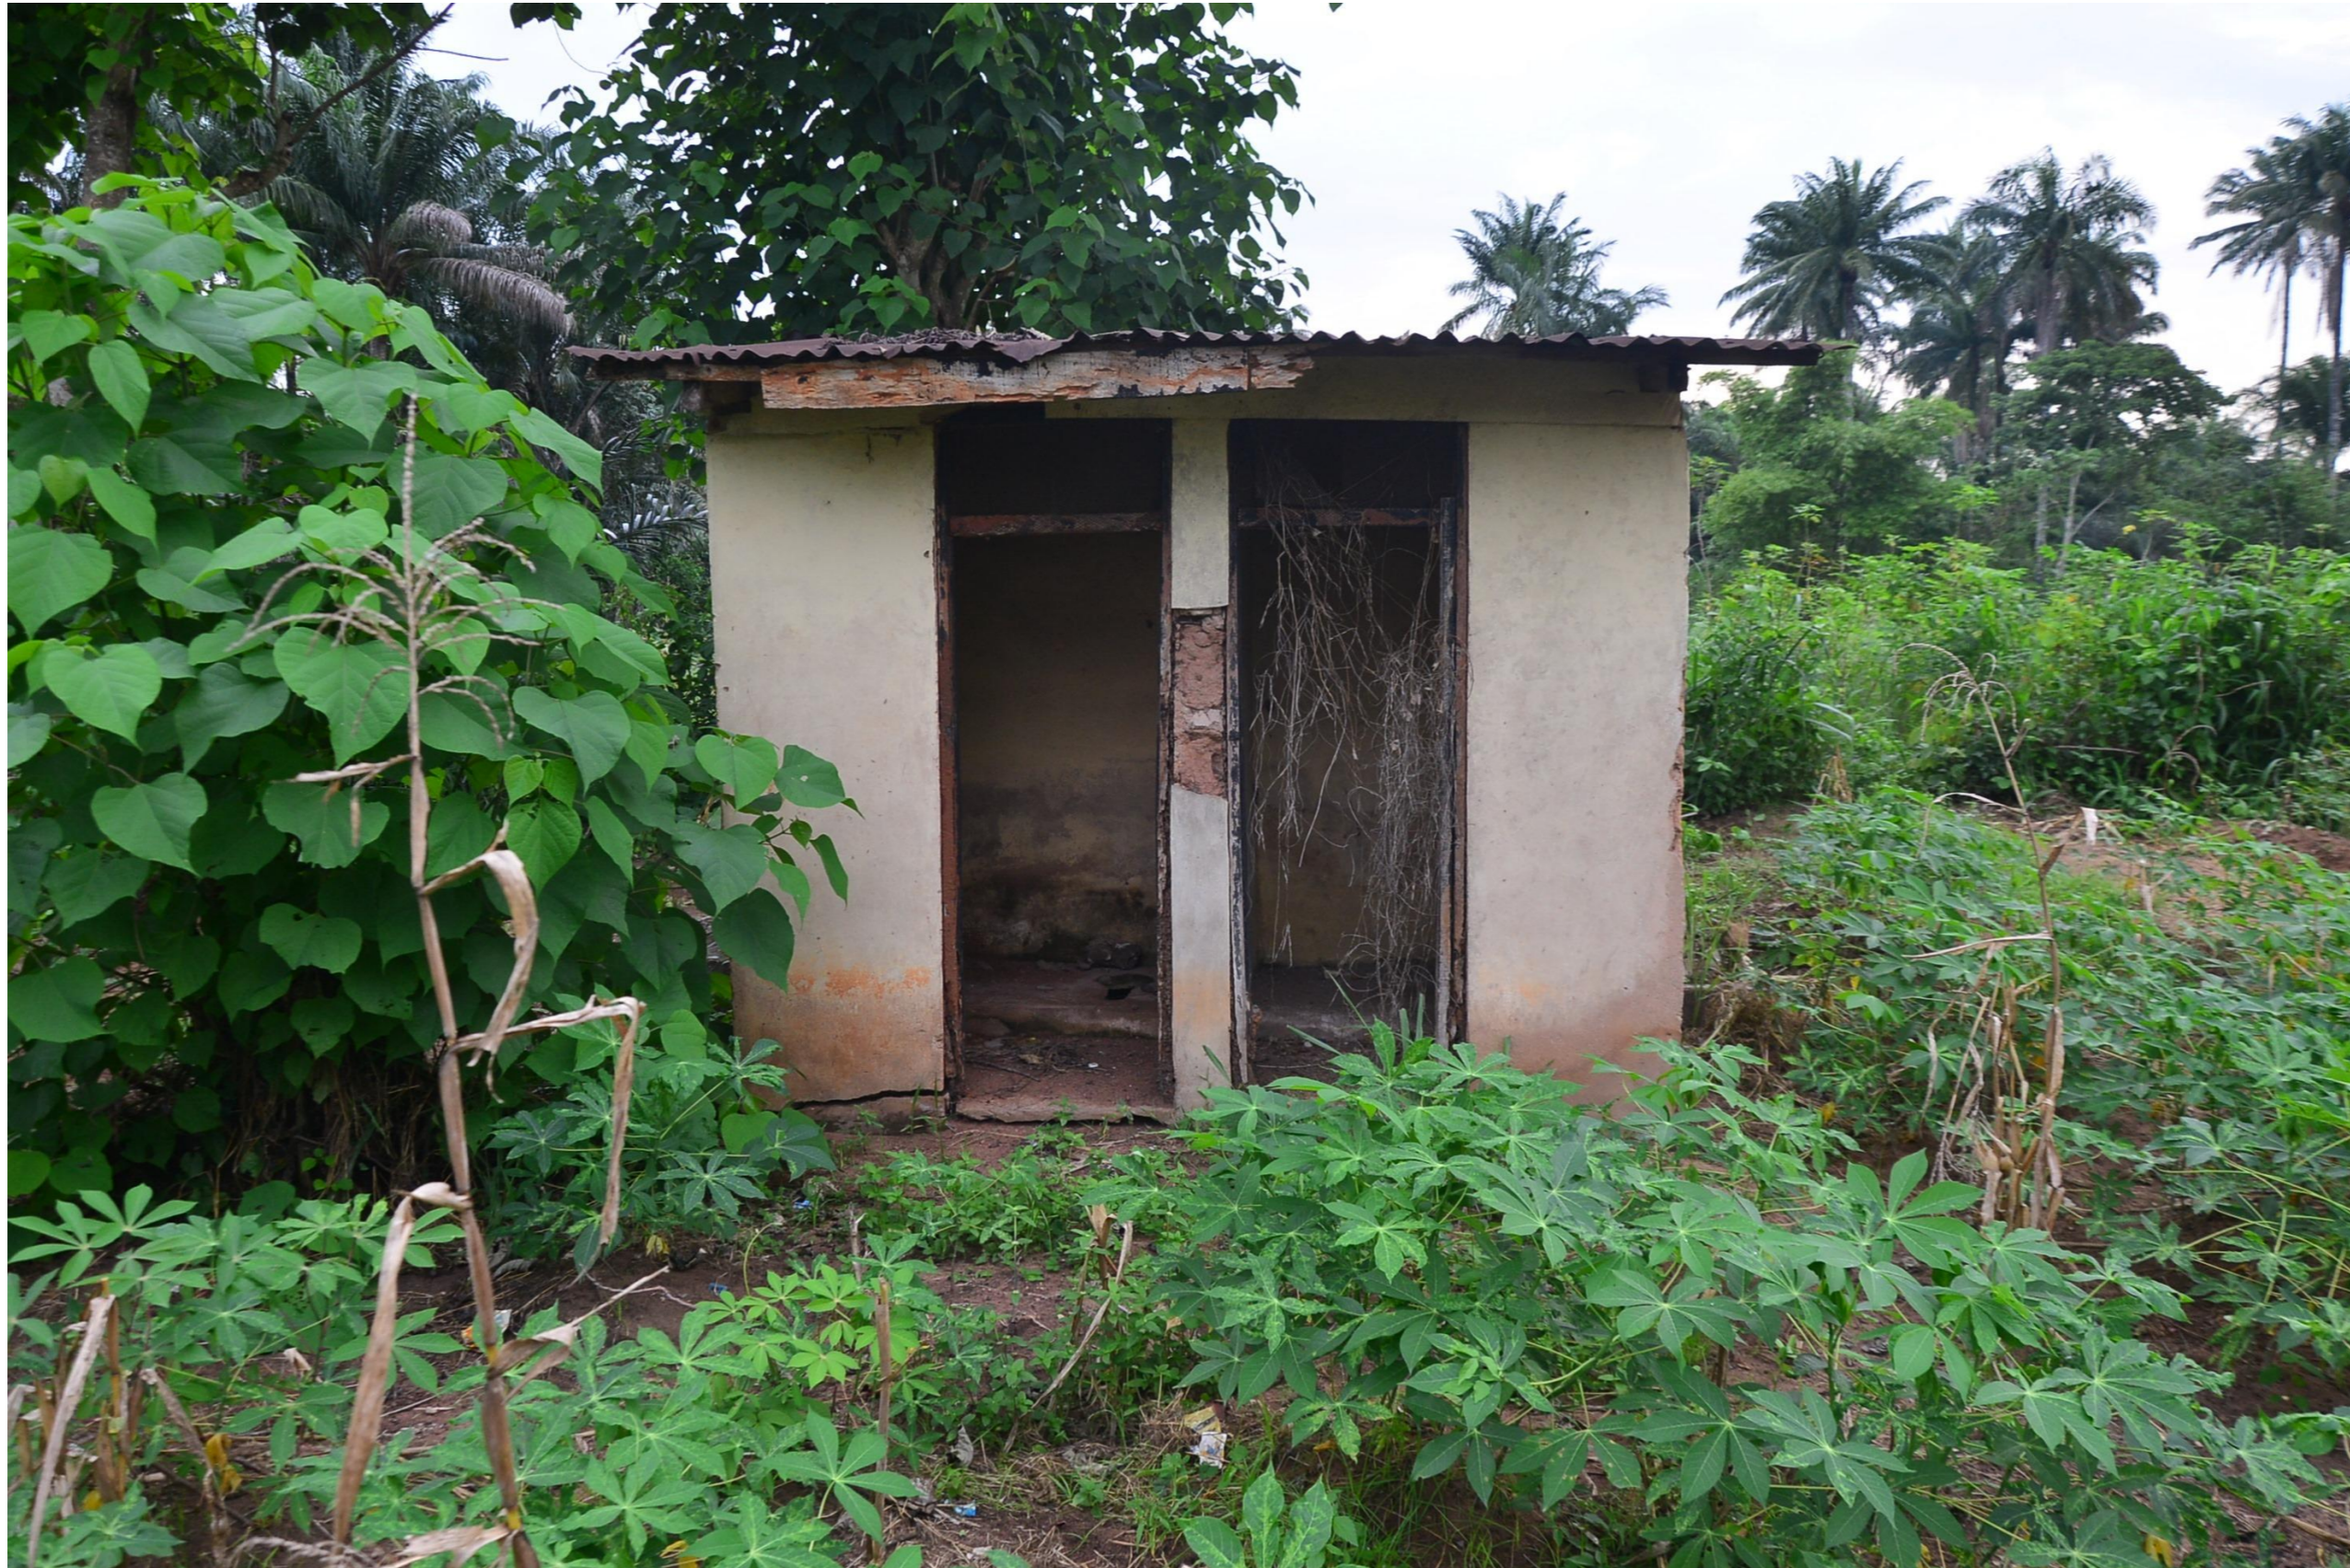
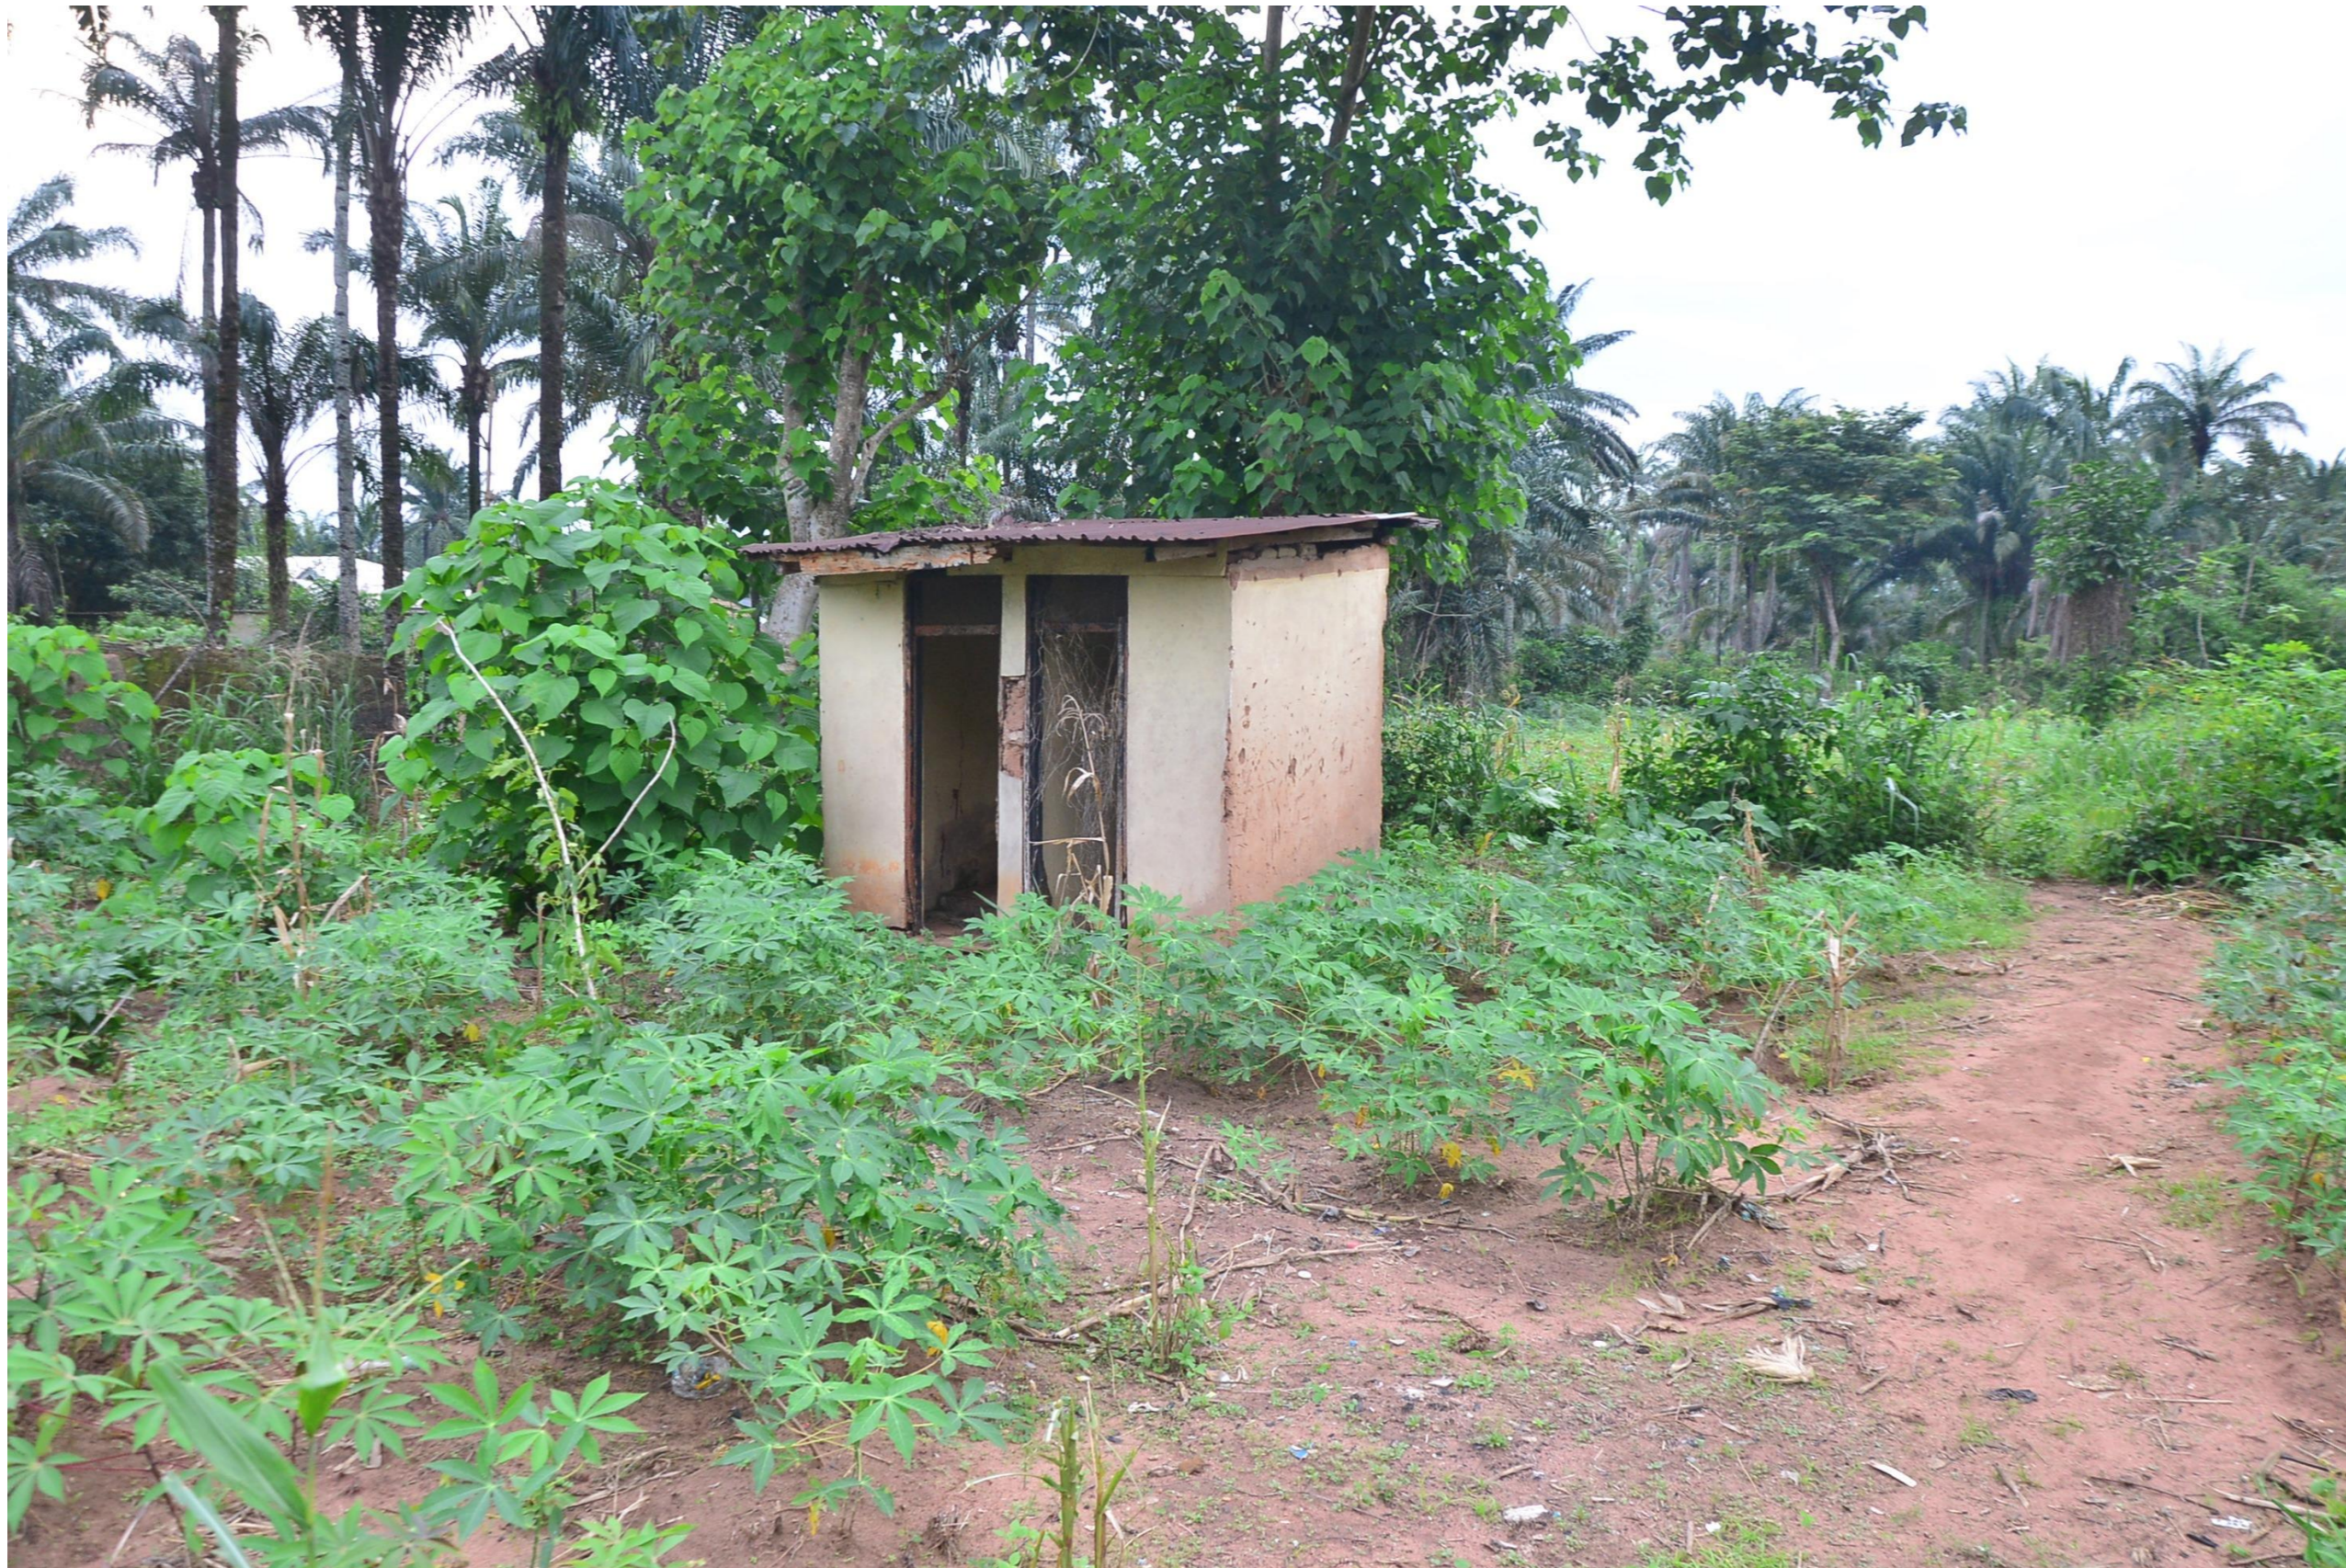
BLOCK I: TOILET

ENVIRONMENTAL ASSESSMENT	
	<ul style="list-style-type: none"> - Very unkempt; overgrown. - Susceptible to environmental predators
STRUCTURAL ASSESSMENT	
	<ul style="list-style-type: none"> - Grossly Substandard - Requires a properly designed-to-standard structure
FACILITIES ASSESSMENT	
	<ul style="list-style-type: none"> - Grossly inadequate, outdated, and in very poor conditions. - Pipe borne water from community borehole does not run into facility. - Poorly designed Pit latrine system in use.

SAFETY ASSESSMENT	
	<ul style="list-style-type: none"> - Environment susceptible to environmental predators such as snakes. - Pit latrine system in use with questionable decomposition means viz a viz pollution of ground water.
