**OHAKPU COMMUNITY
PRIMARY SCHOOL,
ORU WEST,
IMO STATE, NIGERIA.**

CHARIS LEARNING FOUNDATION

SITE ANALYSIS

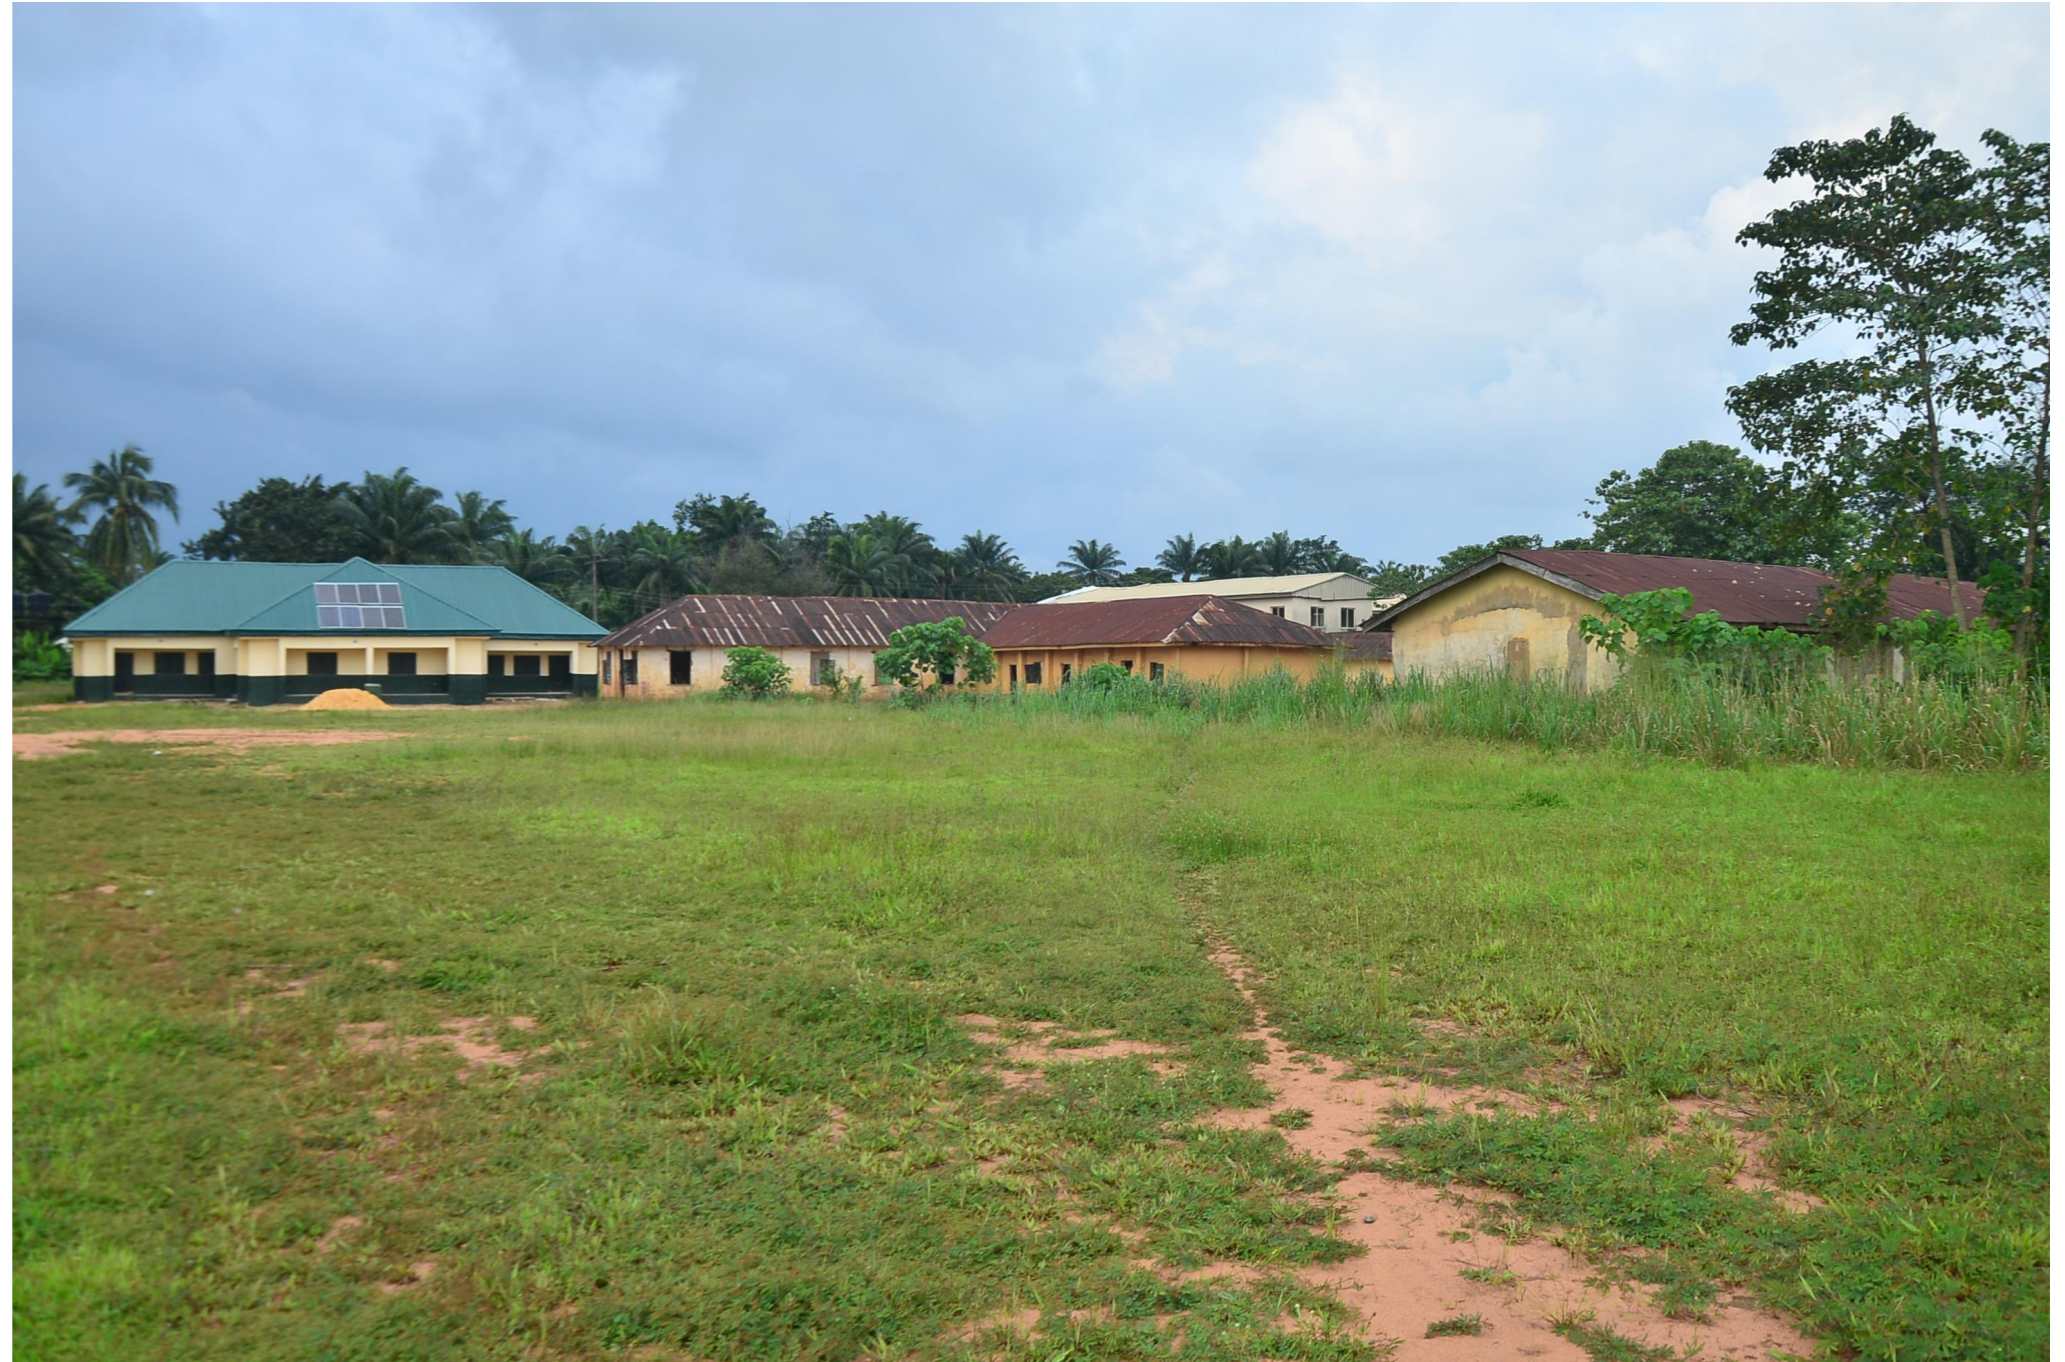
BLOCK B: ROCHAS' ADMINISTRATION'S

ENVIRONMENTAL ASSESSMENT	<ul style="list-style-type: none"> - Surrounding premises, very unkempt, with overgrown bushes. - Surrounding Premises, susceptible to flood.
STRUCTURAL ASSESSMENT	<ul style="list-style-type: none"> - Dilapidating. Roofing sheets and trusses torn out. - Guard Rails structural integrity are suspect. - The structure, a pre-fabricated structure do not appear and feel properly fabricated and fixed, going by the presence of wall cracks and quivering nature of the structure.

FACILITIES ASSESSMENT	<ul style="list-style-type: none"> - Facility not safe for use.
SAFETY ASSESSMENT	<ul style="list-style-type: none"> - Block not adequately burglary-proof - Block not adequately protected from unfavourable weather conditions - Block not structurally sound for use.
